FINDING OF NO SIGNIFICANT IMPACT

KOTZEBUE TO CAPE BLOSSOM ROAD

PROJECT No. NCPD-0002(204)/76884

Department of Transportation
and Public Facilities

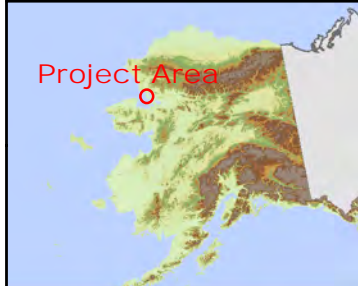
Revision: 3 Figure: 1.1

The project location including the proposed road alternatives is shown in Figure 1.1. Figure 1.2 shows a typical road section. Turnout and trail access typical details are shown in Figure 1.3 and Figure 1.4, respectively. The staging pad typical is shown in Figure 1.5, and Figure 1.6 shows the beach access ramp.

Kotzebue to Cape Blossom Road Project Location

The alternatives are shown on Figure 1.1. They are the Eastern Route, Middle Route via the upper Sadie Creek option, Hillside Route, and Upgrade Route. Table 3.1 provides the length of the alternative route segments and the total length by alternative.

The land ownership and winter trails are shown in Figure 1.1. No camps, cabins, or other structures are located along the proposed road corridor. Several ANCSA 14(c) campsites are located on the coast near the terminus of the road, but not within the proposed road corridor.

Two lakes and the surrounding property adjacent to the proposed road corridor have been set aside for use as a future watershed by the City of Kotzebue. Figure 1.1 shows the watershed location.

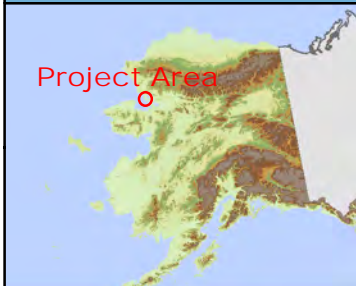
Kotzebue to Cape Blossom Road Wetlands and Waterbodies

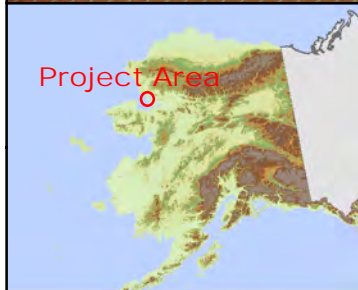
Kotzebue to Cape Blossom Road Selected Mammal Habitat

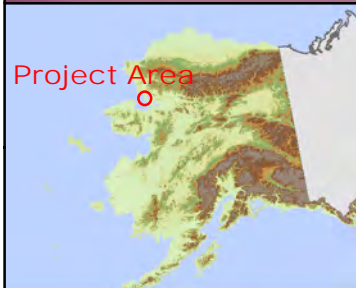
**Kotzebue to Cape Blossom Road
Selected Waterfowl and
Essential Fish Habitat**

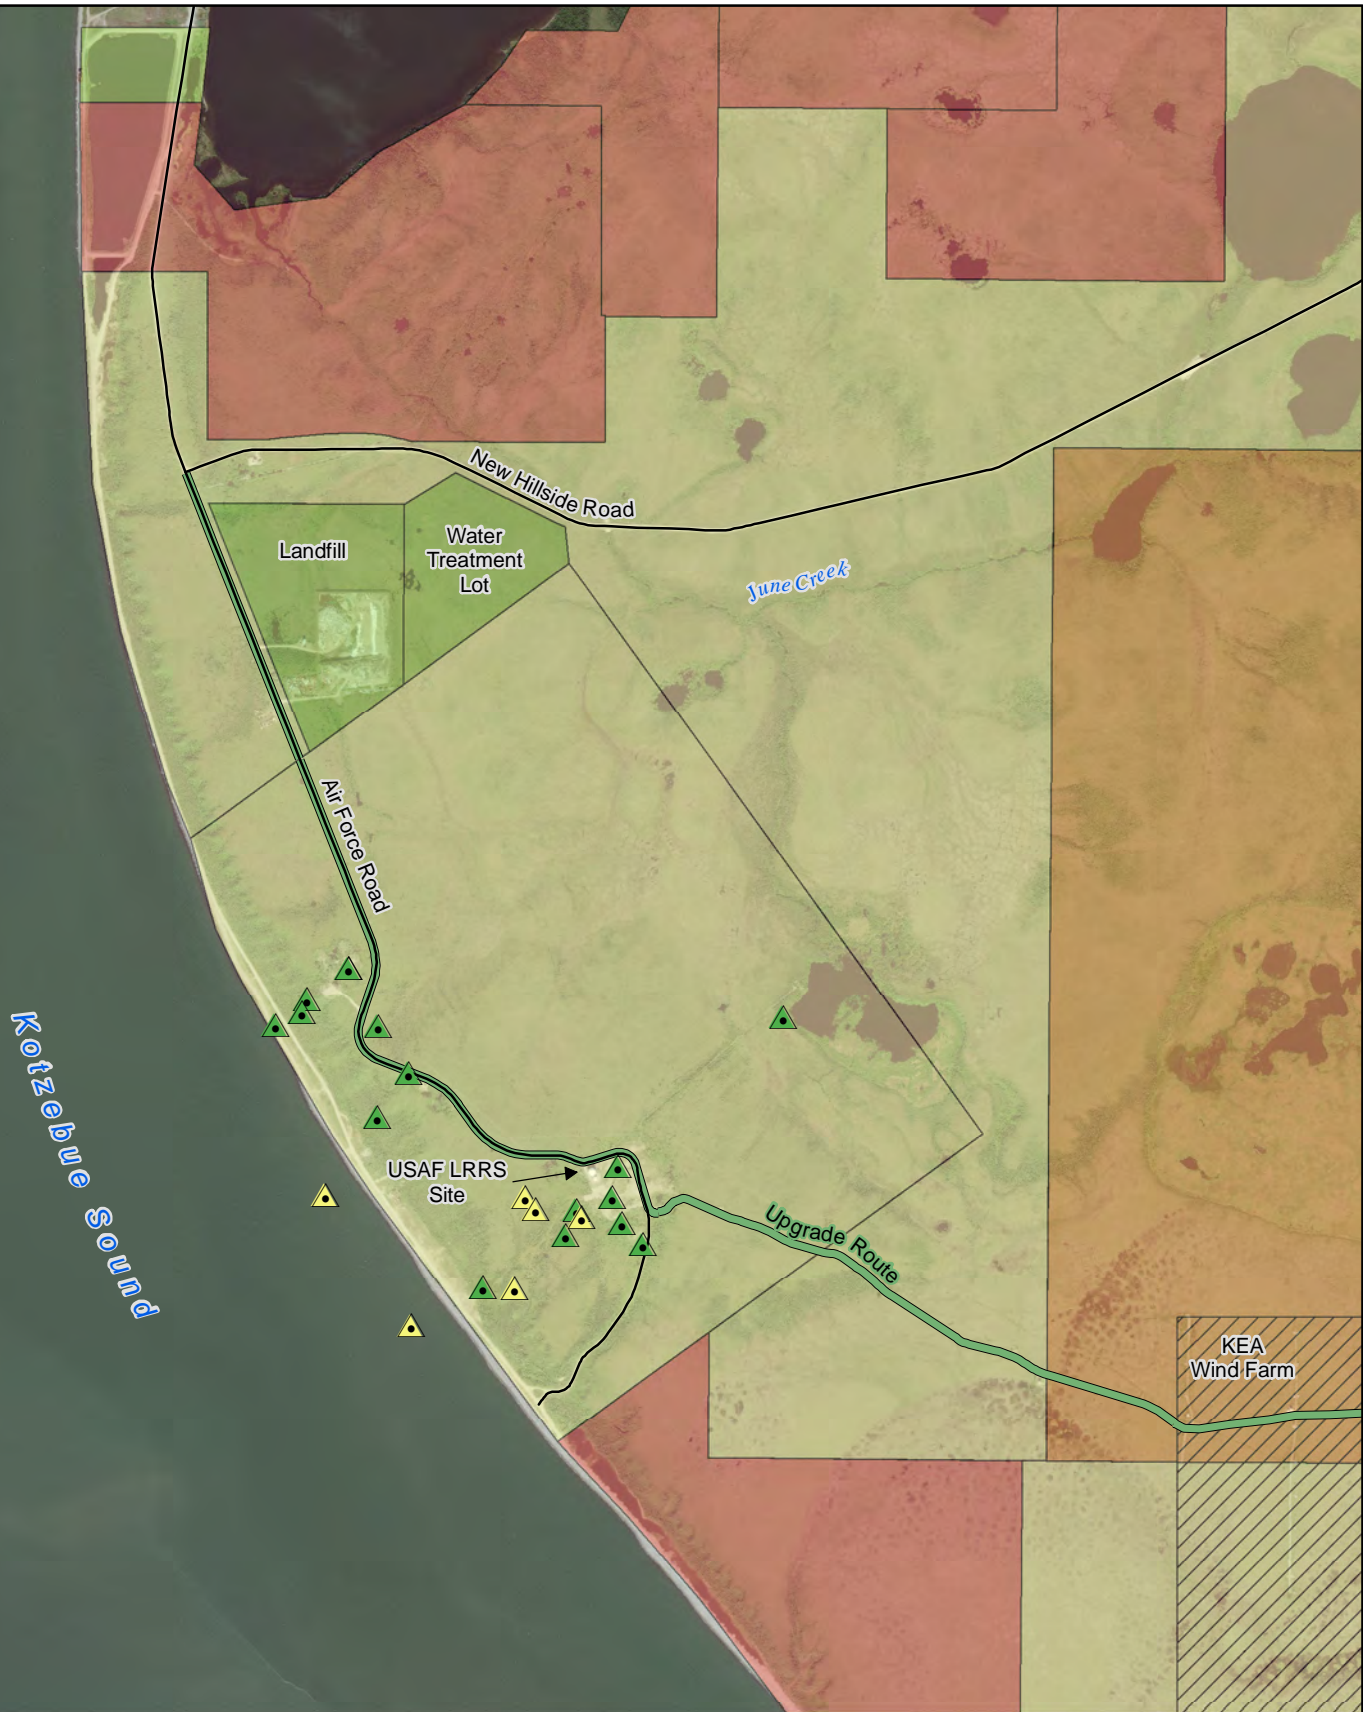
**Kotzebue to Cape Blossom Road
Kotzebue LRRS Contaminated Sites**

SS-15 Garage Power Plant	DRO GRO	Cleanup Complete
SS-16 Navigational Aid Buildings	DRO	Cleanup Complete
SS-17 PCBs at Building 102	PCB, DRO	Cleanup Complete
SS-18 Truck Fill Stand	DRO	Cleanup Complete – Institutional Controls
SS-19 PCB Spills at South Fence	DRO PCB	Cleanup Complete – Institutional Controls
SS-20 Septic Holding Tank	Metal PCB Pesticides	Cleanup Complete – Institutional Controls
AOC 2 POL Line	POL	Cleanup Complete
AOC 8 White Alice Garage	Petroleum PCB	Cleanup Complete

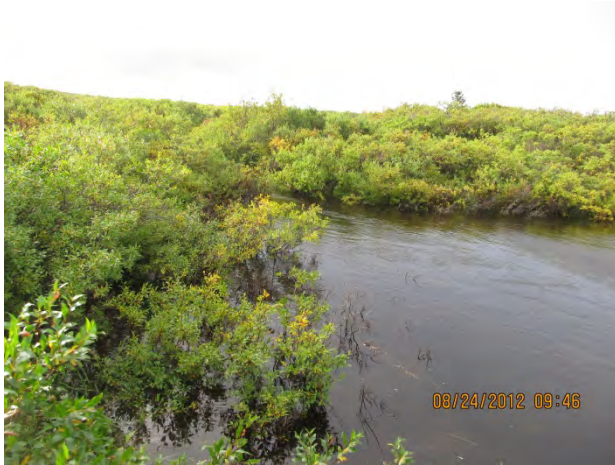
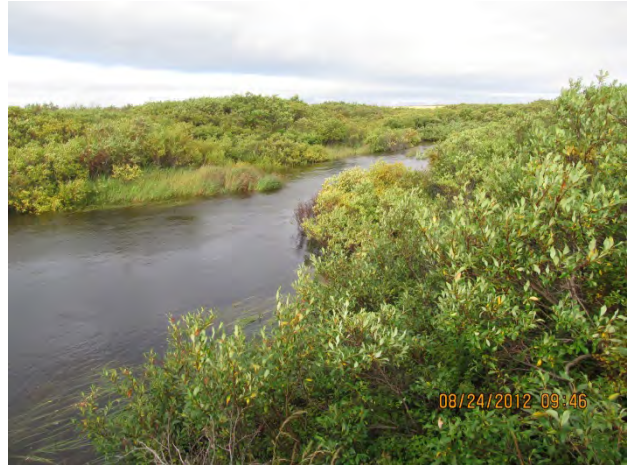
CB_01: Lower Perennial River
NWI Class: R2UBH

Hydrology: Surface water (A1)
Soils: No pit dug, inundated

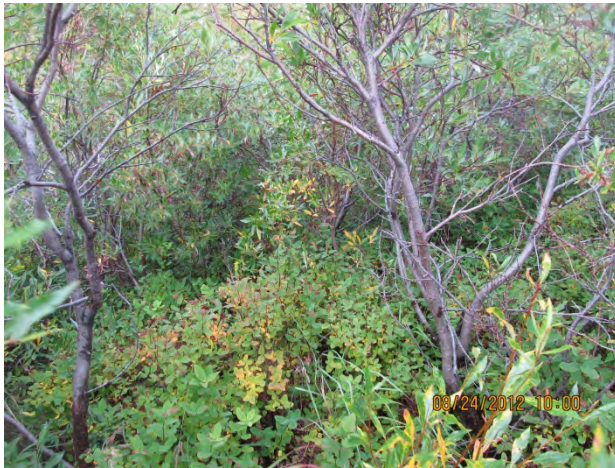
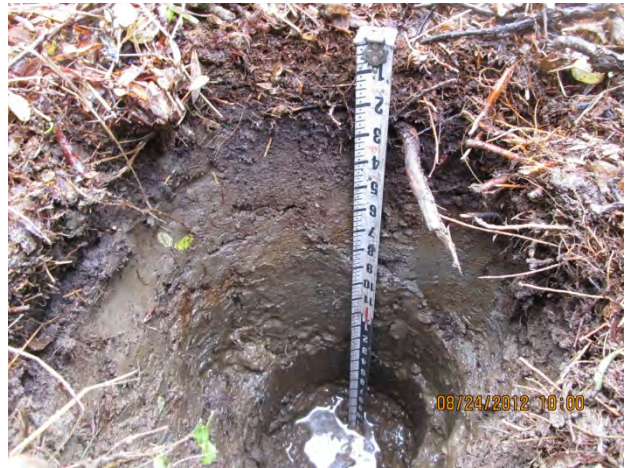
CB_02: Saturated Low and Tall Deciduous Shrub
NWI Class: PSS1B

Hydrology: Saturated (A3) with high water table (A2)
Soils: Organics over silty clay loam (Problematic, AK Gleyed)

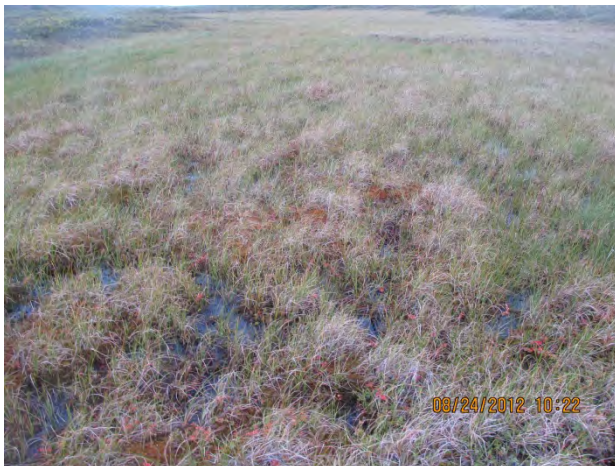
CB_03: Seasonally Flooded Saturated Sedge-Shrub Meadow
NWI Class: PEM1E

Hydrology: Surface water (A1) with shallow aquitard (D3)
Soils: No pit dug, inundated

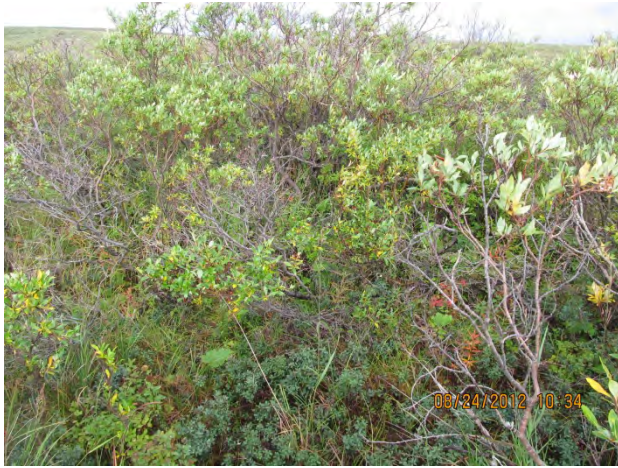
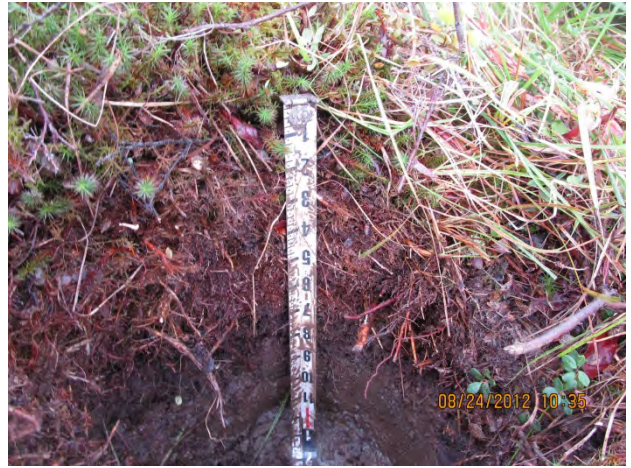
CB_04: Saturated Low and Tall Deciduous Shrub
NWI Class: PSS1B

Hydrology: Saturated (A3) with high water table (A2)
Soils: Organics over silty clay loam (Alaska Redox A14)

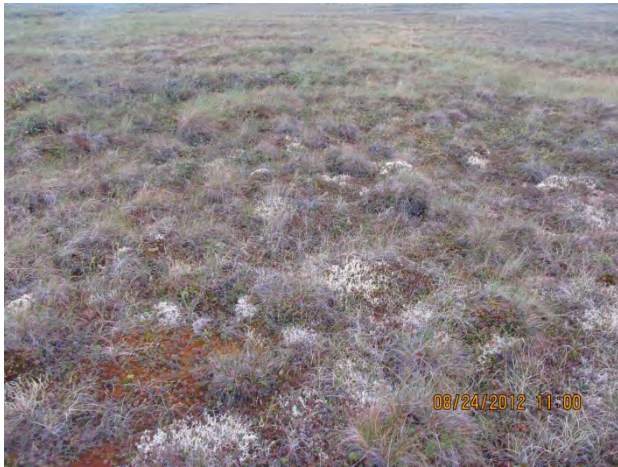
CB_05: Saturated Emergent Sedge-Shrub Meadow
NWI Class: PSS3/EM1B

Hydrology: Saturated (A3) with high water table (A2)
Soils: No pit dug, inundated

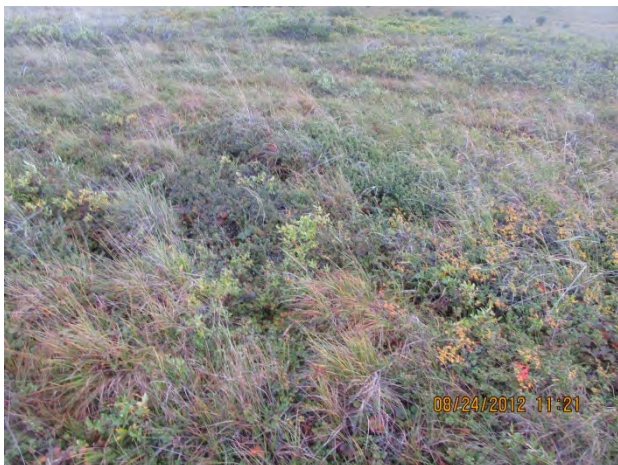
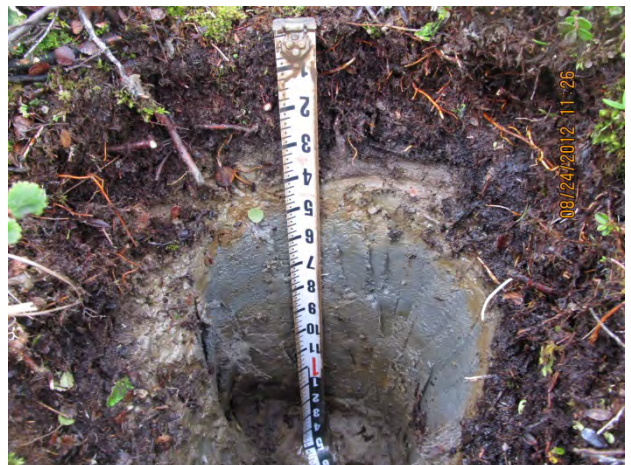
CB_06: Saturated Birch-Ericaceous Scrub Tundra
NWI Class: PSS1B

Hydrology: Saturated (A3) with high water table (A2)
Soils: Organics over silty clay loam (Alaska Redox A14)

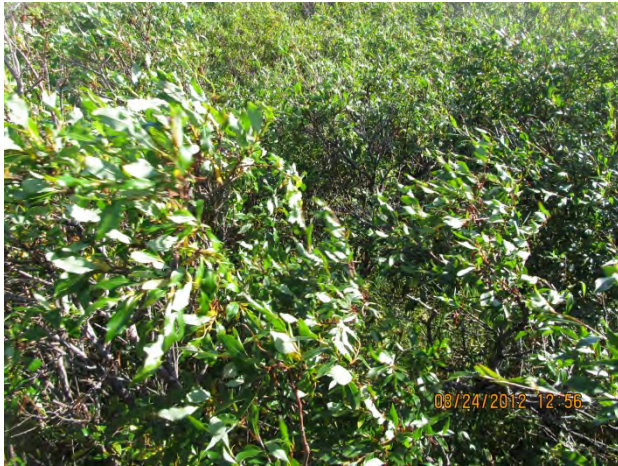
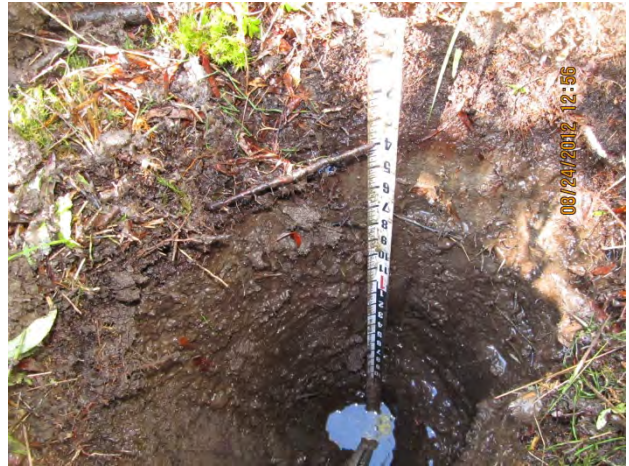
CB_07: Saturated Low and Tall Deciduous Shrub
NWI Class: PSS1B

Hydrology: Saturated (A3) with high water table (A2)
Soils: Organics over silty clay loam (Problematic, Other)

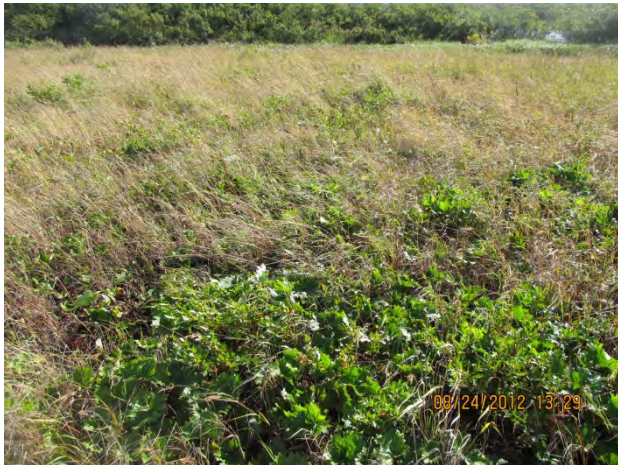
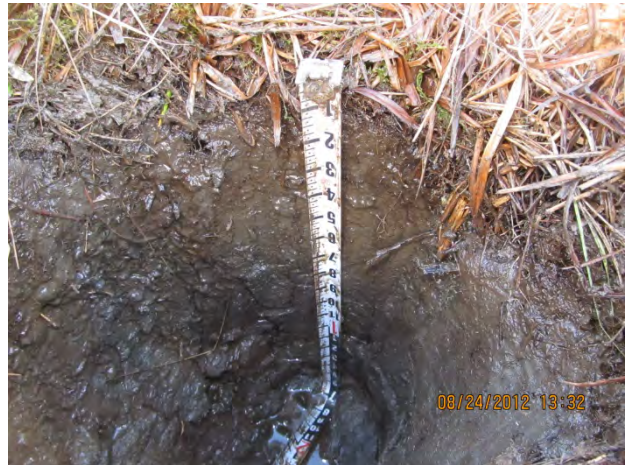
CB_08: Saturated Emergent Sedge-Shrub Meadow
NWI Class: PEM1B

Hydrology: Saturated (A3) with high water table (A2)
Soils: Organics over silty clay loam (Problematic, Other)

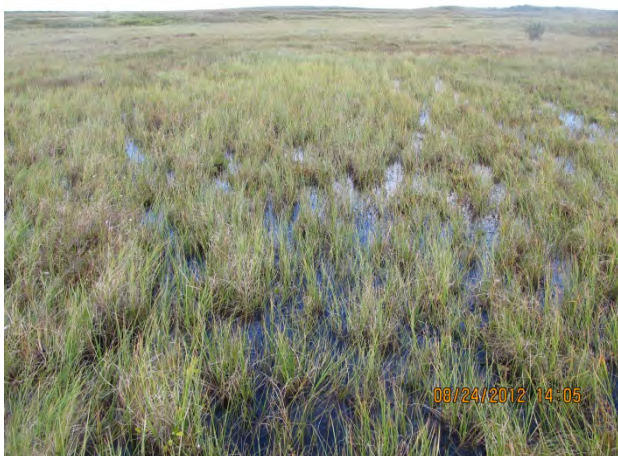
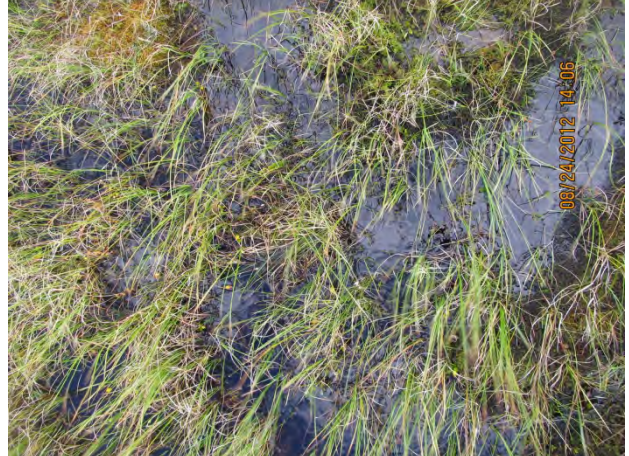
CB_09: Seasonally Flooded Saturated Sedge-Shrub Meadow
NWI Class: PEM1E

Hydrology: Surface water (A1)
Soils: No pit dug, inundated

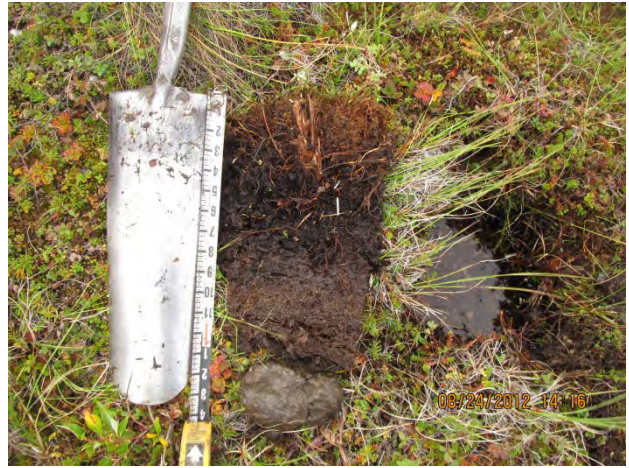
CB_10: Saturated Birch-Ericaceous Scrub Tundra
NWI Class: PSS3B

Hydrology: Saturation (A3) with high water table (A2)
Soils: Organics over silty clay loam (Histic Epipedon A2)

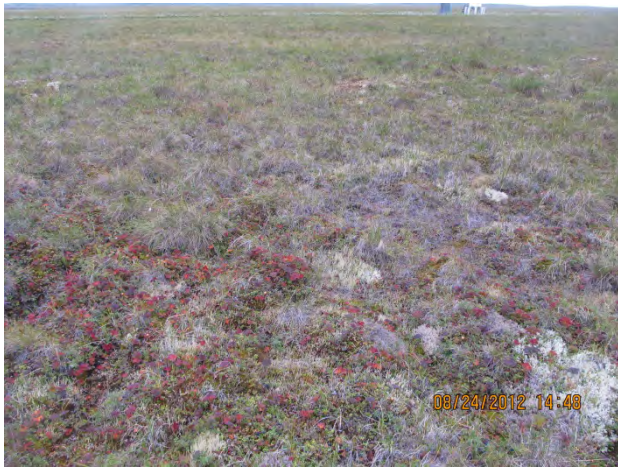
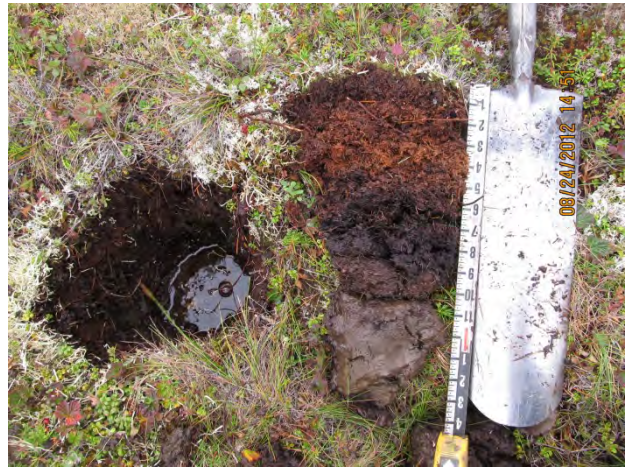
CB_11: Saturated Emergent Sedge-Shrub Meadow
NWI Class: PSS3/EM1B

Hydrology: Saturated (A3) with high water table (A2)
Soils: Organics over silty clay loam (Histic Epipedon A2)

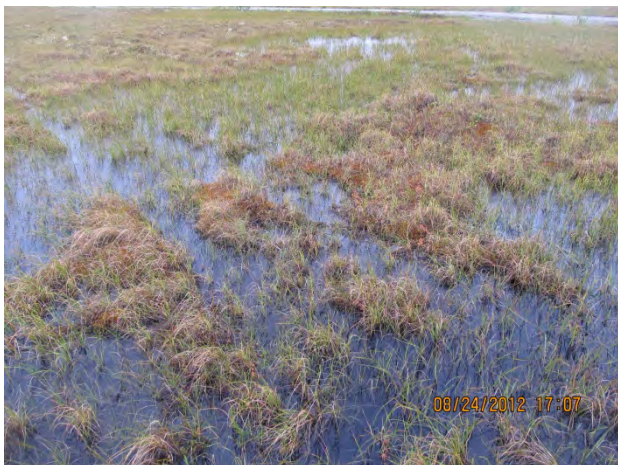
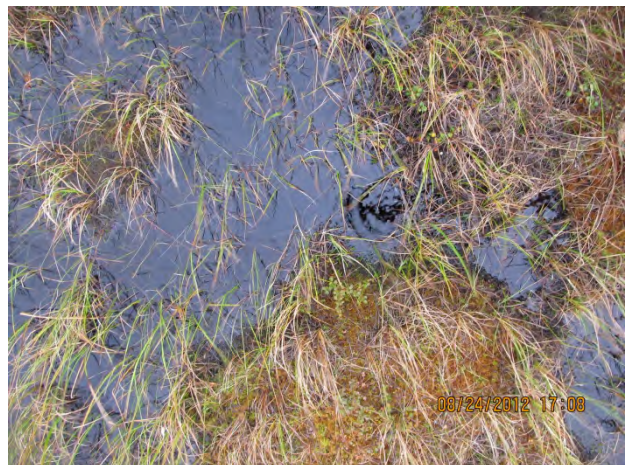
CB_12: Seasonally Flooded Saturated Sedge-Shrub Meadow
NWI Class: PEM1E

Hydrology: Surface water (A1)
Soils: No pit dug, inundated

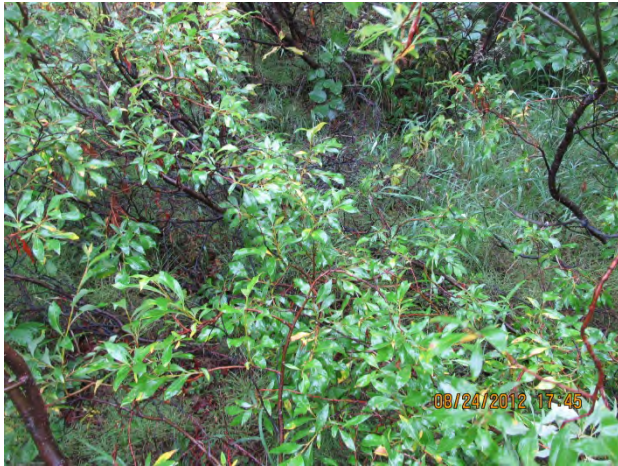
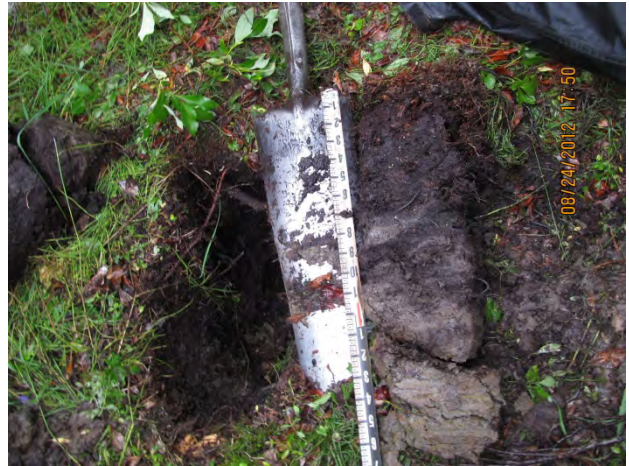
CB_13: Saturated Low and Tall Deciduous Shrub
NWI Class: PSS1B

Hydrology: Saturation (A3) with high water table (A2)
Soils: Organics over silty clay loam (Histic Epipedon A2)

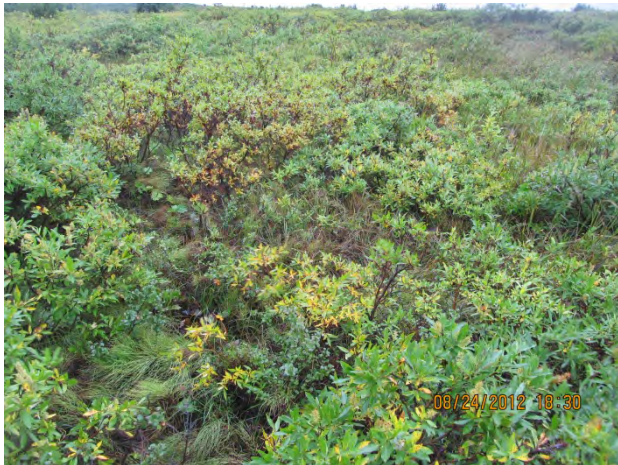
CB_14: Saturated Low and Tall Deciduous Shrub
NWI Class: PSS1B

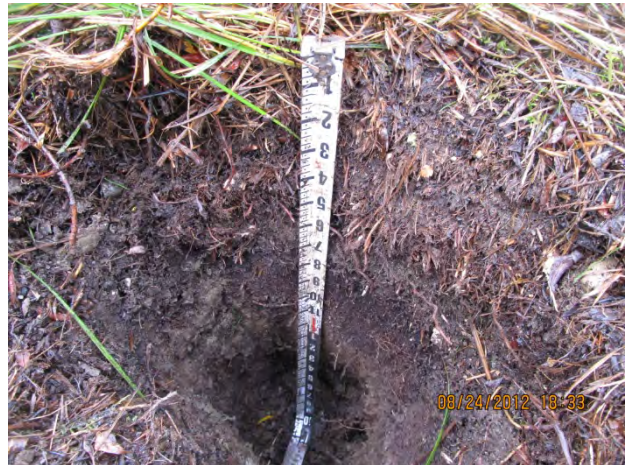
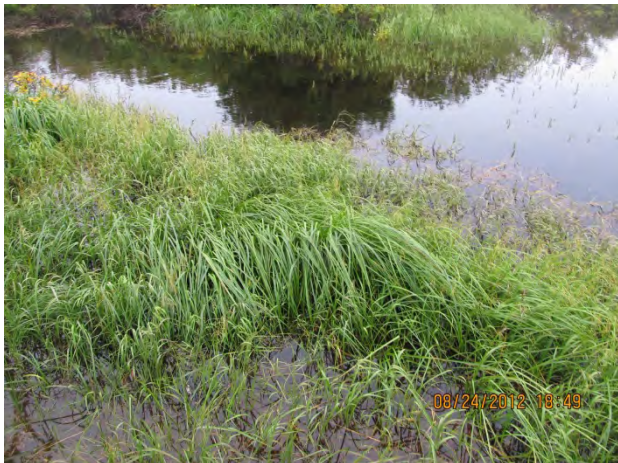
Hydrology: Saturation (A3) with a shallow aquitard (D3)
Soils: Organics over silty clay loam (Histic Epipedon A2)

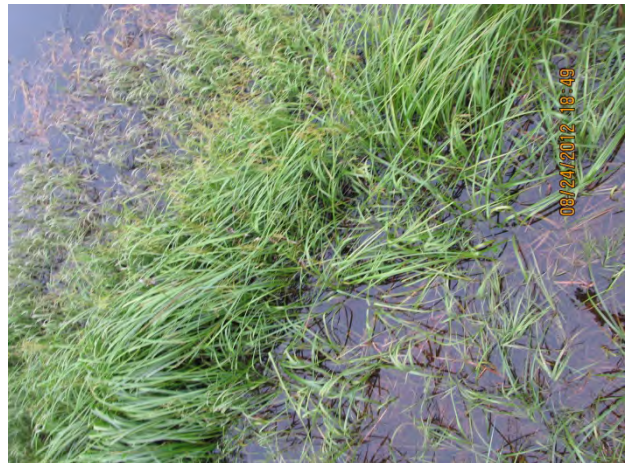
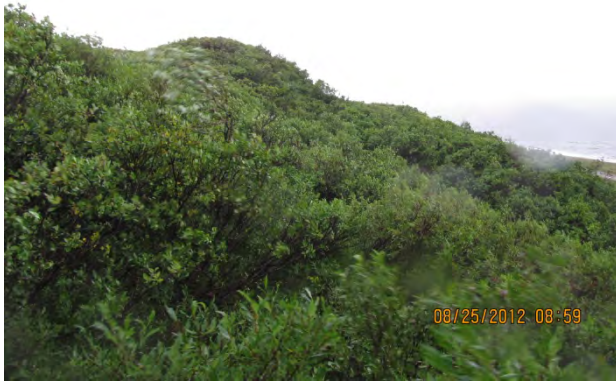
CB_15: Permanently Flooded Lake or Pond
NWI Class: PUBH

Hydrology: Surface water (A1)
Soils: No pit dug, inundated

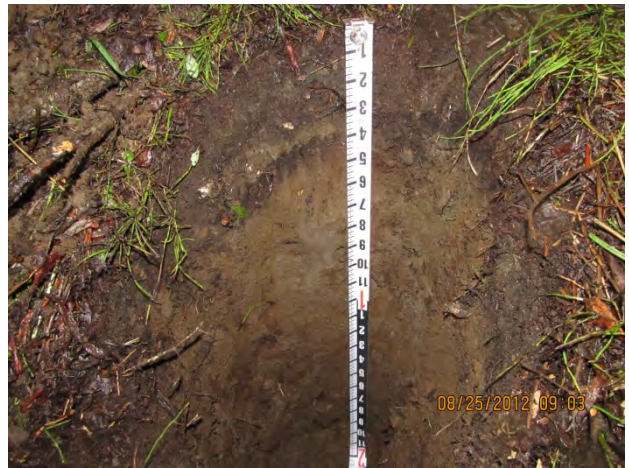
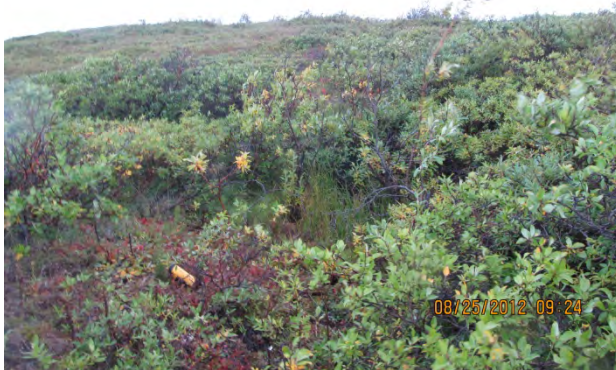
CB_16: Upland
NWI Class: Upland

Hydrology: Well drained
Soils: Organics over silty clay loam

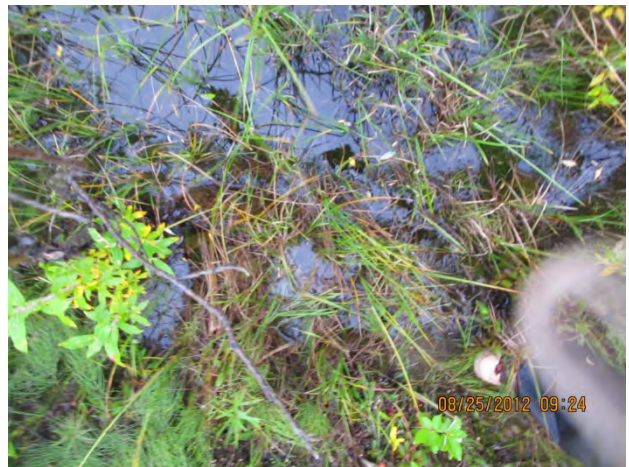
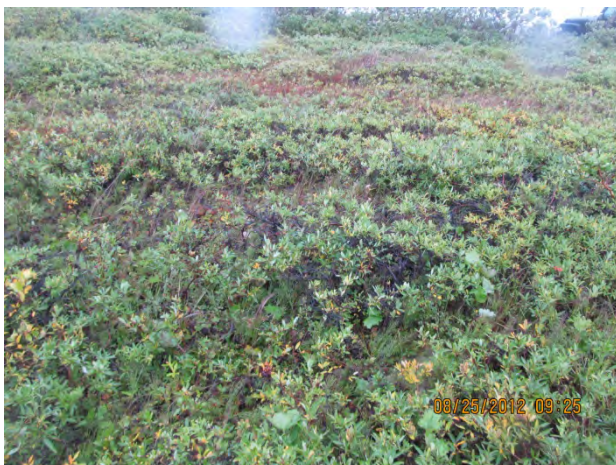
CB_17: Seasonally Flooded Sat. Low and Tall Deciduous Shrub
NWI Class: PSS1C

Hydrology: Surface water (A1)
Soils: No pit dug, inundated

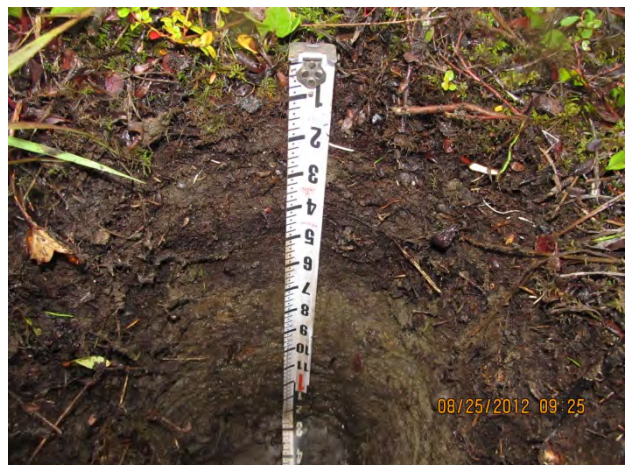
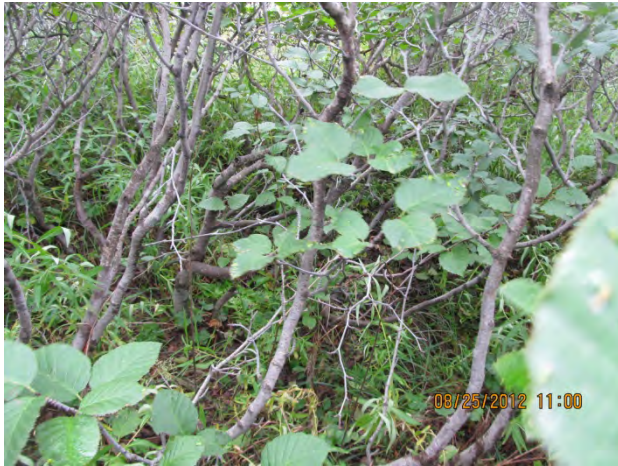
CB_18: Saturated Low and Tall Deciduous Shrub
NWI Class: PSS1B

Hydrology: Shallow aquitard (D3) and FAC-neutral (D5)
Soils: Organics over silty clay loam (Alaska Redox A14)

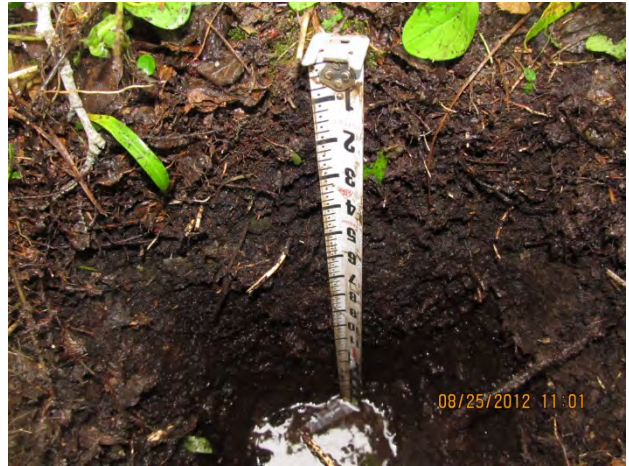
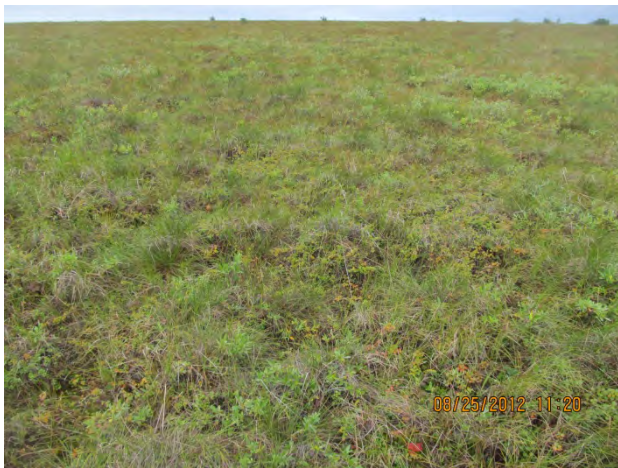
CB_19: Saturated Low and Tall Deciduous Shrub
NWI Class: PSS1B

Hydrology: Saturated (A3) with high water table (A2)
Soils: Organics over silty clay loam (Histic Epipedon A2)

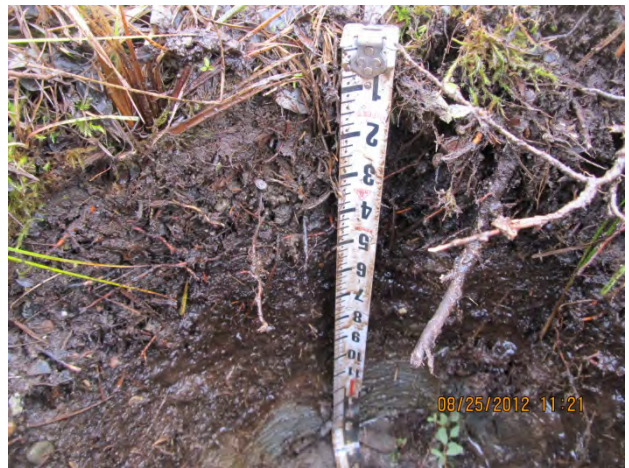
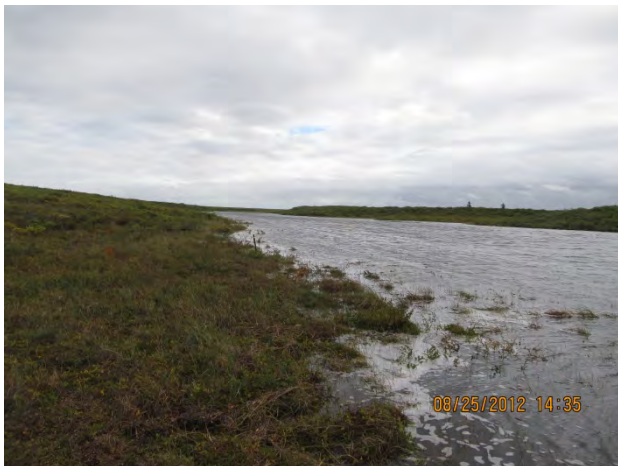
CB_20: Saturated Emergent Sedge-Shrub Meadow
NWI Class: PEM1/SS1B

Hydrology: Saturation (A3) with high water table (A2)
Soils: Organics over silty clay loam (Histic Epipedon A2)

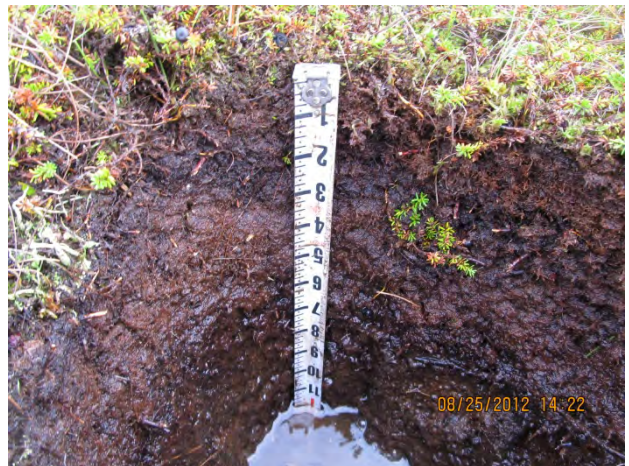
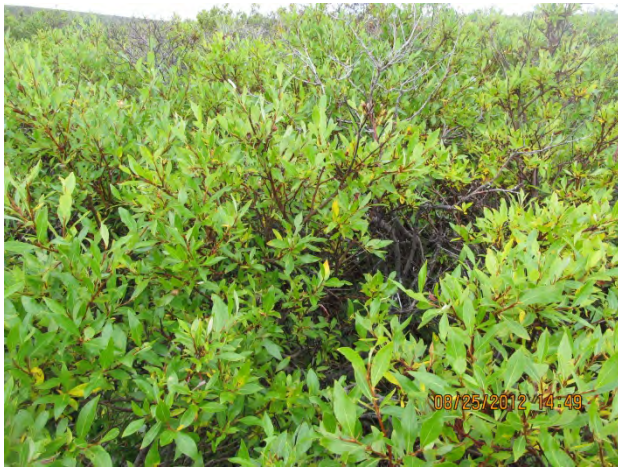
CB_21: Saturated Dwarf Shrub Tundra
NWI Class: PSS4B

Hydrology: Saturation (A3) with high water table (A2)
Soils: Organics over silty clay loam (Histic Epipedon A2)

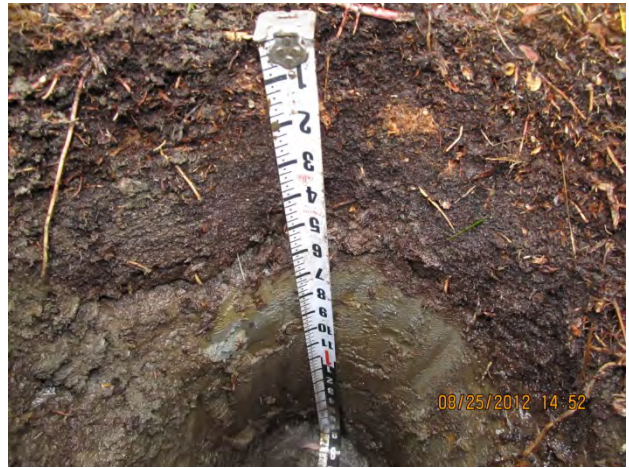
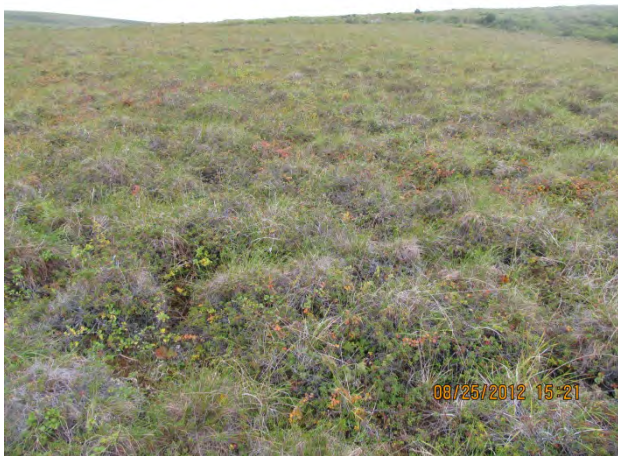
CB_22: Saturated Low and Tall Deciduous Shrub
NWI Class: PSS1B

Hydrology: Saturated (A3) with shallow aquitard (D3)
Soils: Organics over silty clay loam (Alaska Gleyed A13)

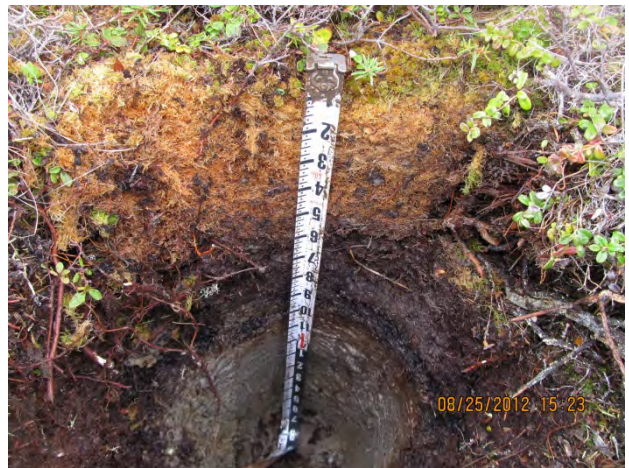
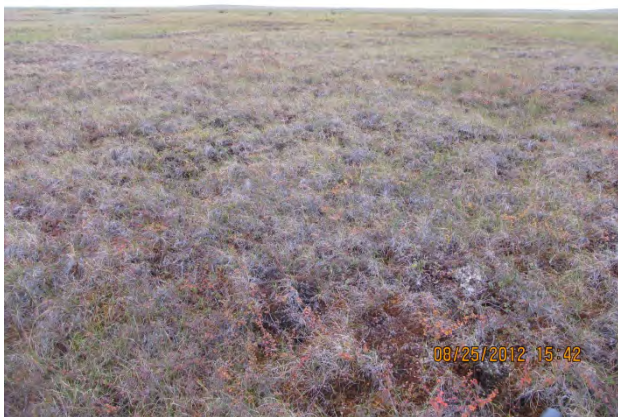
CB_23: Saturated Emergent Sedge-Shrub Meadow
NWI Class: PEM1/SS3B

Hydrology: Saturation (A3) with shallow aquitard (D3)
Soils: Organics over silty clay loam (Histic Epipedon A2)

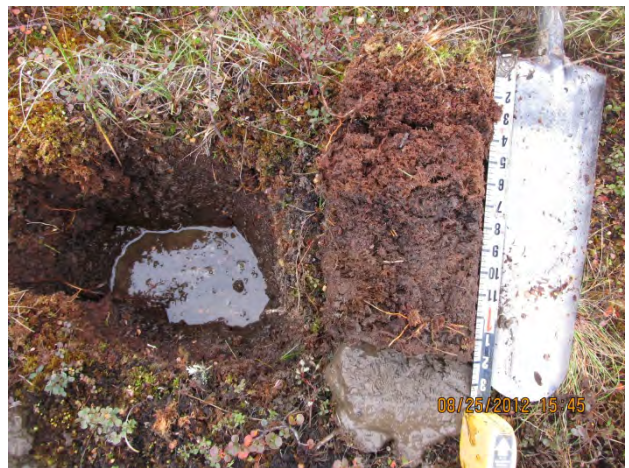
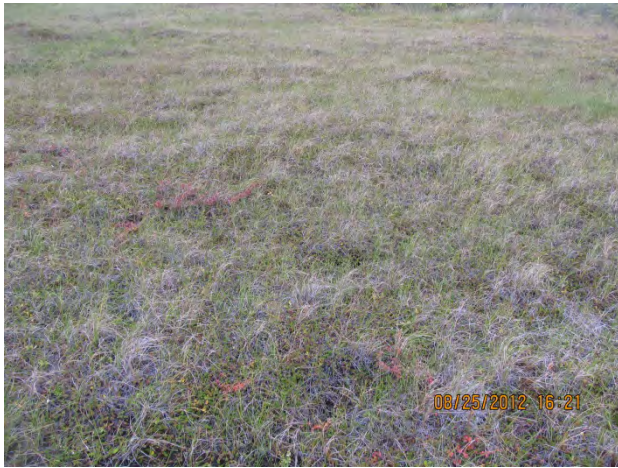
CB_24: Seasonally Flooded Saturated Sedge-Shrub Meadow
NWI Class: PEM1E

Hydrology: Saturation (A3) with a high water table (A2)
Soils: Organics (Histic Epipedon A2)

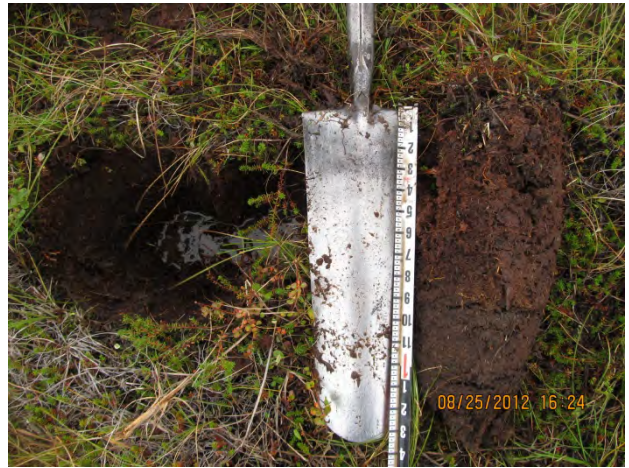
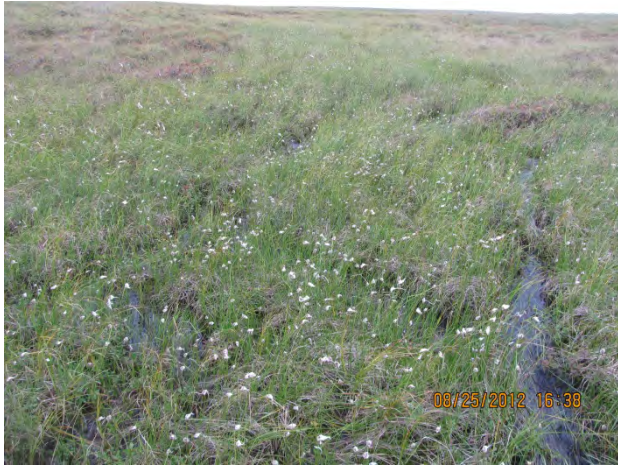
CB_25: Saturated Dwarf Shrub Tundra
NWI Class: PSS4B

Hydrology: Saturated (A3) with high water table (A2)
Soils: Organics over silty clay loam (Histic Epipedon A2)

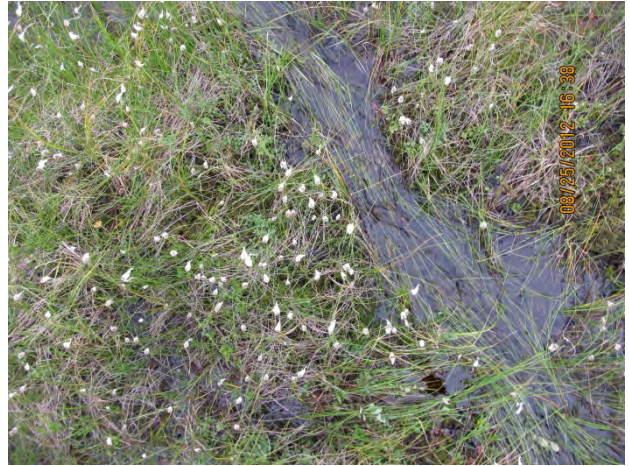
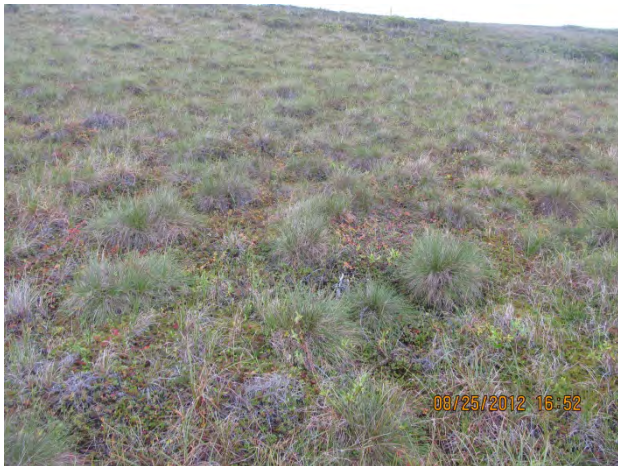
CB_26: Seasonally Flooded Saturated Sedge-Shrub Meadow
NWI Class: PEM1E

Hydrology: Surface water (A1)
Soils: No pit dug, inundated

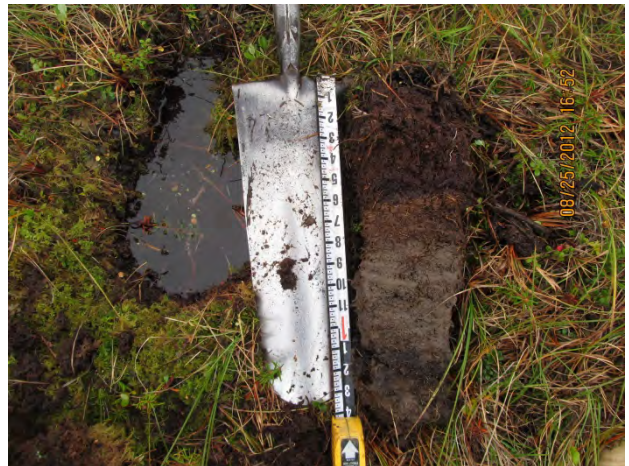
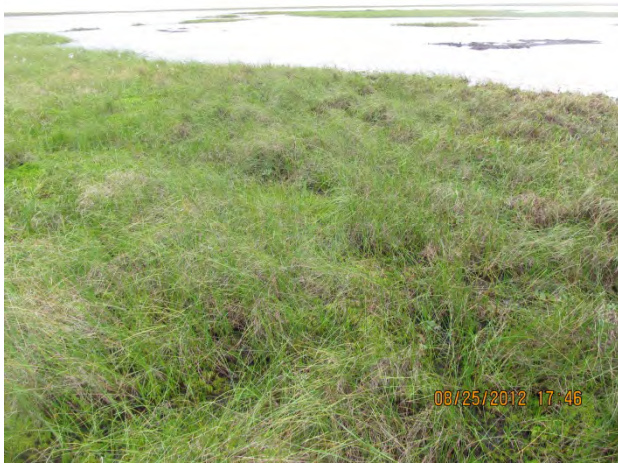
CB_27: Saturated Dwarf Shrub Tundra
NWI Class: PSS4B

Hydrology: Saturation (A3) with a high water table (A2)
Soils: Organics over silty clay loam (Histic Epipedon A2)

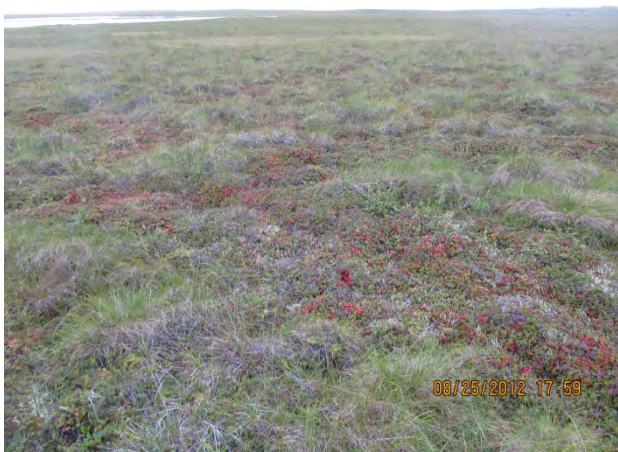
CB_28: Littoral Aquatic Bed and Lacustrine Fringe
NWI Class: PEM1F

Hydrology: Surface water (A1)
Soils: No pit dug, inundated

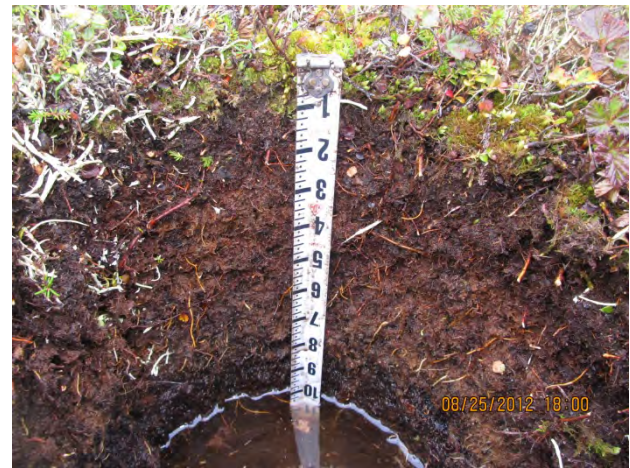
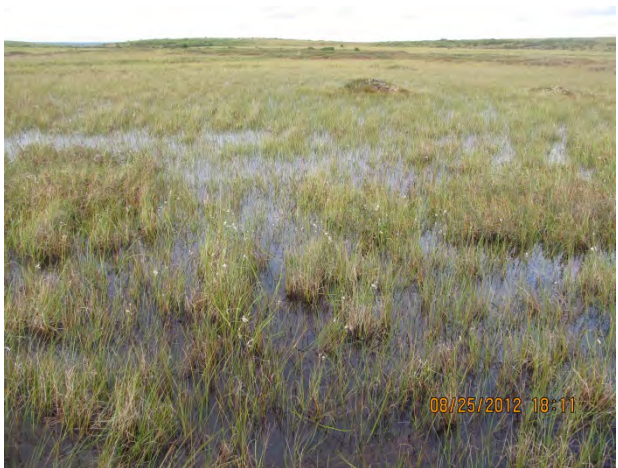
CB_29: Saturated Emergent Sedge-Shrub Meadow
NWI Class: PSS1/EM1B

Hydrology: Saturation (A3) with a high water table (A2)
Soils: Organics (Histic Epipedon A2)

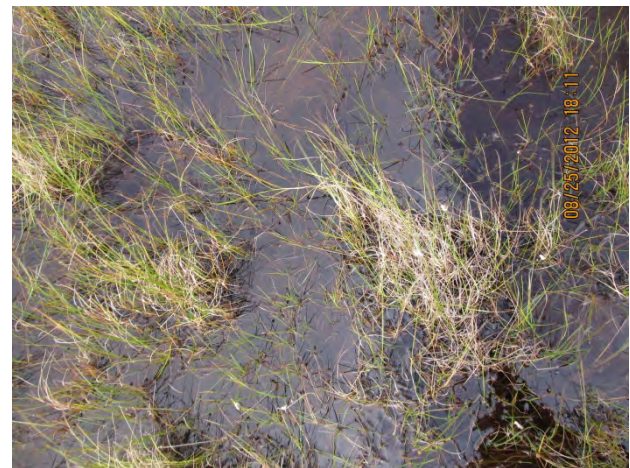
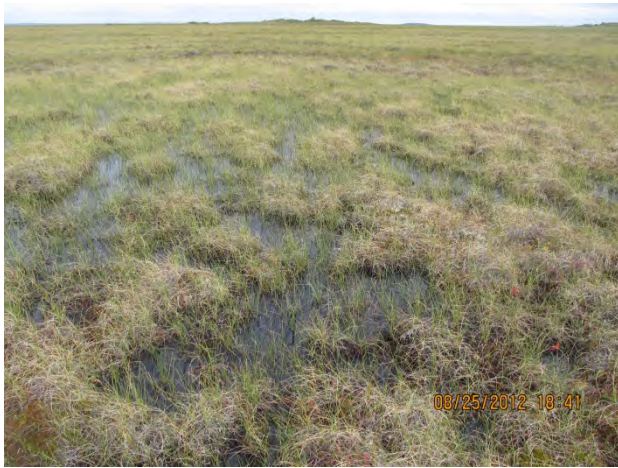
CB_30: Semi-Permanently Flooded Sedge-Shrub Meadow
NWI Class: PEM1F

Hydrology: Surface water (A1)
Soils: No pit dug, inundated

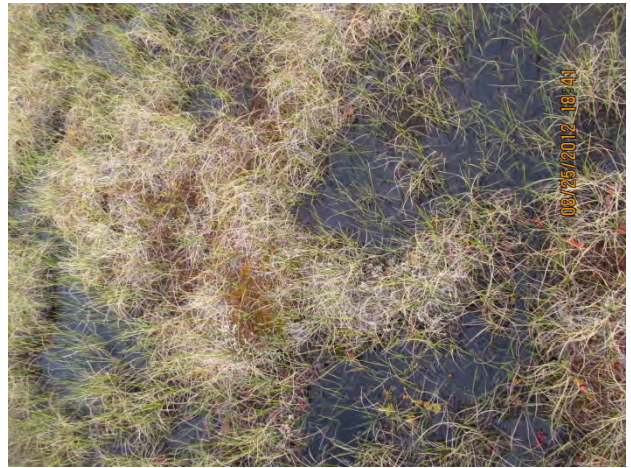
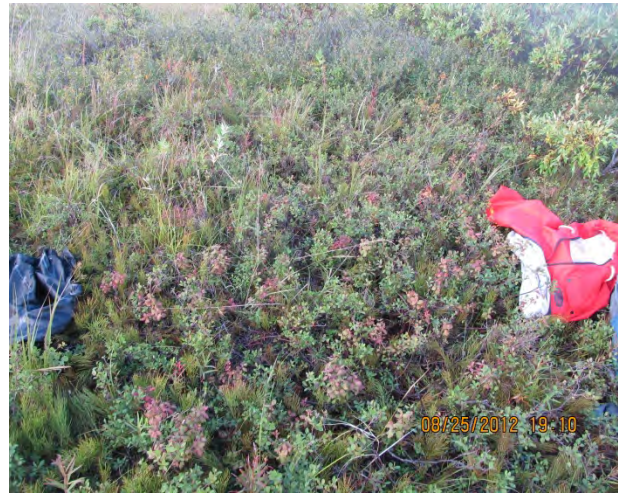
CB_31: Seasonally Flooded Saturated Sedge-Shrub Meadow
NWI Class: PEM1/SS1E

Hydrology: Surface water (A1)
Soils: No pit dug, inundated

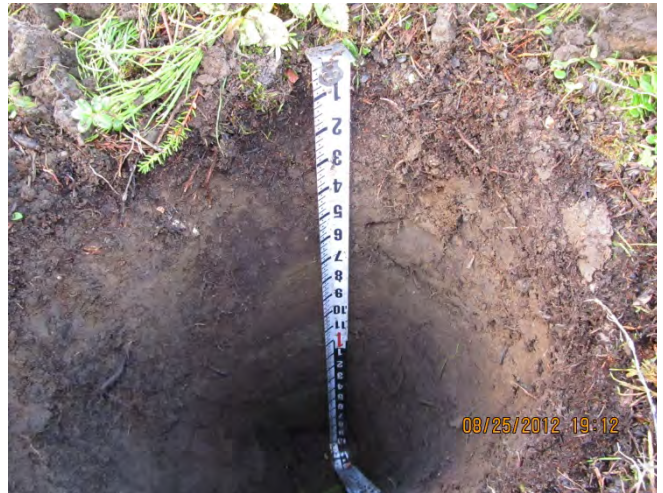
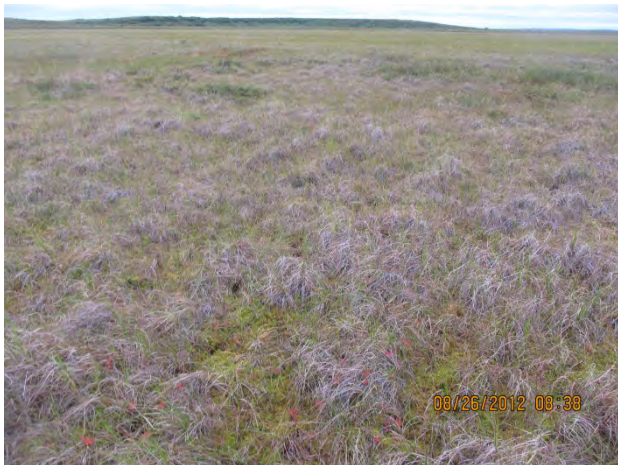
CB_32: Upland
NWI Class: Upland

Hydrology: Well drained
Soils: Organics over silty clay loam

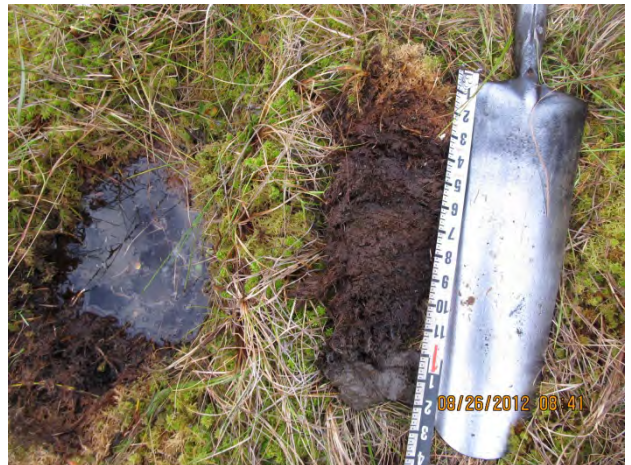
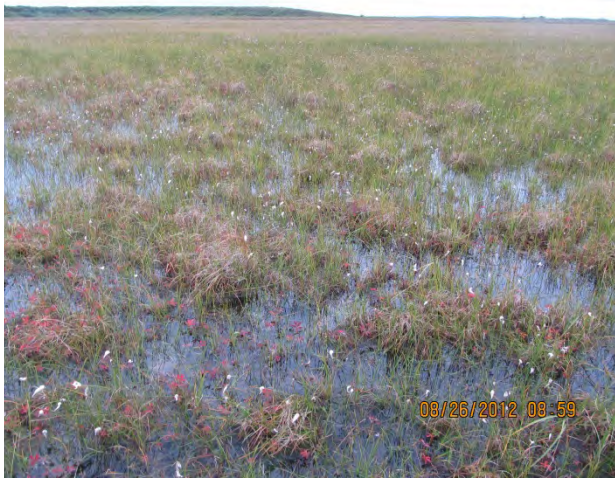
CB_33: Seasonally Flooded Saturated Sedge-Shrub Meadow
NWI Class: PEM1E

Hydrology: Saturation (A3) with a high water table (A2)
Soils: Organics over silty clay loam (Histic Epipedon A2)
