FINDING OF NO SIGNIFICANT IMPACT

KOTZEBUE TO CAPE BLOSSOM ROAD

PROJECT No. NCPD-0002(204)/76884

Department of Transportation
and Public Facilities

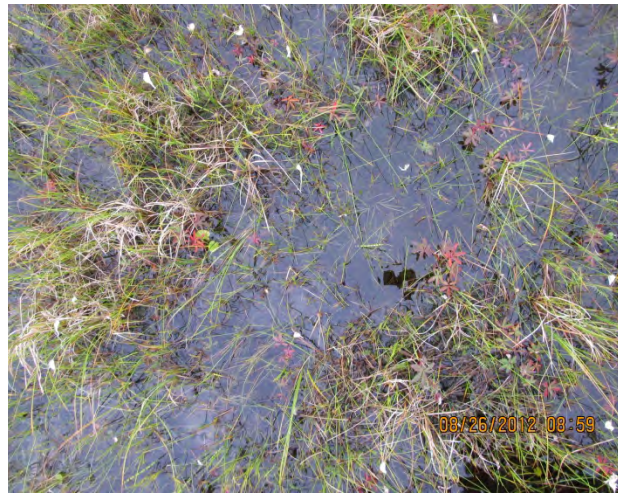
CB_34: Permanently Flooded Sedge Marsh
NWI Class: PEM1H

Hydrology: Surface water (A1)
Soils: No pit dug, inundated

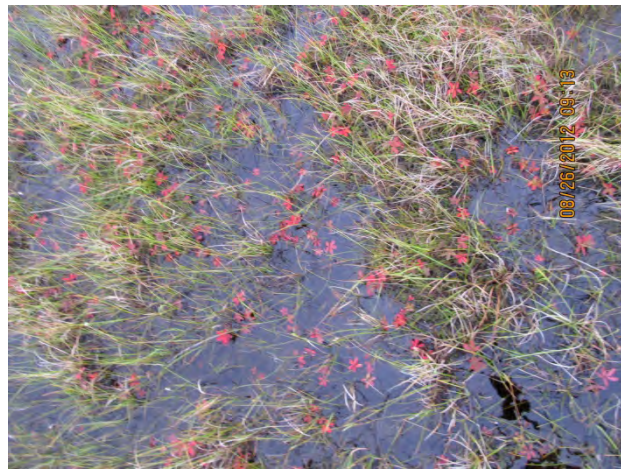
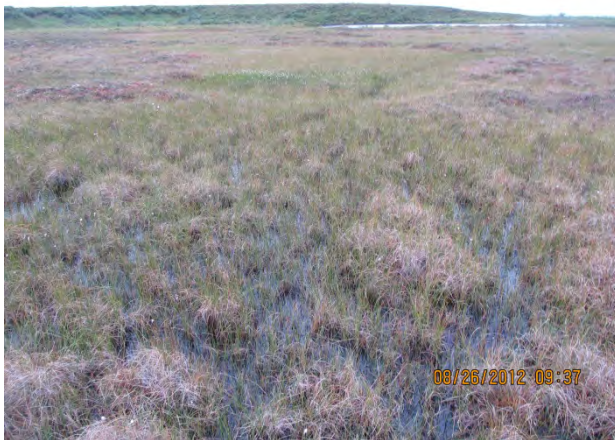
CB_35: Seasonally Flooded Saturated Sedge-Shrub Meadow
NWI Class: PEM1E

Hydrology: Surface water (A1)
Soils: No pit dug, inundated

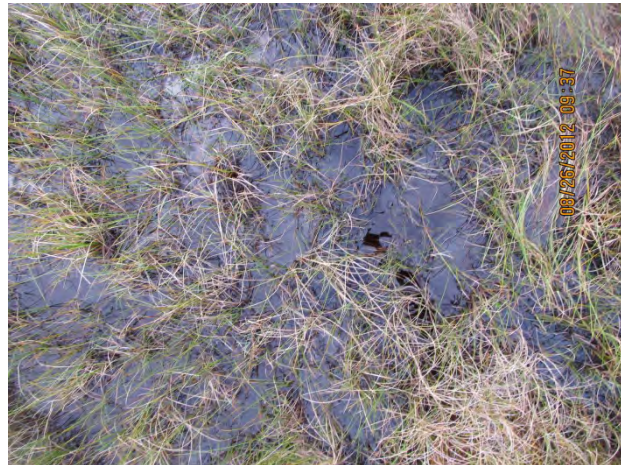
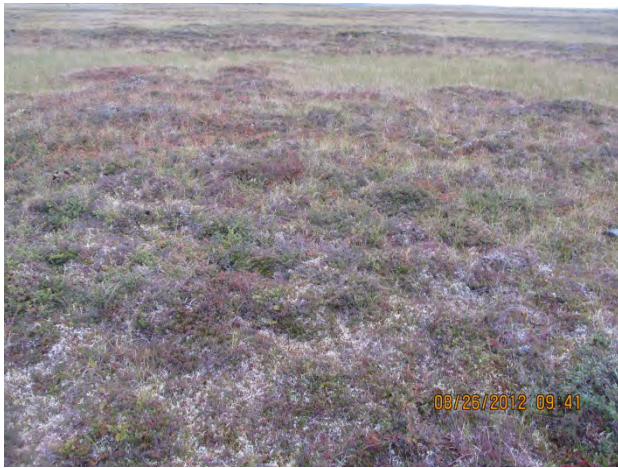
CB_36: Semi-Permanently Flooded Sedge-Shrub Meadow
NWI Class: PEM1/SS1F

Hydrology: Surface water (A1)
Soils: No pit dug, inundated

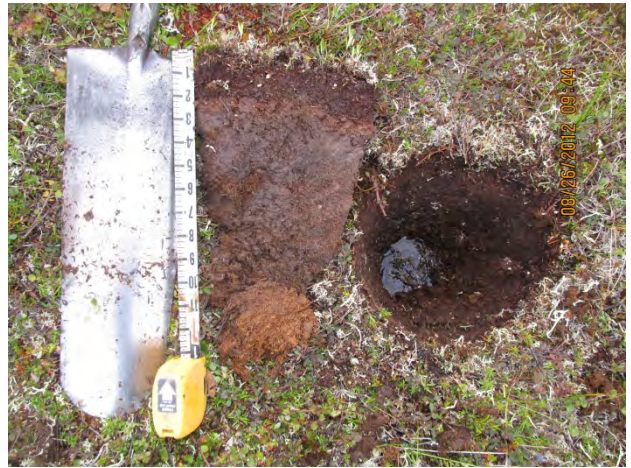
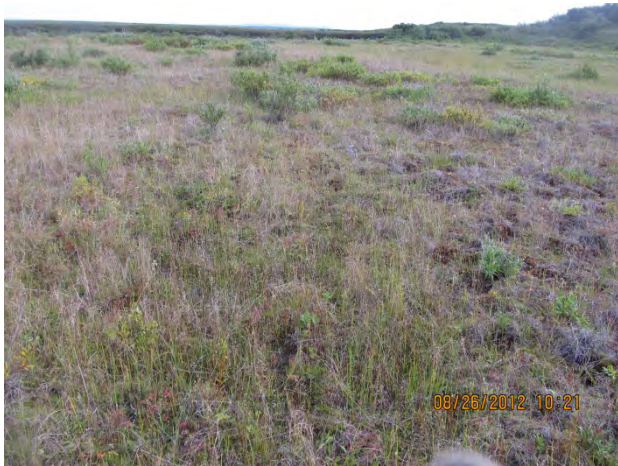
CB_37: Semi-Permanently Flooded Sedge-Shrub Meadow
NWI Class: PEM1/SS1F

Hydrology: Saturation (A3) with high water table (A2)
Soils: Organics (Histic Epipedon A2)

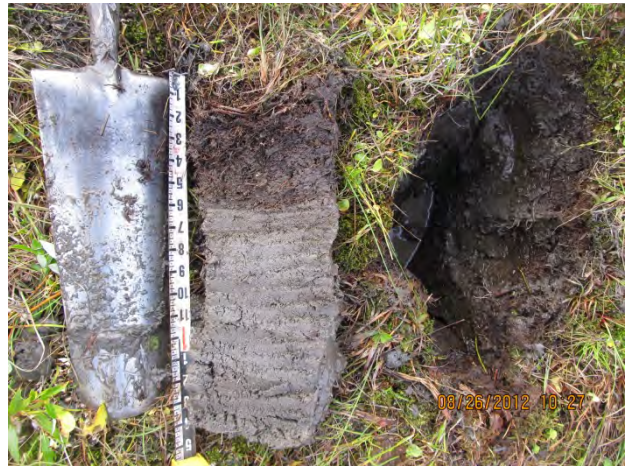
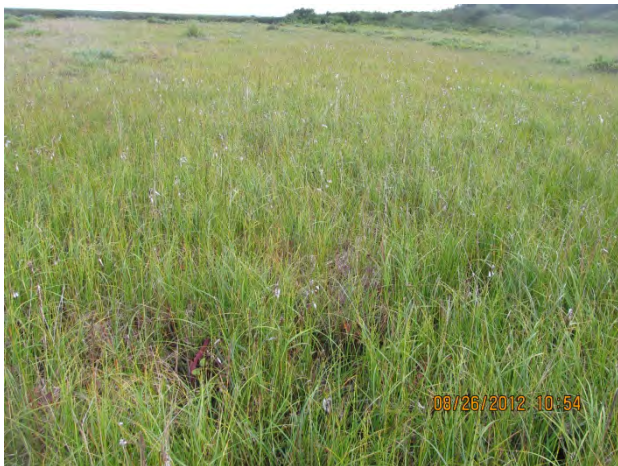
CB_38: Upland
NWI Class: Upland

Hydrology: Saturation (A3) with a high water table (A2)
Soils: Organics over silty clay loam

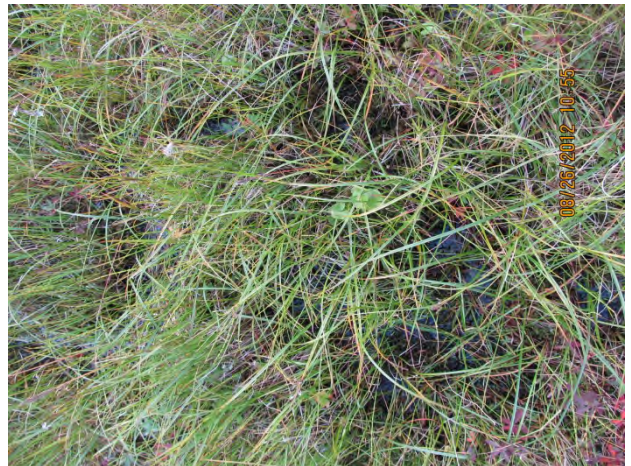
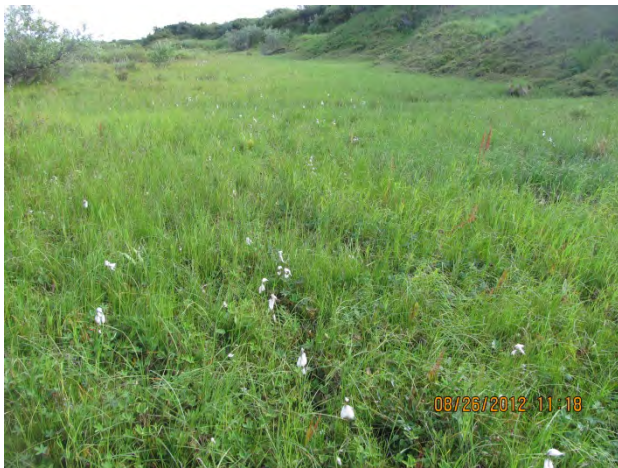
CB_39: Seasonally Flooded Saturated Sedge-Shrub Meadow
NWI Class: PEM1E

Hydrology: Surface water (A1)
Soils: No pit dug, inundated

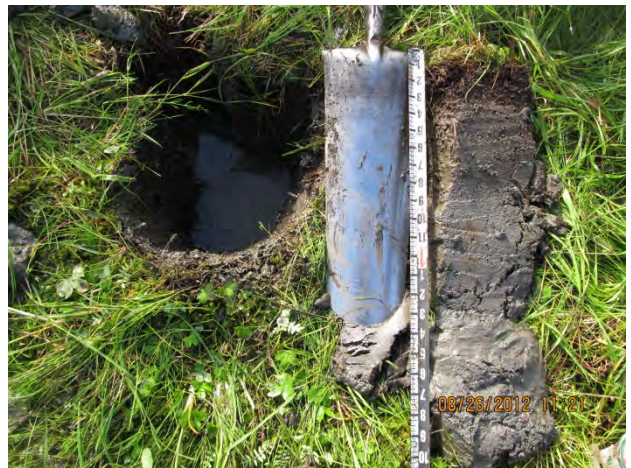
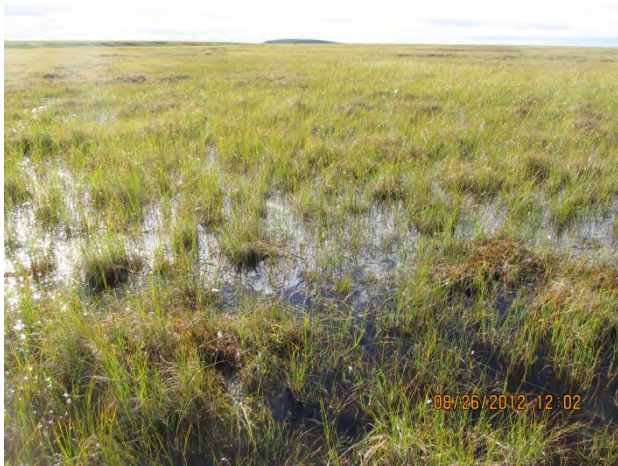
CB_40: Permanently Flooded Sedge Marsh
NWI Class: PEM1F

Hydrology: Saturated (A3) with high water table (A2)
Soils: Organics over silty clay loam (Alaska Redox A14)

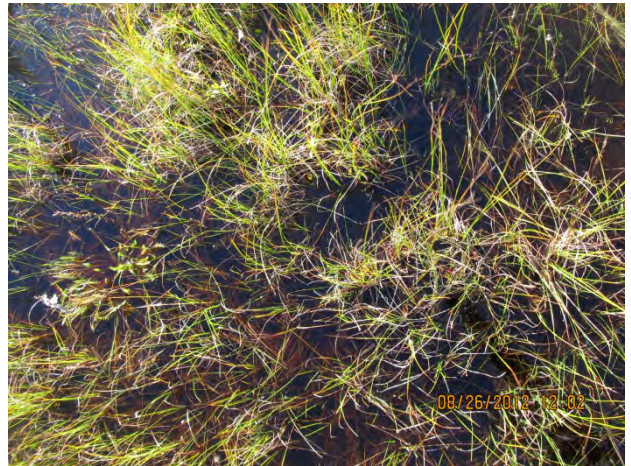
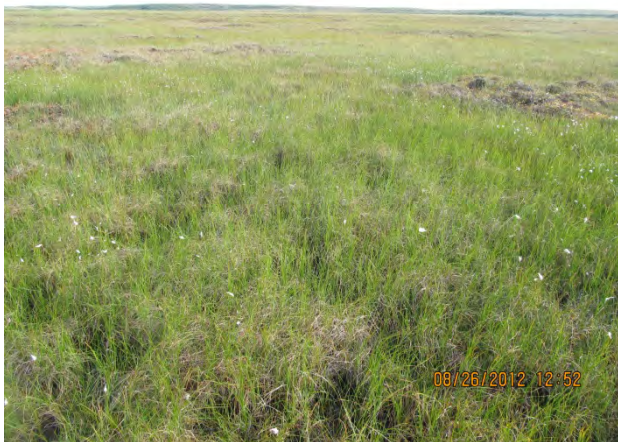
CB_41: Semi-Permanently Flooded Sedge-Shrub Meadow
NWI Class: PEM1/SS1F

Hydrology: Surface water (A1)
Soils: No pit dug, inundated

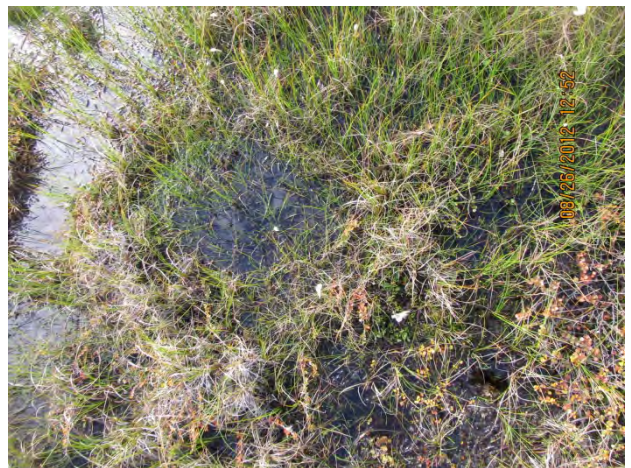
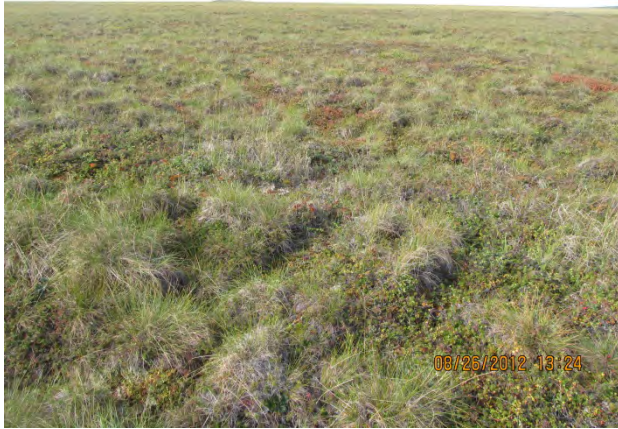
CB_42: Seasonally Flooded Saturated Sedge-Shrub Meadow
NWI Class: PEM1/SS1E

Hydrology: Surface water (A1)
Soils: No pit dug, inundated

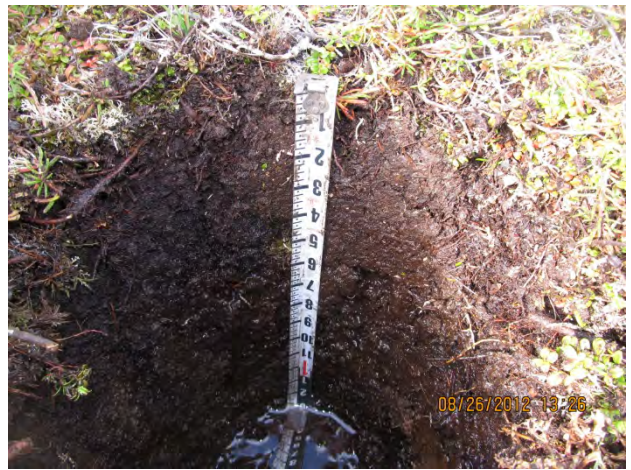
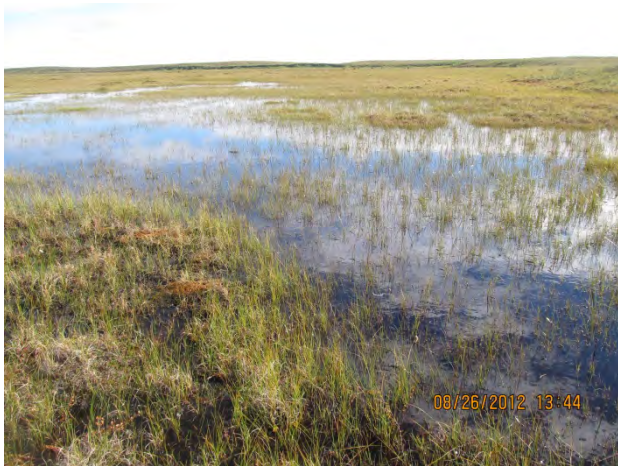
CB_43: Saturated Emergent Sedge-Shrub Meadow
NWI Class: PSS3/EM1B

Hydrology: Saturated (A3) with high water table (A2)
Soils: Organics over silty clay loam (Histic Epipedon A2)

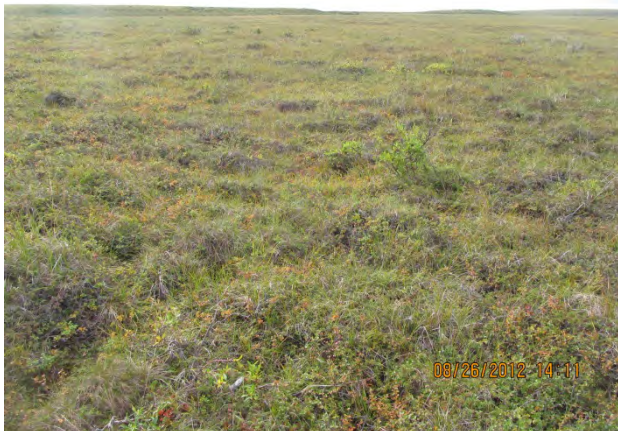
CB_45: Saturated Emergent Sedge-Shrub Meadow
NWI Class: PSS3/EM1B

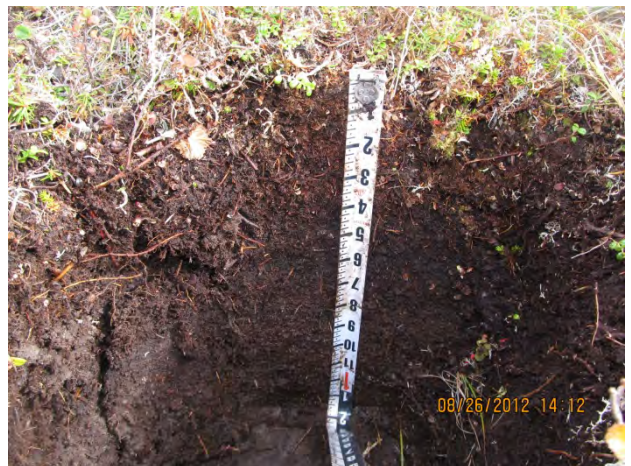
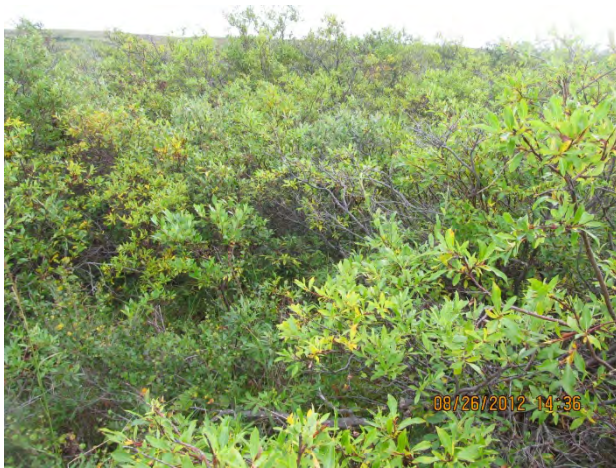
Hydrology: Saturation (A3) with a shallow aquitard (D3)
Soils: Organics over silty clay loam (Histic Epipedon A2)

CB_46: Saturated Low and Tall Deciduous Shrub
NWI Class: PSS1B

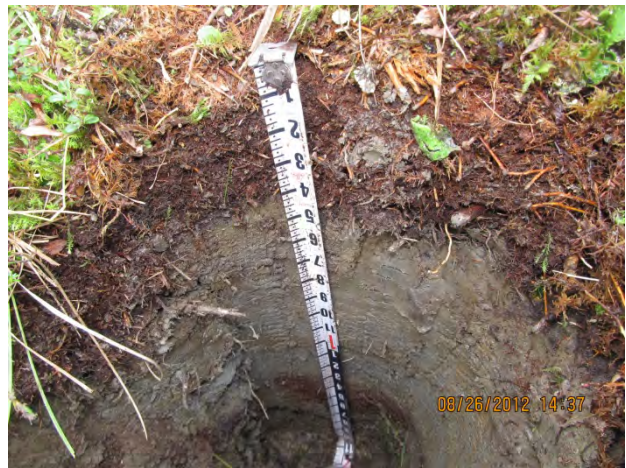
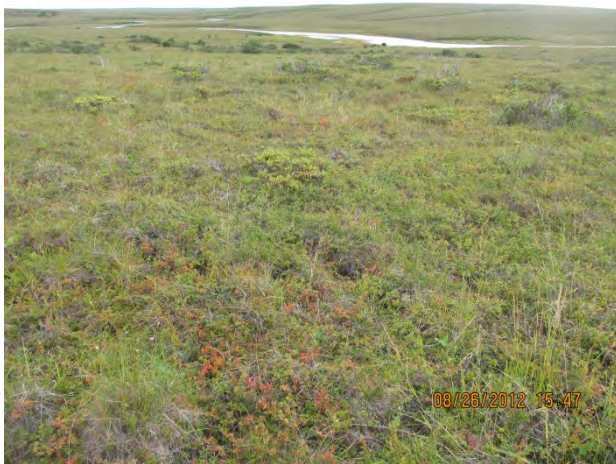
Hydrology: Shallow aquitard (D3) and FAC-neutral (D5)
Soils: Organics over silty clay loam (Alaska Redox A14)

CB_47: Saturated Emergent Sedge-Shrub Meadow
NWI Class: PSS1/EM1B

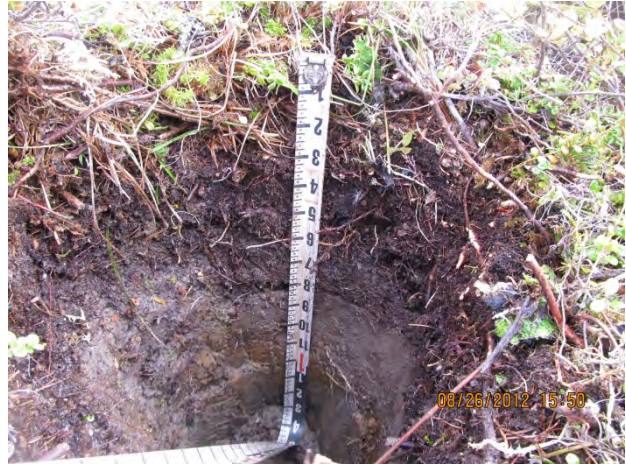
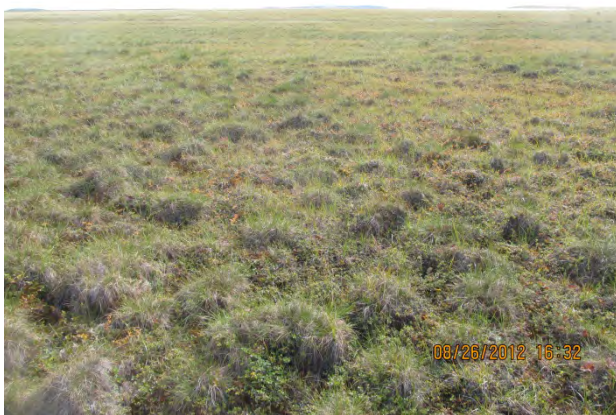
Hydrology: Saturation (A3) with a shallow aquitard (D3)
Soils: Organics over silty clay loam (Alaska Redox A14)

CB_48: Saturated Emergent Sedge-Shrub Meadow
NWI Class: PEM1/SS1B

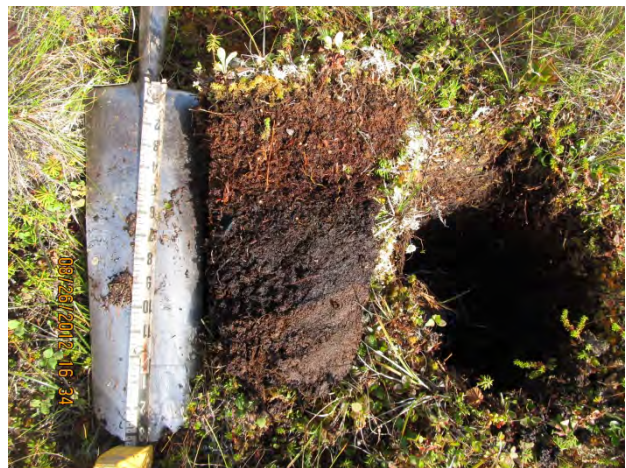
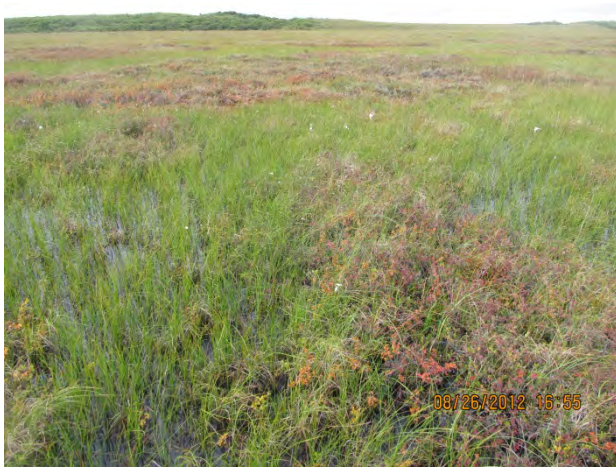
Hydrology: Saturation (A3) and high water table (A2)
Soils: Organics (Histic Epipedon A2)

CB_49: Semi-Permanently Flooded Sedge-Shrub Meadow
NWI Class: PEM1/PSS1F

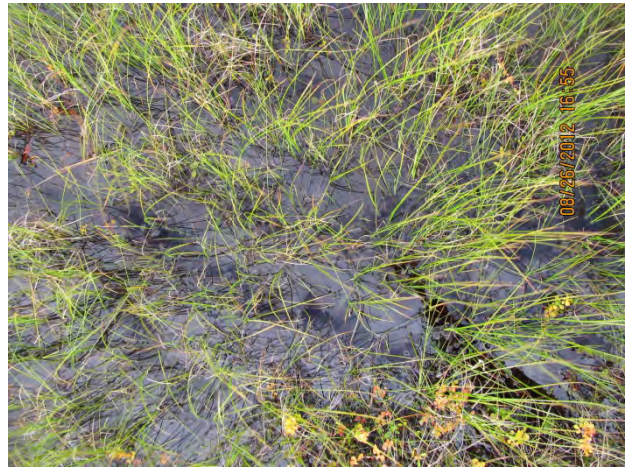
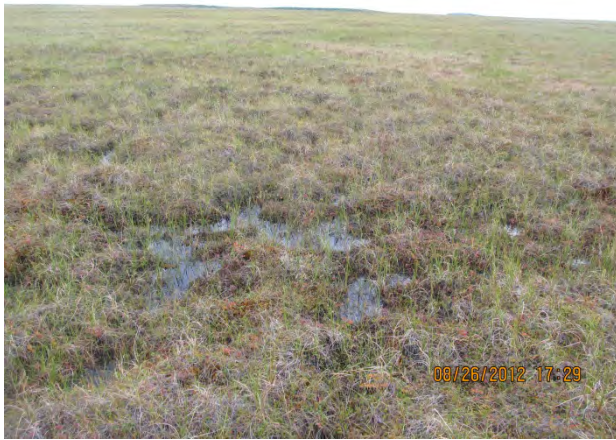
Hydrology: Surface water (A1)
Soils: No pit dug, inundated

CB_50: Saturated Emergent Sedge-Shrub Meadow
NWI Class: PSS1B

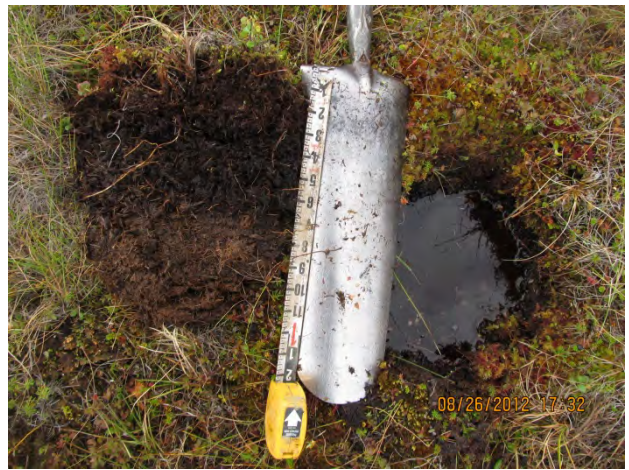
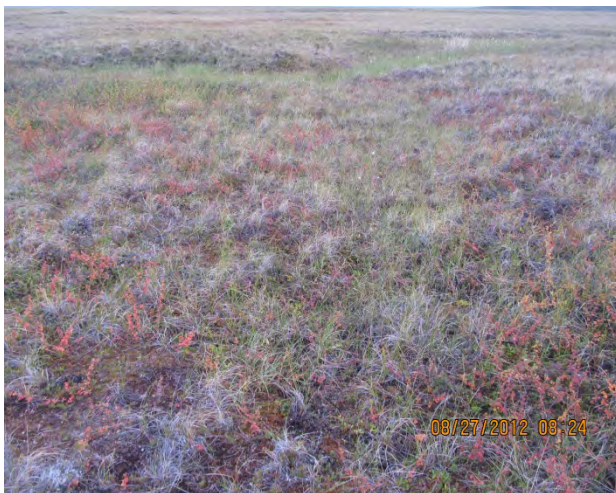
Hydrology: Saturation (A3) with a high water table (A2)
Soils: Organics (Histic Epipedon A2)

CB_51: Saturated Emergent Sedge-Shrub Meadow
NWI Class: PSS1B

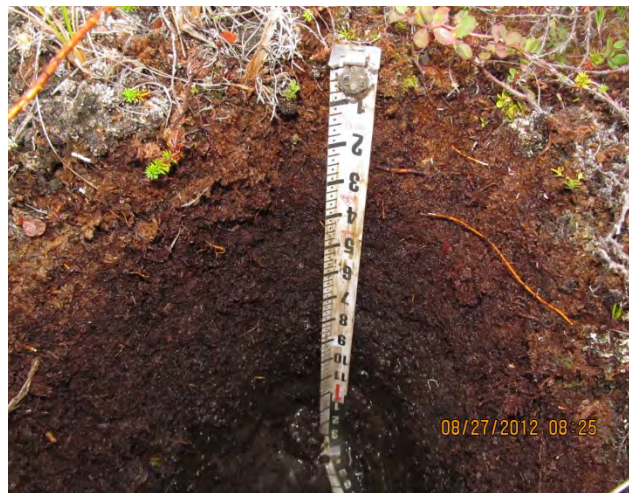
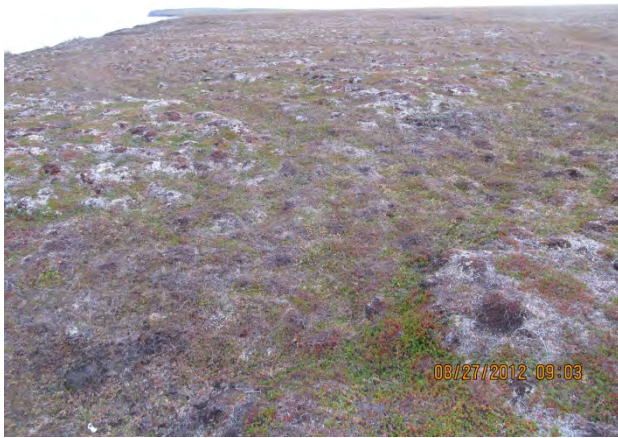
Hydrology: Saturation (A3) with a high water table (A2)
Soils: Organics (Histic Epipedon A2)

CB_52: Saturated Emergent Sedge-Shrub Meadow
NWI Class: PSS1/EM1B

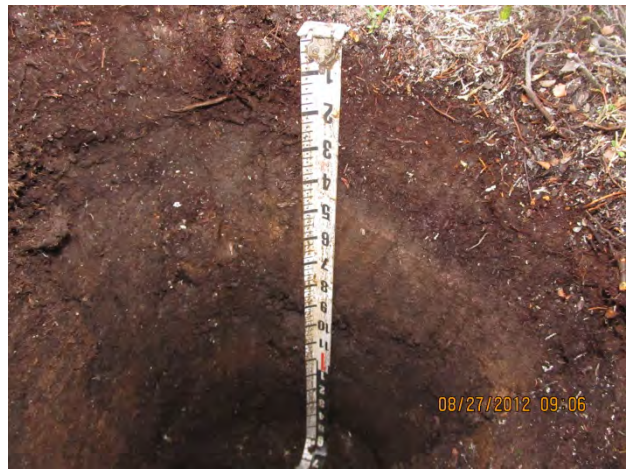
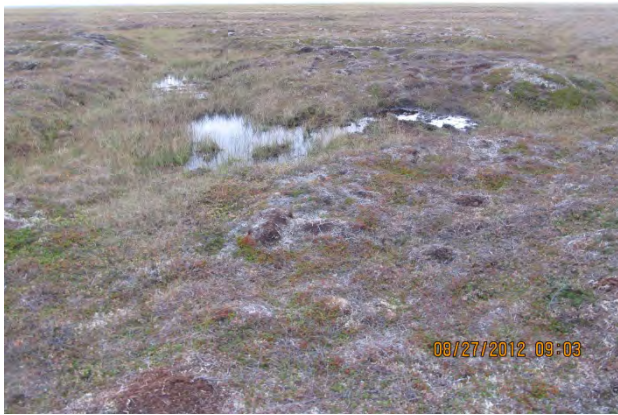
Hydrology: Shallow aquitard (D3) and FAC-neutral (D5)
Soils: Histel (A1)

CB_53: Saturated Emergent Sedge-Shrub Meadow
NWI Class: PSS1/EM1B

Hydrology: Surface water (A1)
Soils: No pit dug, inundated

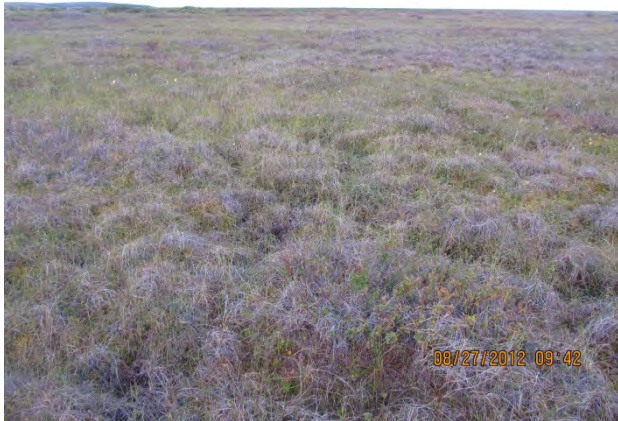
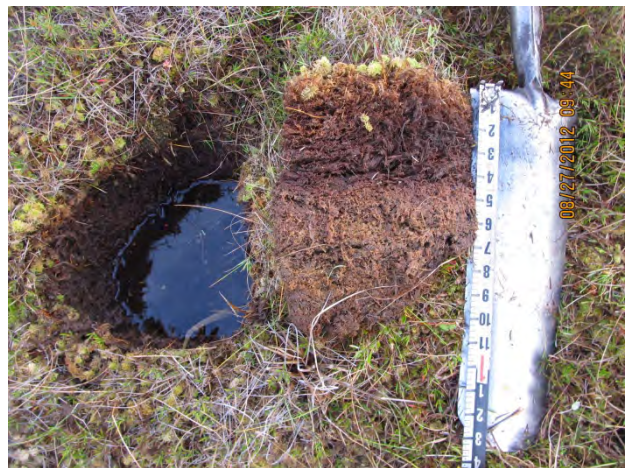
CB_54: Seasonally Flooded Saturated Sedge-Shrub Meadow
NWI Class: PEM1/SS1E

Hydrology: Saturation (A3) and high water table (A2)
Soils: Organics (Histic Epipedon A2)

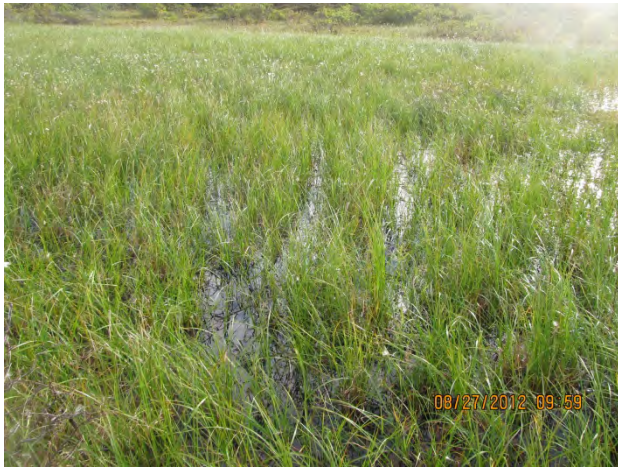
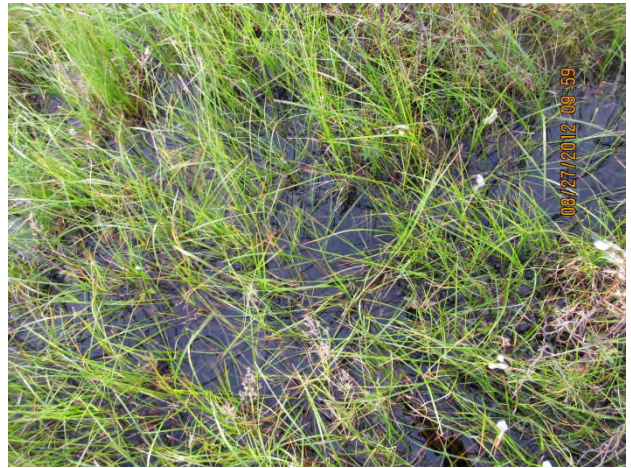
CB_55: Seasonally Flooded Saturated Sedge-Shrub Meadow
NWI Class: PEM1E

Hydrology: Surface water (A1)
Soils: No pit dug, inundated

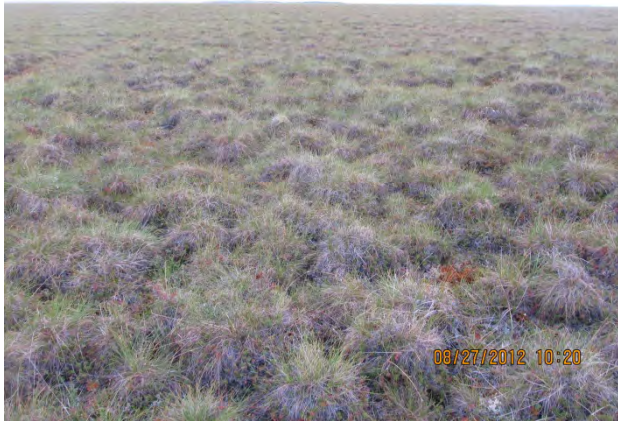
CB_56: Saturated Emergent Sedge-Shrub Meadow
NWI Class: PEM1/SS1B

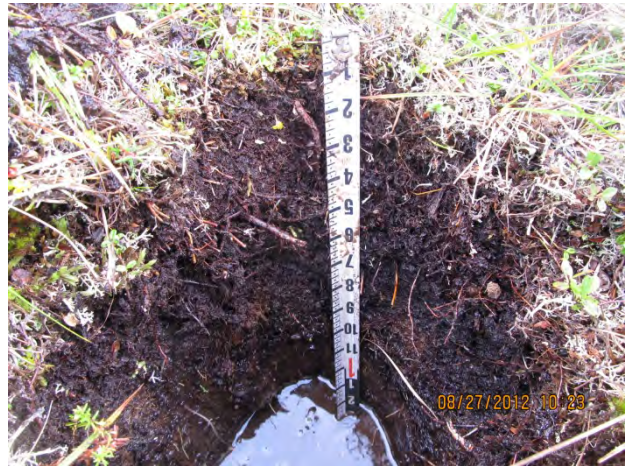
Hydrology: Saturation (A3) with a high water table (A2)
Soils: Organics over silty clay loam (Histic Epipedon A2)

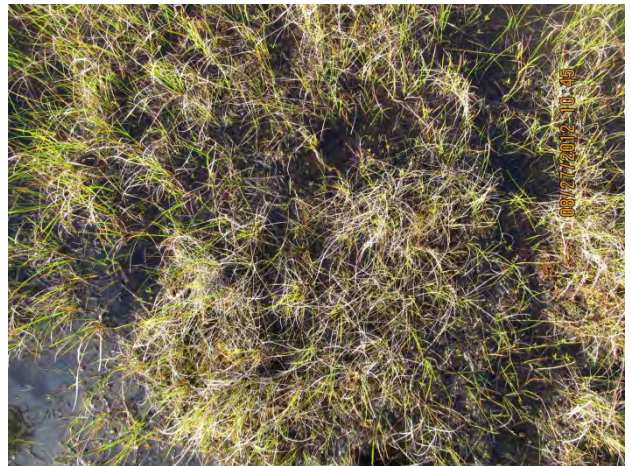
CB_57: Seasonally Flooded Saturated Sedge-Shrub Meadow
NWI Class: PEM1/SS1E

Hydrology: Surface water (A1)
Soils: No pit dug, inundated

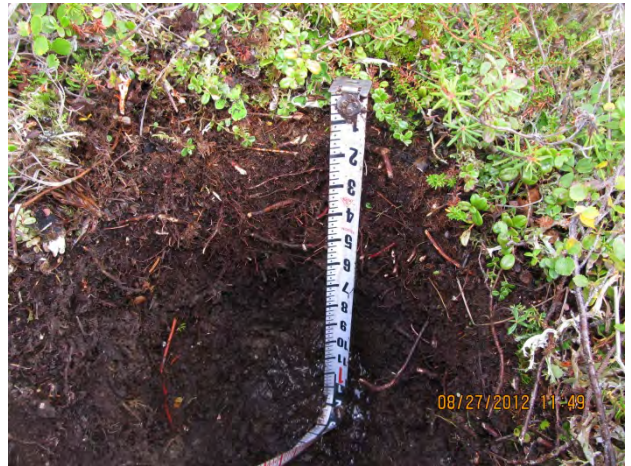
CB_59: Saturated Dwarf Shrub Tundra
NWI Class: PSS1/3B

Hydrology: Saturation (A3) and high water table (A2)
Soils: Organics over silty clay loam (Histic Epipedon A2)

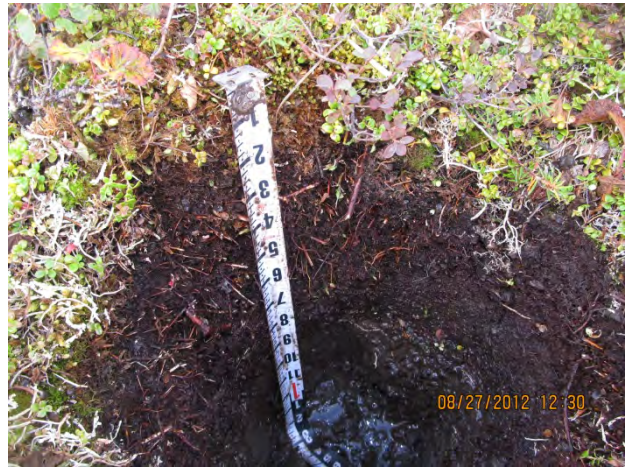
CB_61: Saturated Emergent Sedge-Shrub Meadow
NWI Class: PSS3/EM1B

Hydrology: Saturation (A3) with shallow aquitard (D3)
Soils: Organics over silty clay loam (Histic Epipedon A2)

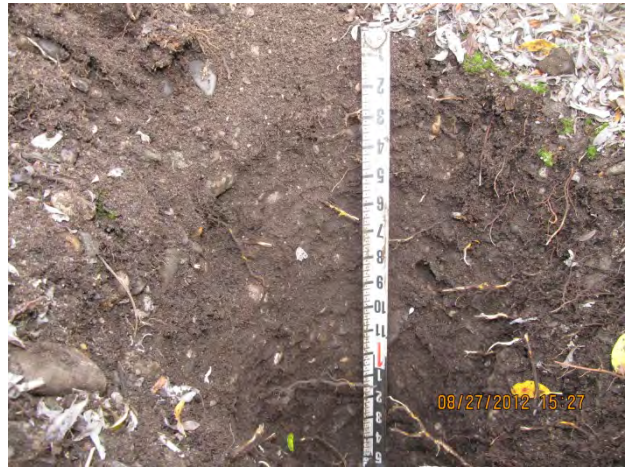
CB_65: Upland
NWI Class: Upland

Hydrology: Well drained
Soils: course sandy loam

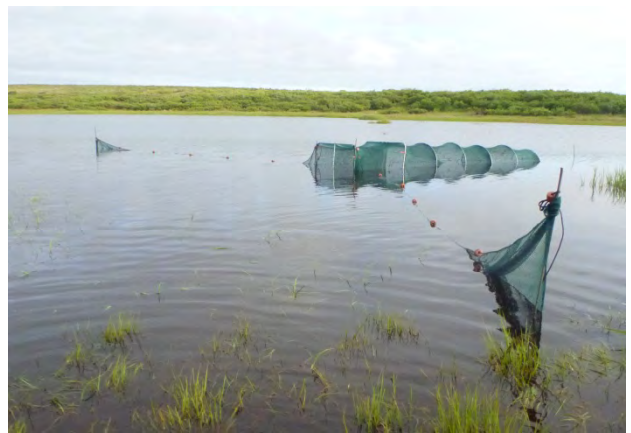
Plate 4. Example of a fyke net set along stream margins, Site NF1

Fyke nets had 1.2 m² frame openings and 0.25-inch mesh with 25 foot wings. Because water levels during the July sampling event were high, the nets could not be set across the entire stream. Instead, the nets were set along the stream margins and thus did not fish the entire stream width. Fyke net wings were set from 1 side of the frame opening to the vegetated stream margin on 1 bank and then from the other side of the frame out to the deepest section of wadeable stream. Two fyke nets were set per site on opposite banks, 1 facing upstream, and 1 facing downstream (Appendix D, Plate 4). During the August sampling event, water levels had dropped sufficiently to allow for 2 fyke nets to be set across the full width of the stream at each site sampled (Appendix D, Plate 5).

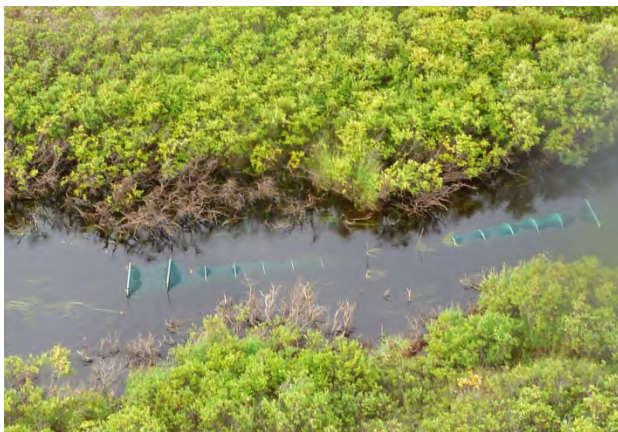
Plate 5. Aerial view of fyke nets set cod-end to cod-end

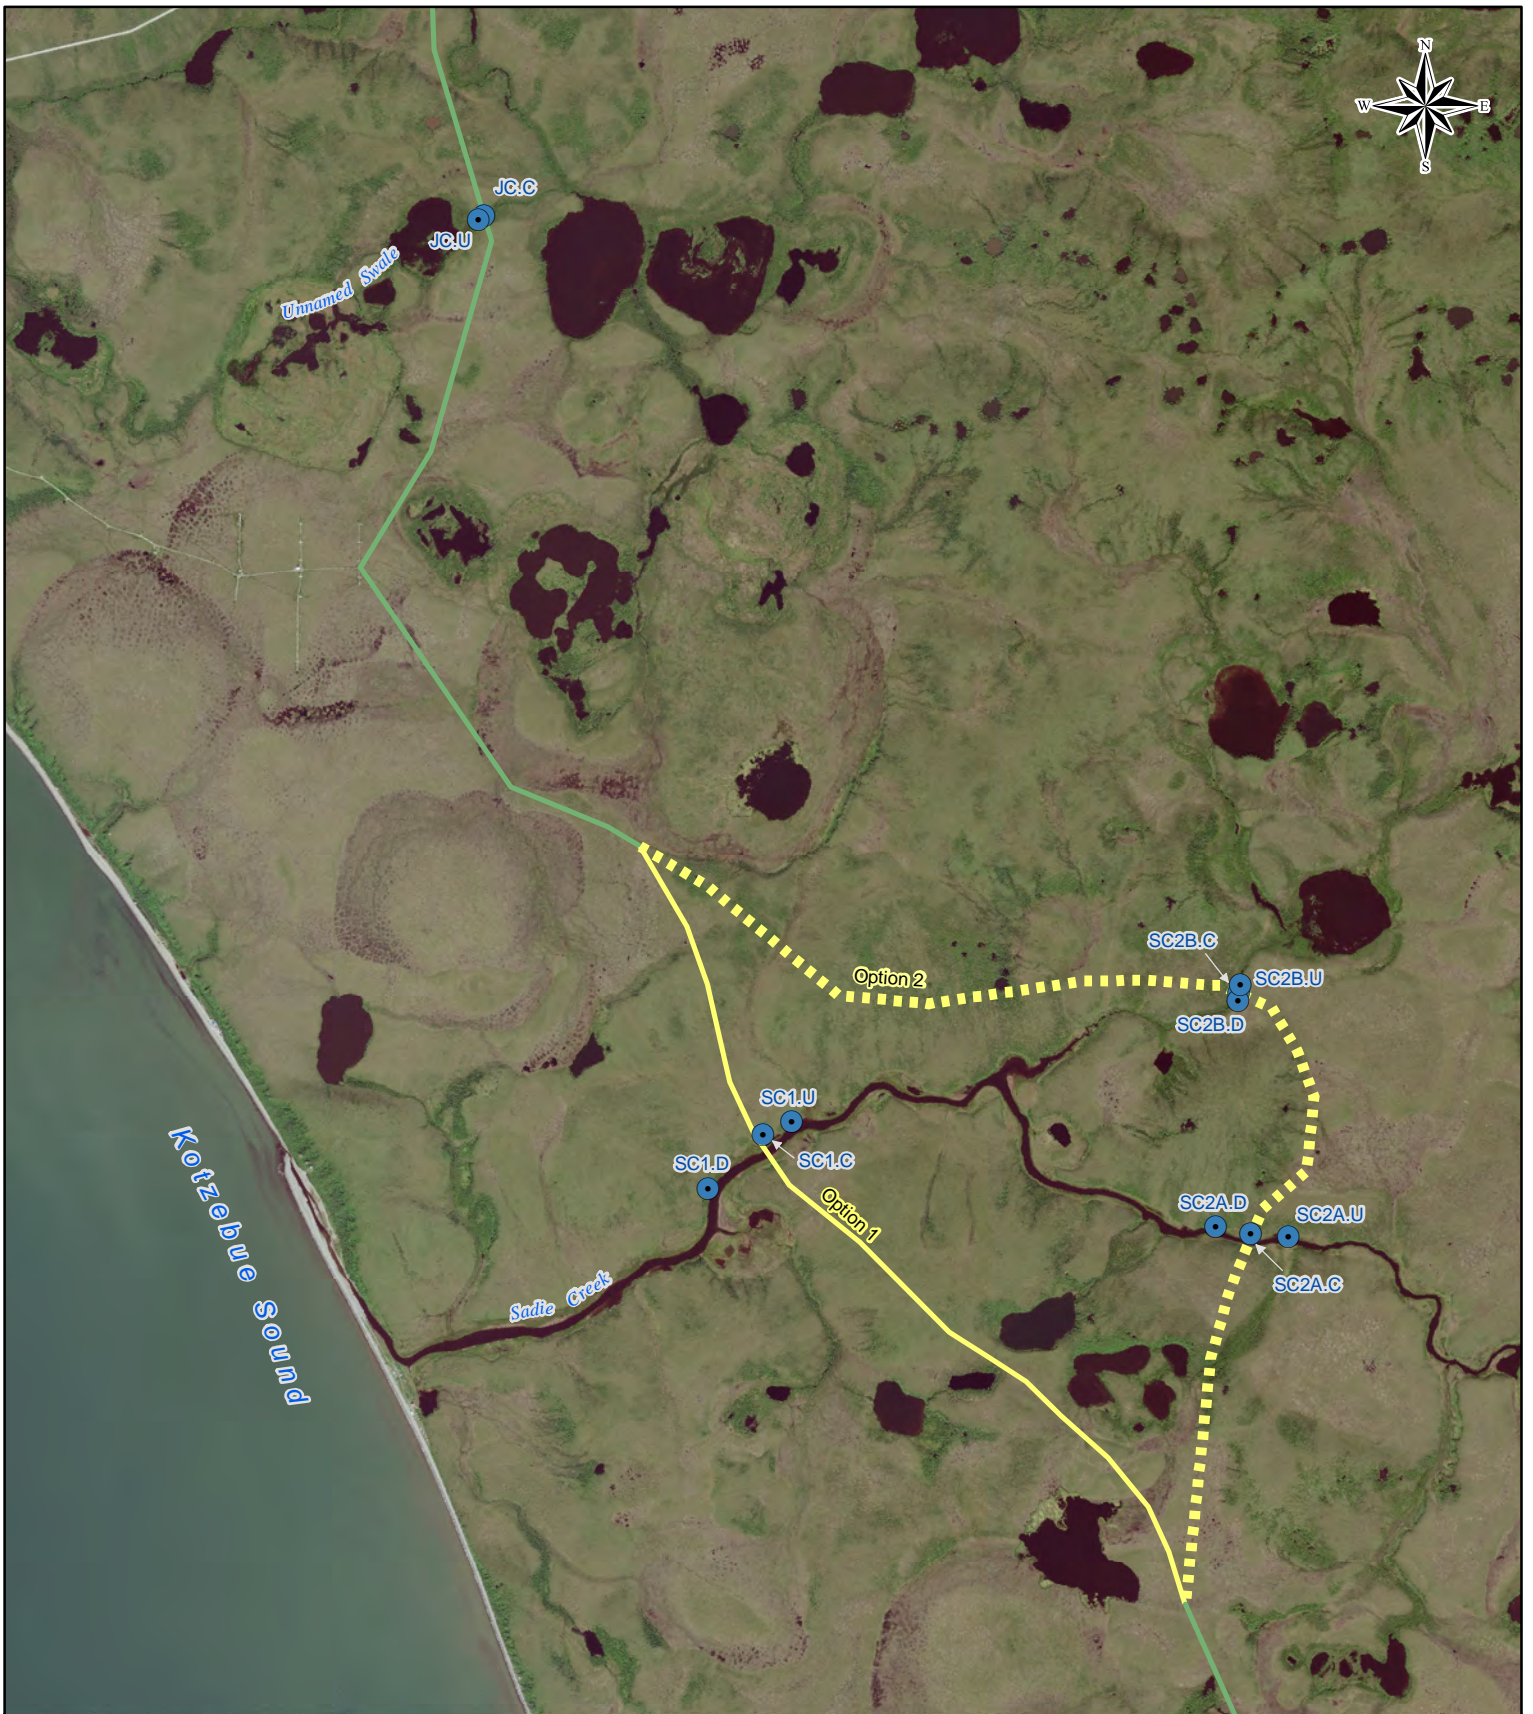
Kotzebue to Cape Blossom Road
Monitoring Locations
Figure 2.1

Monitoring was conducted at four channel crossings associated with the proposed alignment, presented in Figure 2.1. Two alternative alignments cross Sadie Creek; the Upgrade Route (Option 1) crosses Sadie Creek (SC1) where all flow is confined to a single channel, while the dismissed upper option (Option 2) crosses two smaller branches of Sadie Creek (SC2A and SC2B) approximately 1.5 river miles (RM) upstream of the western alignment. The confluence of the SC2A and SC2B channels lies approximately 0.75 RM upstream of the SC1 crossing. The fourth crossing is an unnamed swale (JC) which drains a ponded wetland area into June Creek.

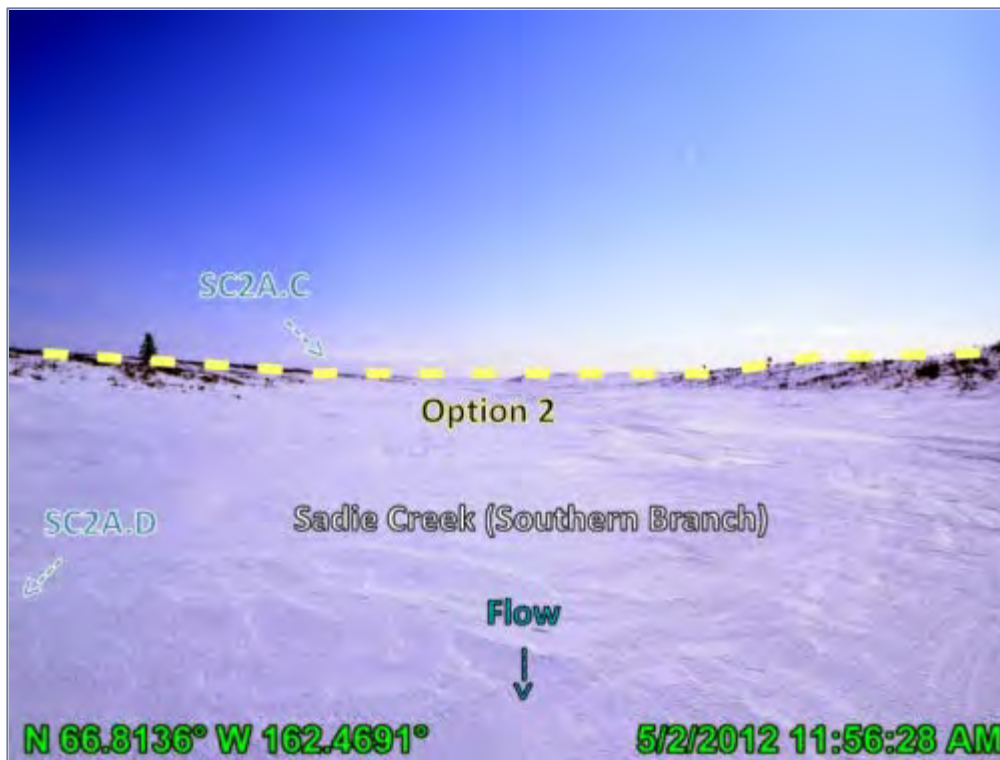
PHOTO 2.2: PROPOSED SC2A CROSSING PRIOR TO BREAKUP, LOOKING EAST; MAY 2, 2012

Gages located at SC2A were installed along a nearly straight reach and surveyed for elevation on May 4. Gages were established at the proposed road crossing centerline and approximately 500 feet upstream and downstream. PTs were installed at SC2A.U and SC2A.D. Hydrologic staff gage locations at SC2A are presented in Figure 2.5 through Figure 2.7. Photo 2.2 shows pre-breakup conditions at SC2A on May 2.

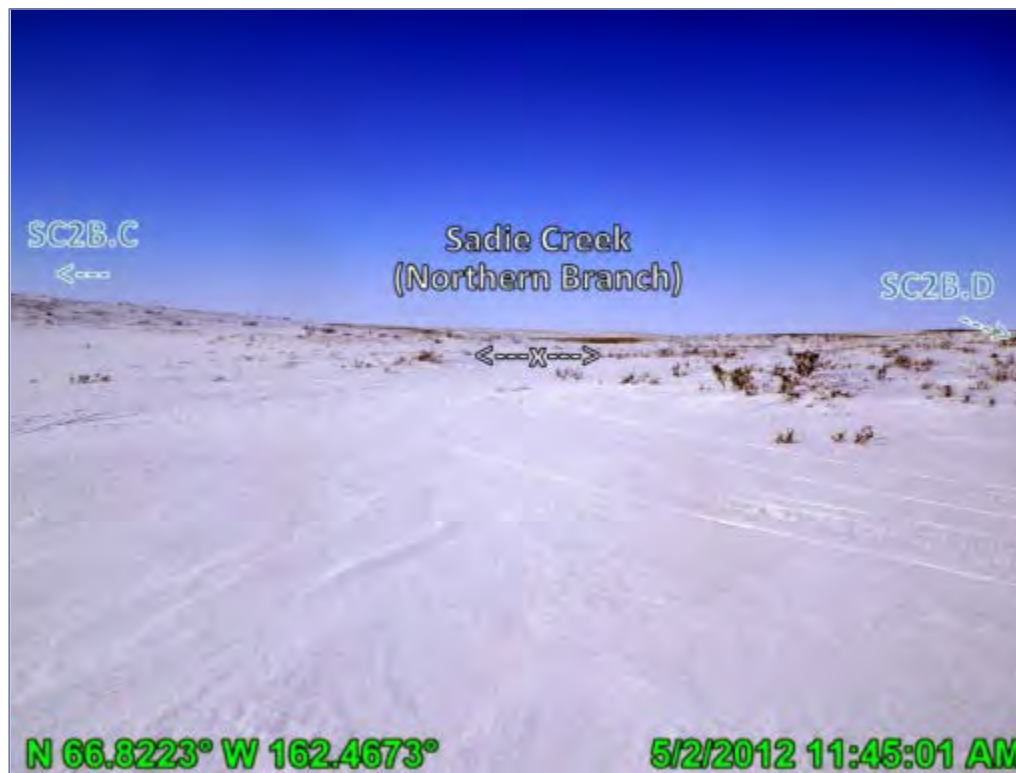
PHOTO 2.3: SC2B PRIOR TO BREAKUP, LOOKING EAST; MAY 2, 2012

Gages were established at the proposed road crossing centerline along a nearly straight reach, approximately 100 feet upstream and downstream, and surveyed for elevation on May 5. PTs were installed at SC2B.U and SC2B.D at the base of the “A” gages. Hydrologic staff gage locations at SC2B are presented in Figure 2.8. Photo 2.3 shows pre-breakup conditions at SC2B on May 2 (“←x→” indicates location and alignment of channel).

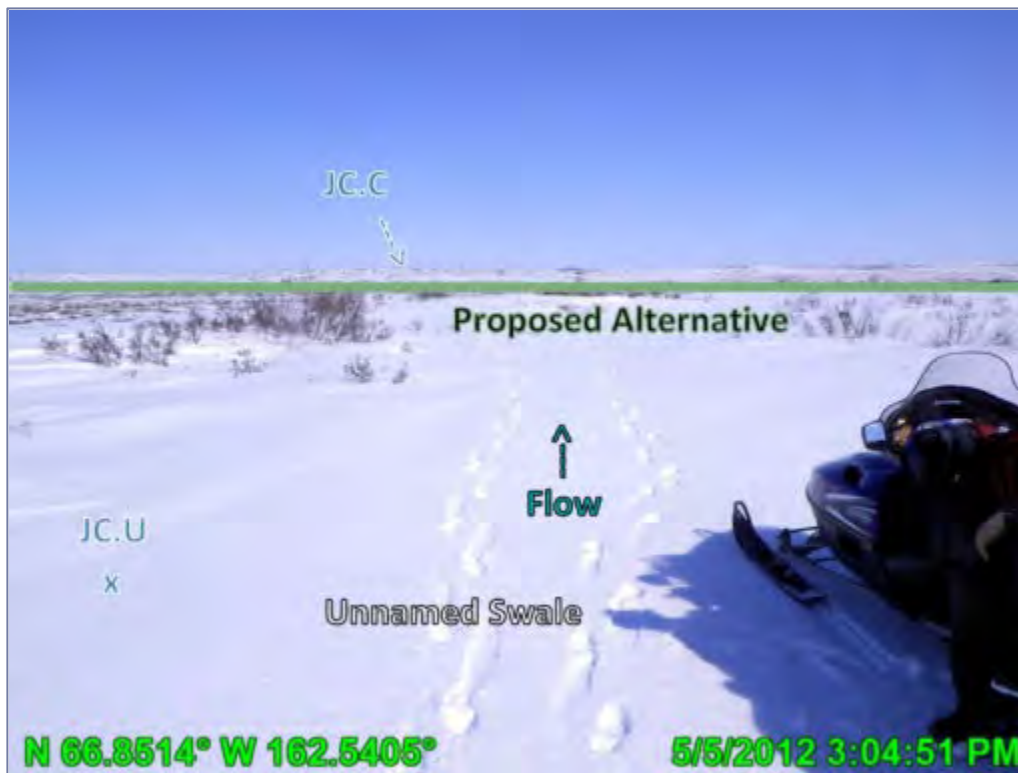
PHOTO 2.4: PROPOSED CROSSING OF THE UNNAMED SWALE PRIOR TO BREAKUP, LOOKING EAST; MAY 5, 2012

The proposed crossing of the unnamed swale is located 3 miles southeast of Kotzebue. Upstream of the site is a pond connected to a small network of wetlands or smaller ponds. This crossing was characterized by small brush and grasses with a fairly well defined drainage once the snowpack opened to floodwaters. On May 5, gages were installed and surveyed for elevation at the proposed road crossing centerline and 100 feet upstream. PTs were installed at JC.U and JC.C at the base of the "A" staff gages. Hydrologic staff gage locations at JC are presented in Figure 2.9. Photo 2.4 shows pre-breakup conditions at the proposed crossing on May 2.

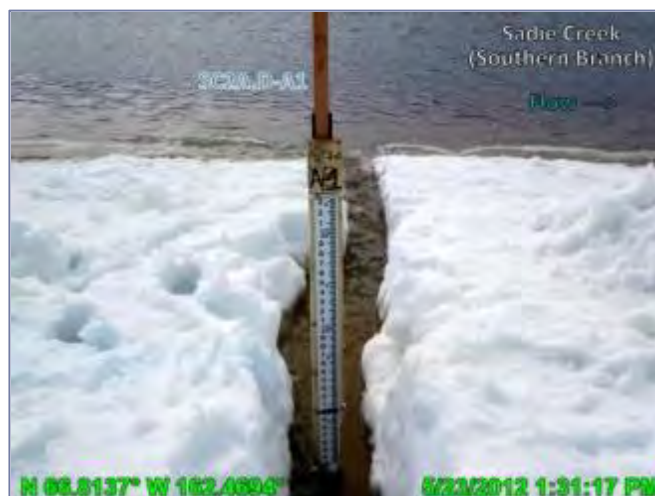
Each gage assembly consisted of a 3.33-foot long metal gage faceplate mounted on a two-by-four timber attached to a 6-foot long 1.5-inch angle iron post driven approximately 2 feet into the ground. The horizontal position of each gage was recorded using a handheld Garmin GPSMAP® 62st GPS device in North American Datum of 1983 (NAD83). Photo 3.1 shows an example of a staff gage after installation.

PHOTO 3.1: GAGE ASSEMBLY AT SC2A.D, LOOKING SOUTH; MAY 23, 2012

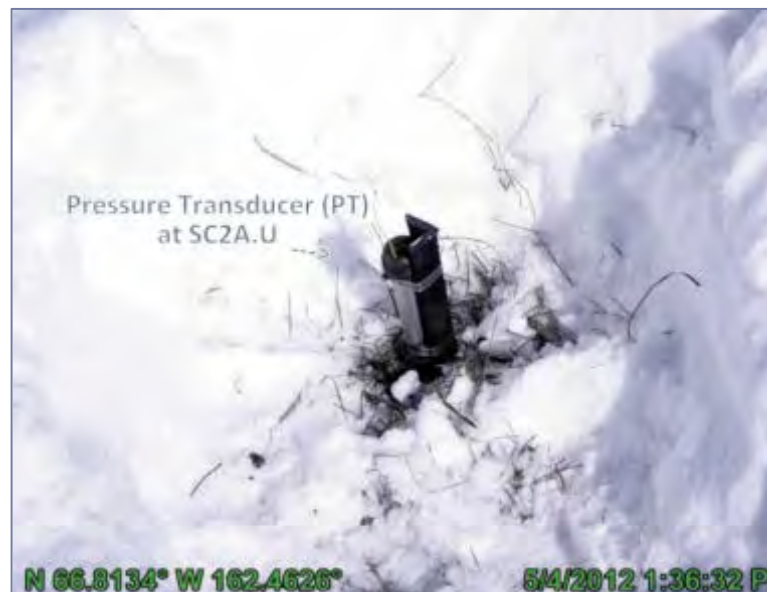
PHOTO 3.2: PT ASSEMBLY INSTALLED AT SC2A.U; MAY 4, 2012

Water depth was calculated as the density of water multiplied by gage pressure. Gage pressure was calculated as the difference in simultaneous absolute and barometric pressure data. A standard density of water at 0 degrees Celsius (°C) was used for all

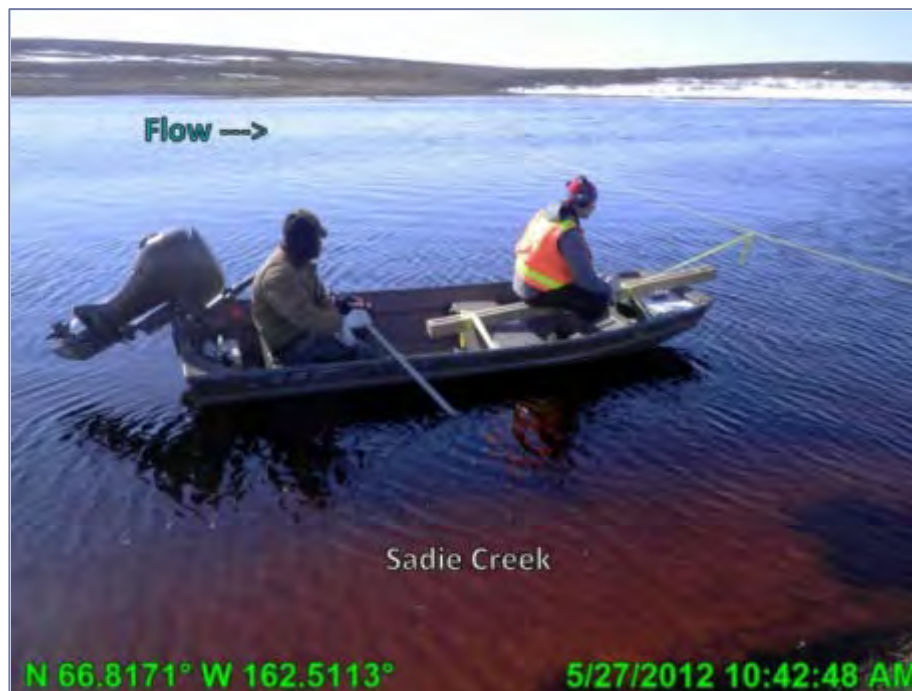
PHOTO 3.3: DIRECT-DISCHARGE MEASUREMENT AT SC1, LOOKING SOUTHEAST; MAY 27, 2012

Depth and velocity measurements were taken from a jon boat at SC1 and SC2A with a sounding reel mounted on a wooden boom (Photo 3.3). A Price AA velocity meter was attached to the sounding reel and stabilized with a 30-pound Columbus-type lead sounding weight. A tag line was placed across the channel to define the cross section and to delineate measurement subsections within the channel. To ensure accurate performance of meters, procedures outlined in the Office of Surface Water Technical Memorandum No. 99.06 (OSW 1999) were followed.
