FINDING OF NO SIGNIFICANT IMPACT

KOTZEBUE TO CAPE BLOSSOM ROAD

PROJECT No. NCPD-0002(204)/76884

Department of Transportation
and Public Facilities

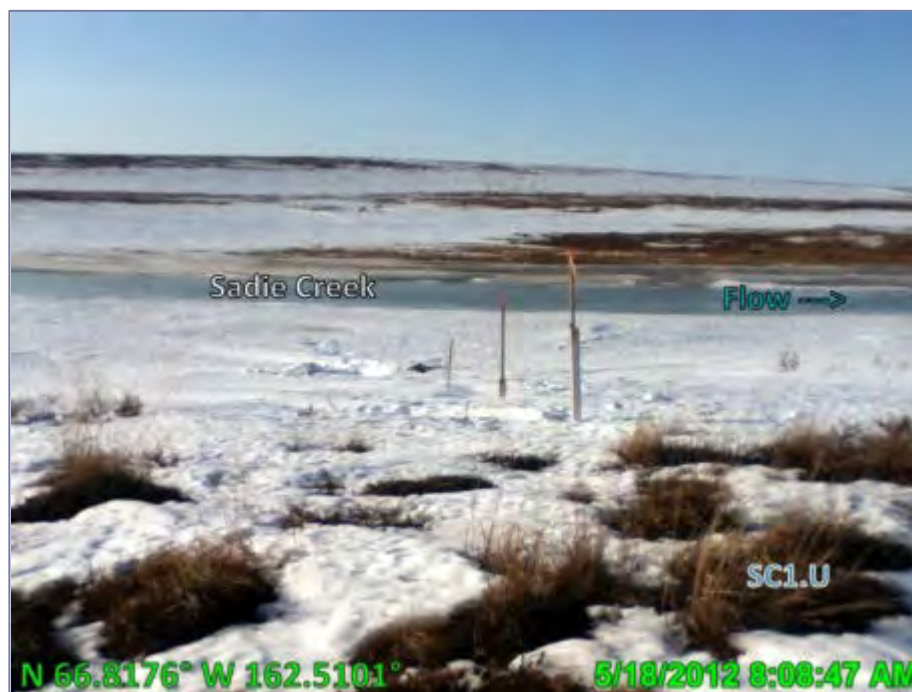
PHOTO 4.1: BREAKUP INITIATION AT SC1.U, LOOKING SOUTH; MAY 18, 2012

Victor Jones, a local subcontractor with the Native Village of Kotzebue, provided photographic evidence of breakup processes at the monitoring areas beginning on May 18 (Photo 4.1), prior to Baker field crew mobilization to Kotzebue on May 22.

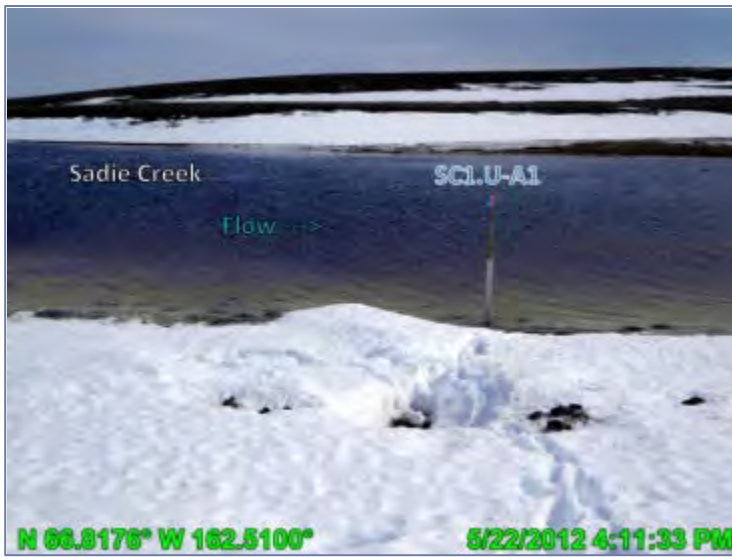
PHOTO 4.2: BOTTOM-FAST ICE AT SC1.U, LOOKING SOUTHEAST; MAY 22, 2012

On May 22, stage was low with no discernible velocity. Ice was bottom-fast in the channel and no ice floes were present (Photo 4.2). Stage continued decreasing on May 23, reaching the lowest elevations during the breakup period before rising again.

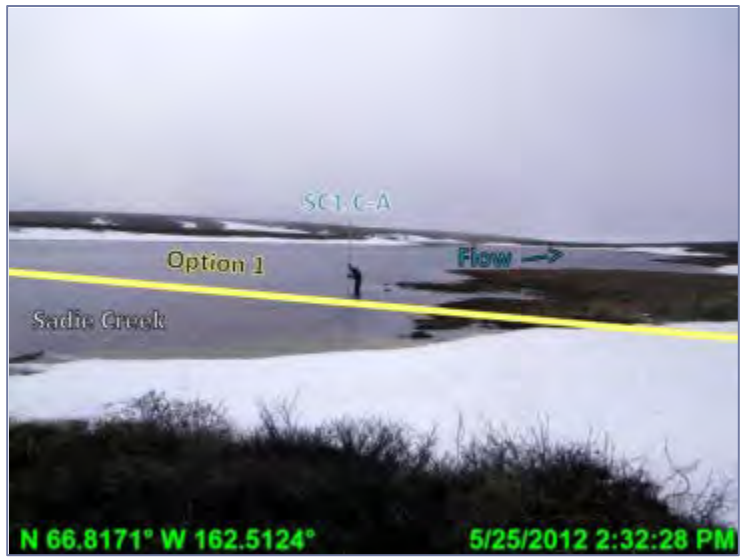
PHOTO 4.3: BOTTOM-FAST ICE ALONG TOE OF BANK AT SC1.C, LOOKING DOWNSTREAM; MAY 25, 2012

All gage locations experienced a second stage crest on May 24, when peak stage was recorded at SC1.C and SC1.D. The width of flow was approximately 300 feet during the second crest, with floodwaters and snow present in both left and right overbank areas. The gradient at the crossing location is relatively shallow and flow velocities were low during the peak stage period. Flow was ineffective in the overbank areas, with the majority being conveyed through the thalweg. Stage recession for the second time during breakup continued on May 25 at which time bottom-fast ice was still present along the toe of the left (north) bank (Photo 4.3).

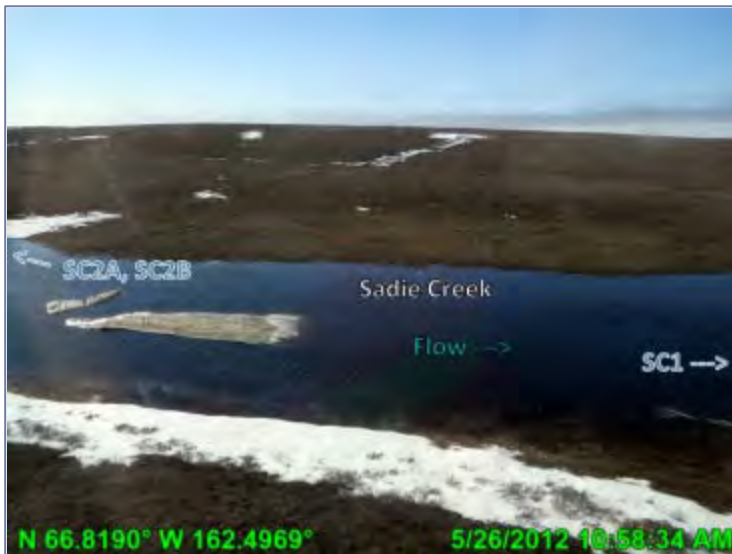
PHOTO 4.4: ICE LIFTING OFF THE CHANNEL BED 0.5 MILES UPSTREAM OF SC1 GAGES, LOOKING SOUTH; MAY 26, 2012

By May 26, ice had lifted off the channel bed both upstream and downstream of the SC1 reach (Photo 4.4) and stage at all locations rose slightly. The following day, ice floes were observed approximately 0.5 RM upstream of SC1 (Photo 4.5). No significant effects to flow were seen at the crossing location as a result of this ice. Floes remained in the channel upstream of SC1 on May 29 as stage continued to drop.

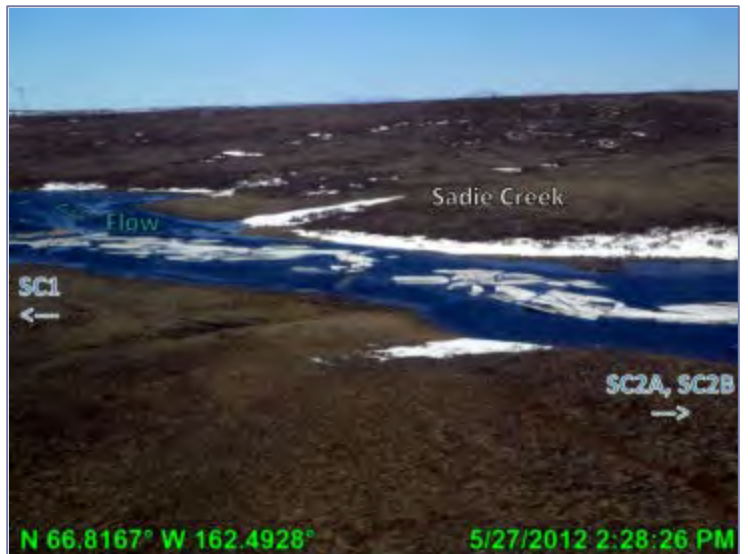
PHOTO 4.5: ICE FLOES UPSTREAM OF SC1 GAGES, LOOKING NORTHWEST; MAY 27, 2012

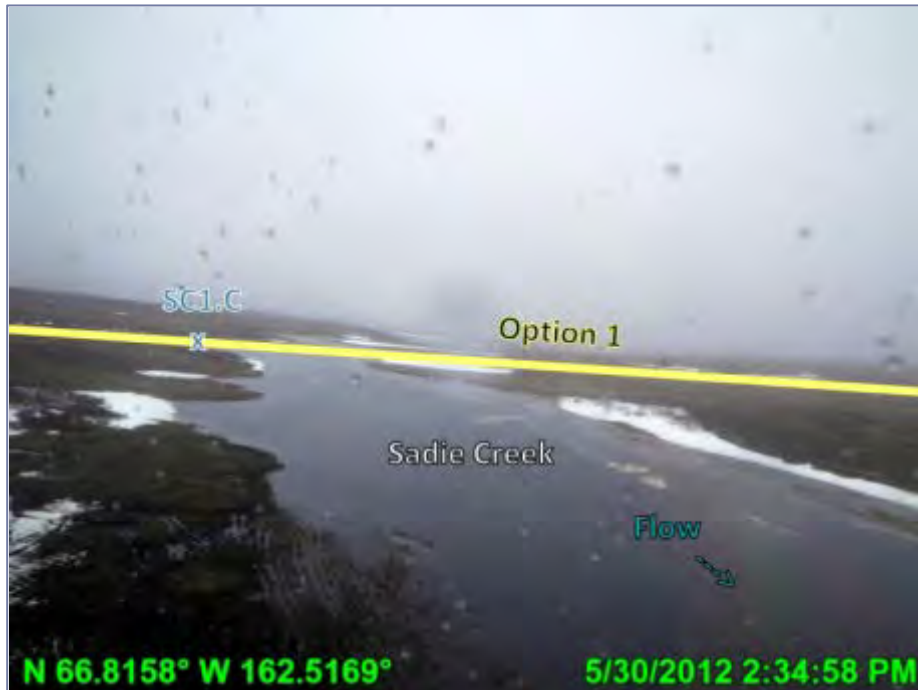
PHOTO 4.6: OPEN CHANNEL CONDITIONS DOWNSTREAM OF SC1 GAGES,
LOOKING UPSTREAM TO CROSSING LOCATION; MAY 30, 2012

By the final day of monitoring on May 30, the channel reach at the crossing location was open though occasional ice floes were present downstream (Photo 4.6). Flow was becoming more contained within the defined channel banks as stage continued decreasing. Both overbanks were still inundated with floodwater in places and some snow was present.

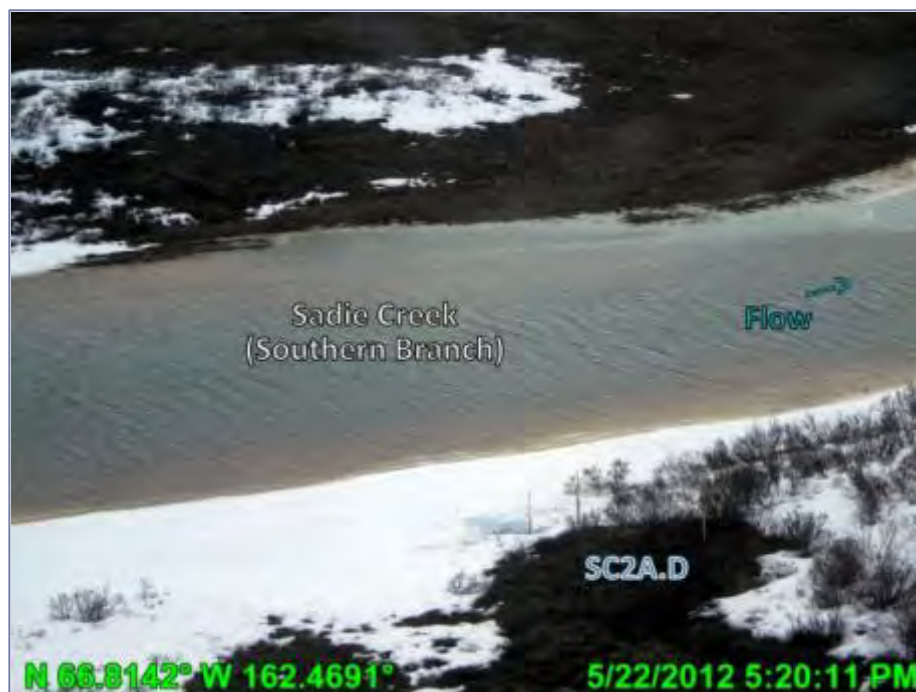
PHOTO 4.7: BOTTOM-FAST ICE ALONG BANKS AT SC2A.D, LOOKING SOUTHWEST; MAY 22, 2012

The leading edge of meltwater flow is estimated to have passed SC2A on May 21. An initial low stage crest was experienced at all gaging locations on this day, based on PT data. Stage had dropped below gage levels by May 22, reaching a breakup low on May 23. Bottom-fast ice was present along both banks and the channel was free of floes (Photo 4.7). Stage increased once again, reaching a peak at all locations on May 24. The width of flow at SC2A was approximately 160 feet during peak stage, with floodwaters and snow in both overbanks (Photo 4.8). No floes were in the vicinity. The gradient at the crossing location is relatively shallow and flow velocities were low during the peak period. Flow was ineffective in the overbank areas, with the majority being conveyed through the thalweg.

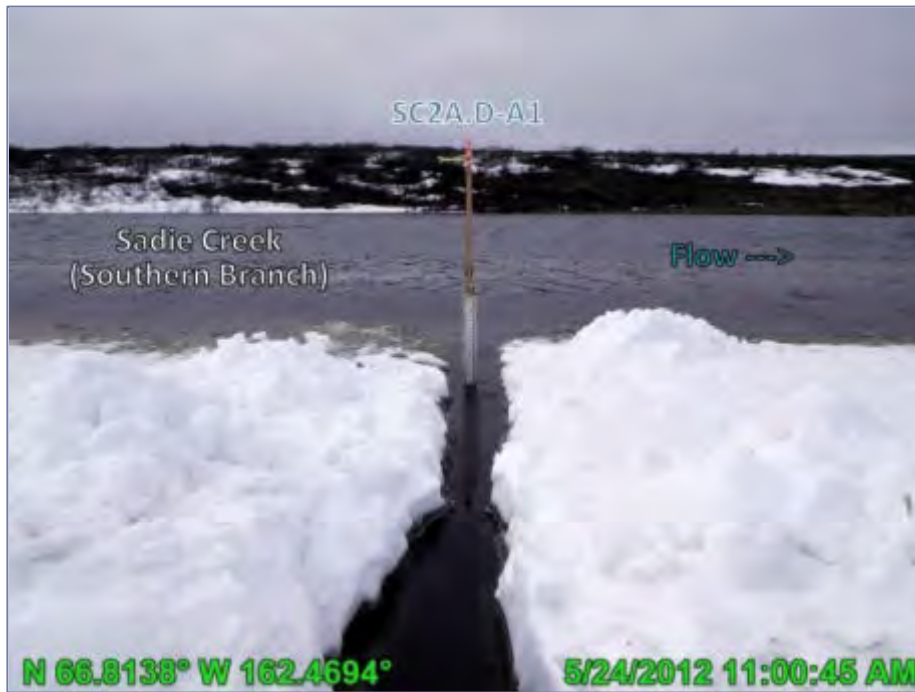
PHOTO 4.8: CONDITIONS DURING PEAK STAGE AT SC2A.D, LOOKING SOUTHWEST; MAY 24, 2012

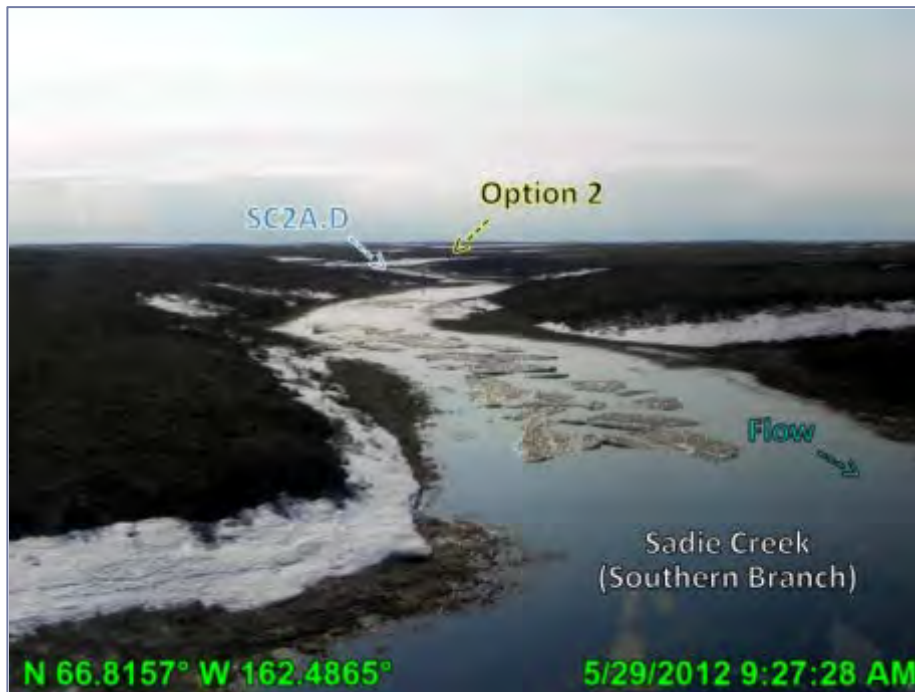
PHOTO 4.9: ICE FLOES 0.5 RM DOWNSTREAM OF SC2A, LOOKING WEST; MAY 29, 2012

On May 25, the channel remained free of snow and ice floes as stage continued to drop. Conditions were similar until May 28 when bottom-fast ice lifted to the surface. Stage dropped below gages by May 29. Ice floes were grounding out approximately 0.5 RM downstream of SC2A and flow within the reach was confined almost entirely within the channel banks (Photo 4.9). No backwater effects were observed at the crossing location as a result of the rafted floes downstream. The majority of the snow in the area had melted and monitoring was discontinued.

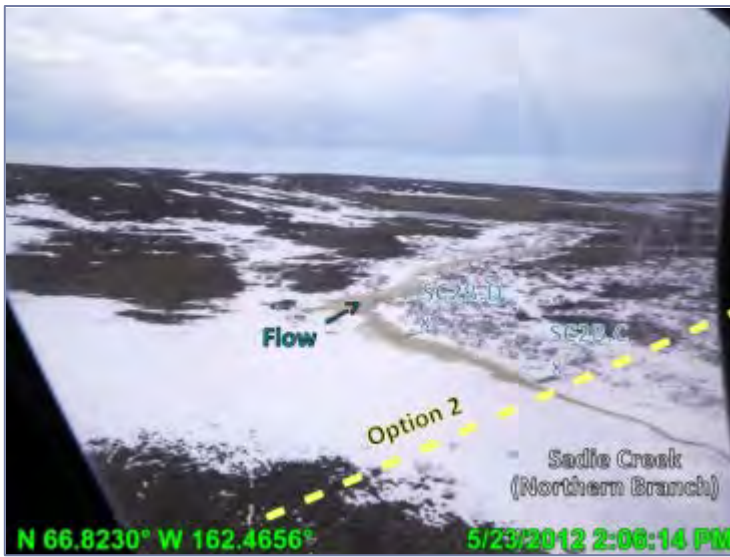
PHOTO 4.10: STEEPER TO SHALLOWER GRADIENT FLOW OVER SNOW AT SC2B, LOOKING DOWNSTREAM; MAY 23, 2012

Field crews first collected visual observations on May 23. The upstream gradient through this reach was steeper and flow was more confined within the channel cut through the snow. Downstream, the gradient became shallower, flow had lower velocity and was less confined, and ponding occurred on top of the snow (Photo 4.10 and Photo 4.11 on May 24). By May 25, the incised channel was more defined through the entire reach, though snow along both sides was saturated with ineffective flow (Photo 4.12). Water continued to pond just downstream, the shallow gradient and snow contributing to a backwater effect. Flow continued to deepen and widen the channel cut into the snowpack (Photo 4.13), reaching the natural channel by May 27 (Photo 4.14). The natural channel was partially under the left bank snowpack, which had been eroded over 10 feet deep and up to 20 feet wide in some locations through the crossing reach (Photo 4.15).

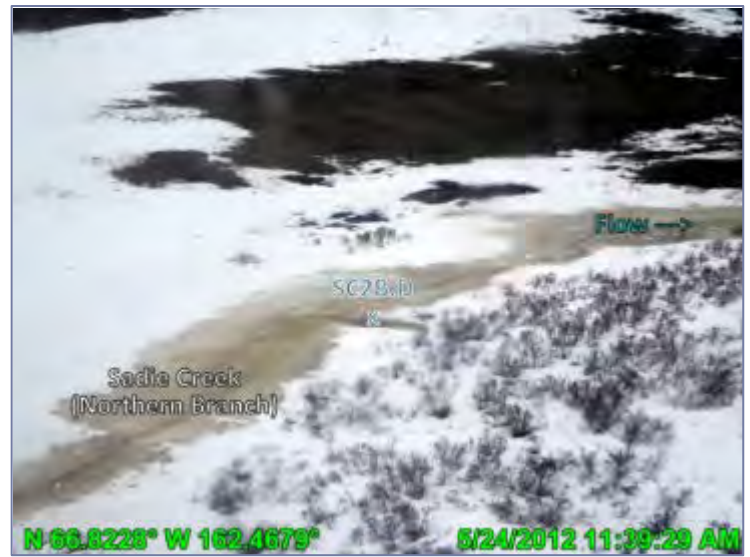
PHOTO 4.11: FLOW LESS CONFINED AS A RESULT OF SHALLOWER DOWNSTREAM GRADIENT AT SC2B, LOOKING DOWNSTREAM; MAY 24, 2012

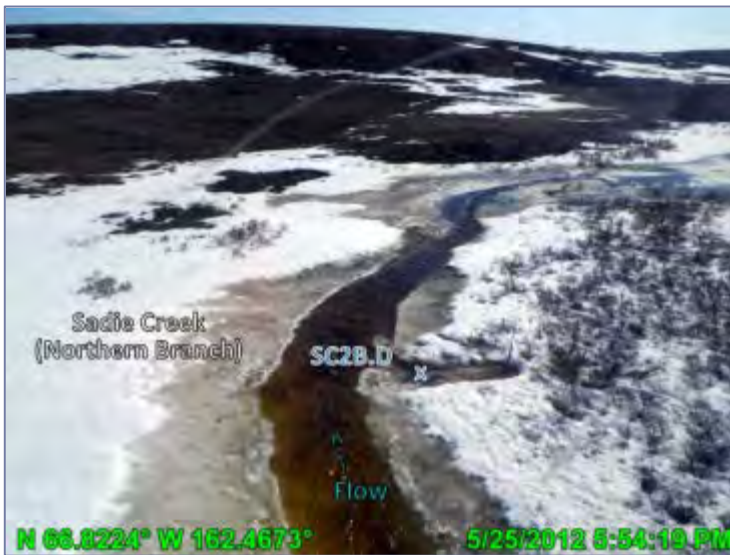
PHOTO 4.12: BREAKUP PROGRESSION AT SC2B AND DOWNSTREAM PONDING, LOOKING DOWNSTREAM; MAY 25, 2012

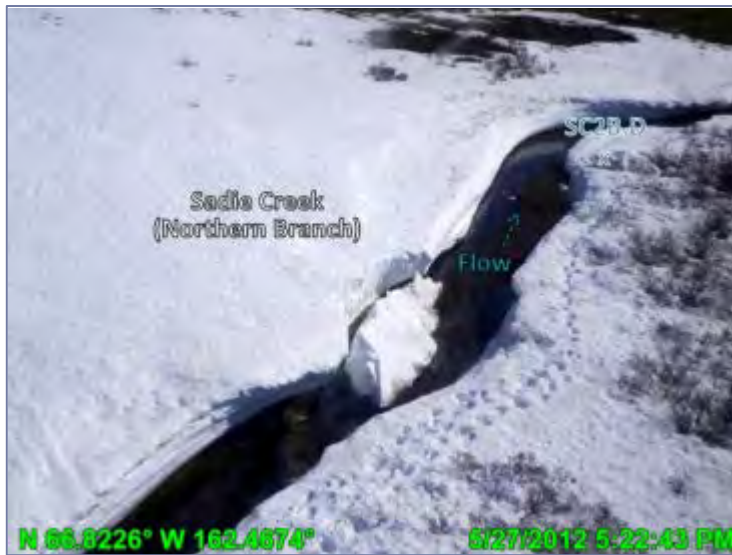
PHOTO 4.14: SC2B CHANNEL CUT TO THE BOTTOM OF THE SNOWPACK, LOOKING DOWNSTREAM; MAY 27, 2012

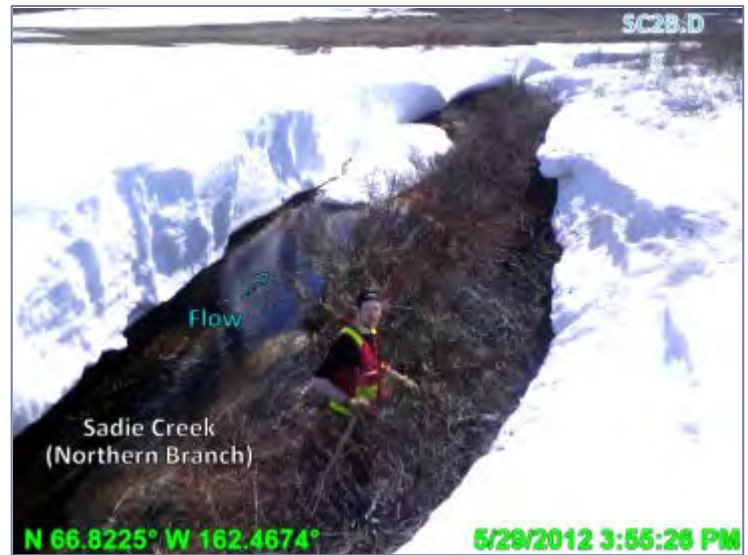
PHOTO 4.15: CUT IN SNOWPACK LEFT BY SC2B AND MIGRATION OF FLOW TOWARD NATURAL CHANNEL, LOOKING DOWNSTREAM; MAY 29, 2012

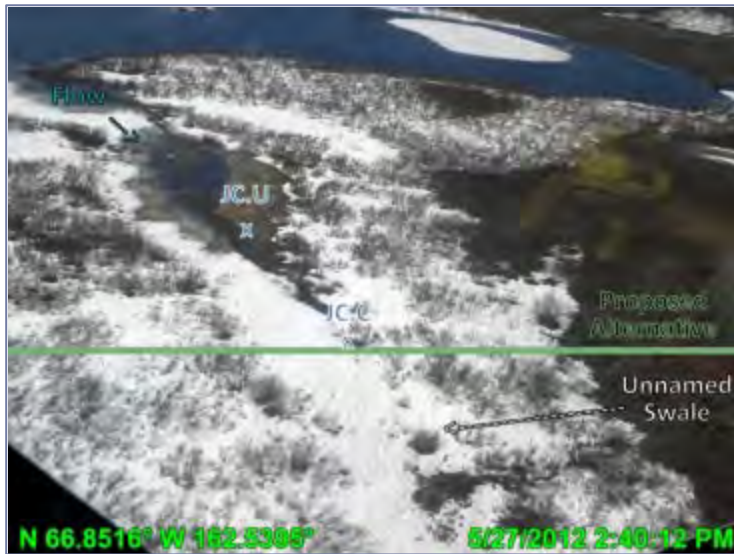
PHOTO 4.16: DISMISSED UNNAMED SWALE CROSSING, LOOKING WEST; MAY 27, 2012

The swale drains a network of small ponds and wetlands into June Creek. Local melt was observed at JC gages during the reconnaissance flight on May 22. By May 27, melt in the pond upstream had progressed sufficiently so water had reached the crossing location but stage was low (Photo 4.16). Snow was still present downstream of the gages and there was no flow. This swale was conveying flow at a maximum top-width of 30 feet by May 29 (Photo 4.17). The maximum depth was 1.3 feet and the surface of the water was discontinuous with ice, snow, and vegetation. Stage and flow had decreased by May 30, after which monitoring was discontinued.

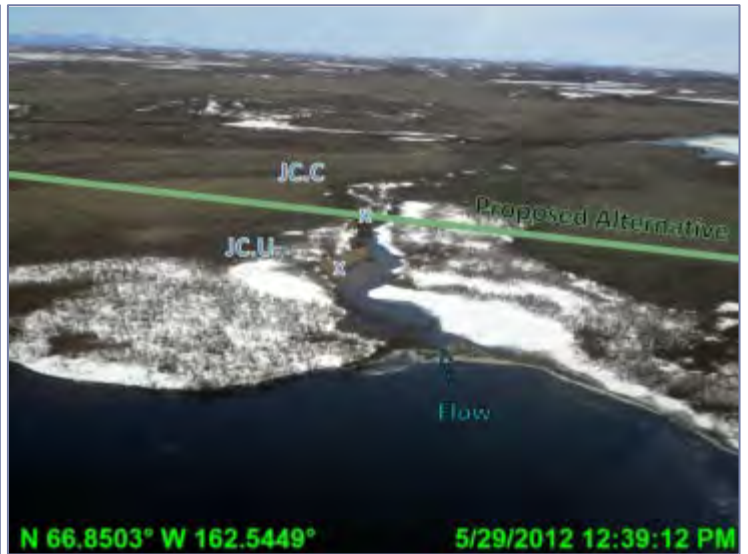
PHOTO 4.17: DISMISSED UNNAMED SWALE CROSSING, LOOKING NORTHEAST; MAY 29, 2012

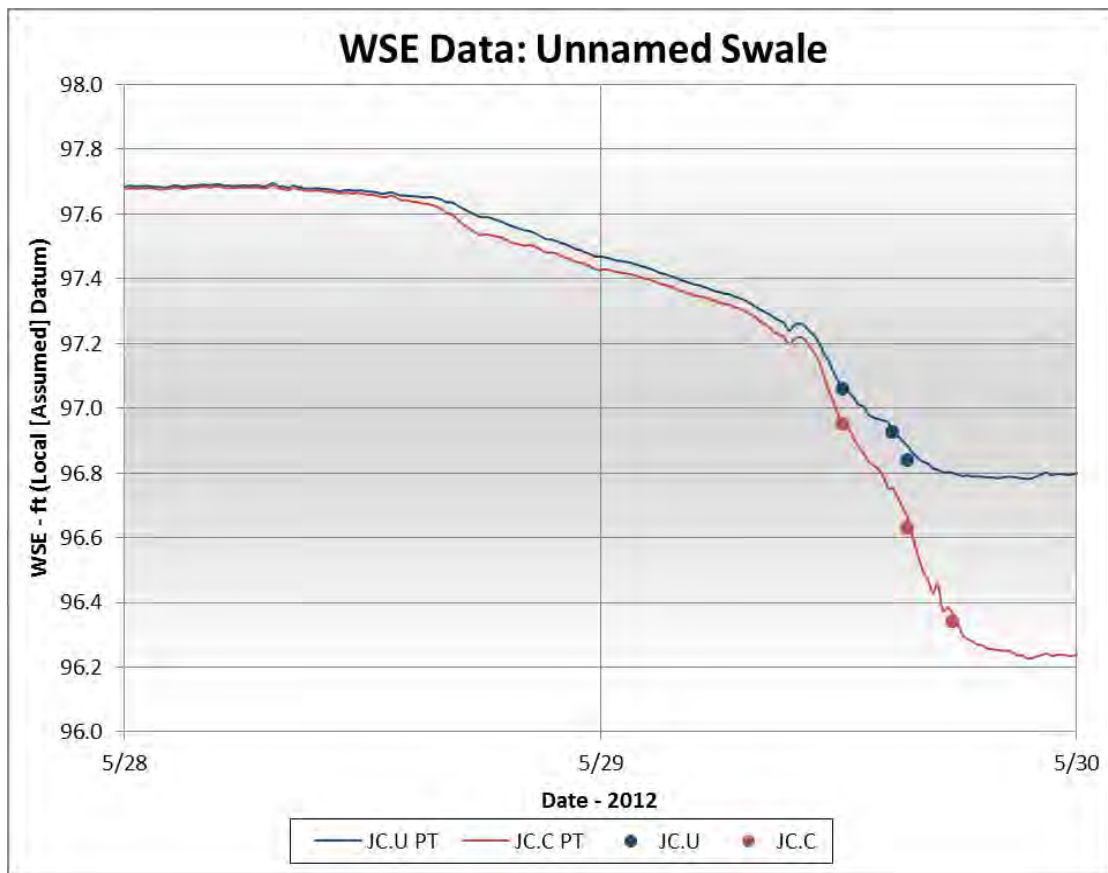
1. Elevations are based on JC at 100.00 feet (local datum - assumed elevation) surveyed by Baker in 2012.
2. Local melt only through morning of May 28.
3. Only limited outflow was observed through the swale.

GRAPH 4.4: STAGE DATA, JC GAGES

Stage data for the JC gages during breakup monitoring are contained in Table 4.4 and Graph 4.4.

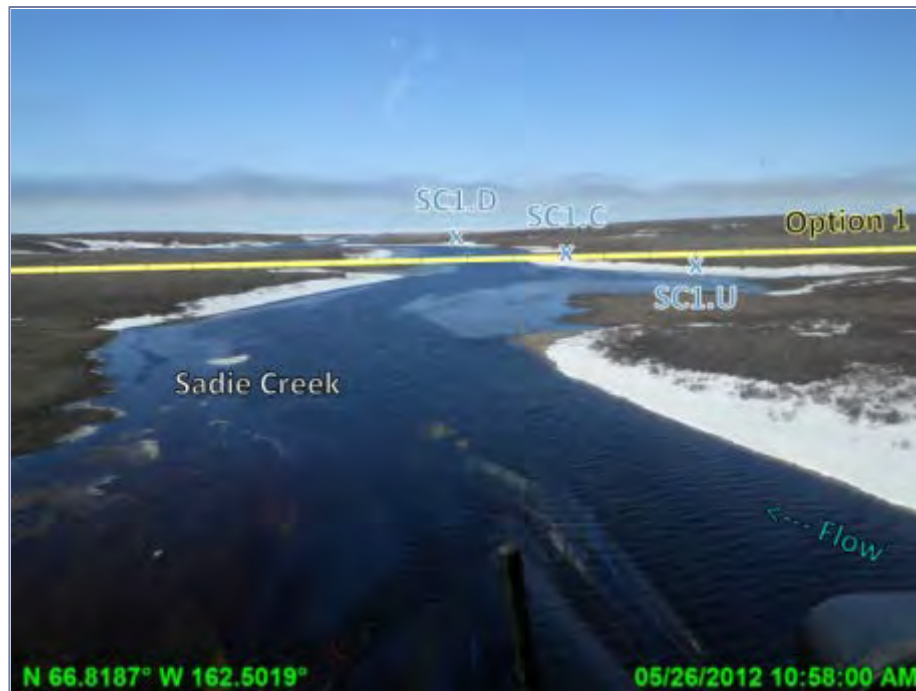
PHOTO 5.1: SC1 REACH UPSTREAM OF GAGES, LOOKING DOWNSTREAM; MAY 26, 2012

Conditions affecting discharge measurements were fairly consistent each day (Photo 5.1). A strong west wind persisted throughout the monitoring period and was strong enough to push the boat upstream of the tagline during each measurement. Direct discharge measurements were most likely impacted by the flow resistance induced by the wind, which varied in strength, and was weakest on May 26. The reach banks were free of snow prior to the first discharge measurement on May 24. Bottom-fast ice lined approximately half the channel cross section and remained in place during all discharge measurements. Bottom-fast ice began lifting upstream and downstream of the SC1.C on May 26. These floes gathered 0.5 RM upstream of SC1 and remained in place. No floes were in the vicinity of the crossing location during discharge measurements. No significant backwater effects were evident at SC1 as a result of downstream ice conditions.

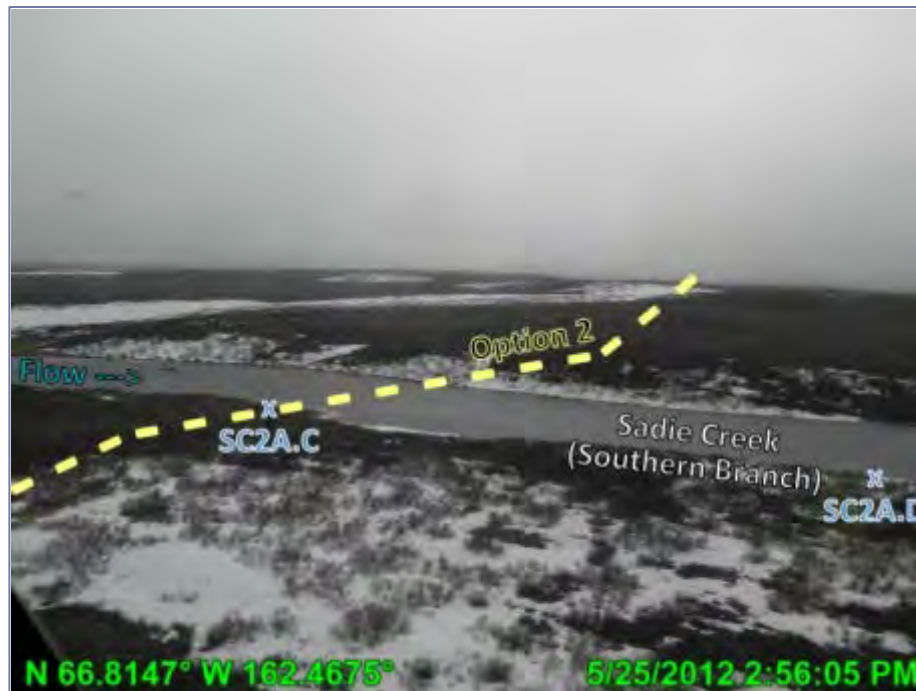
PHOTO 5.2: SC2A REACH, LOOKING SOUTH; MAY 25, 2012

Conditions at SC2A were similar to SC1 and remained fairly consistent each day (Photo 5.2). Similar to SC1, wind resistance most likely had an impact on direct discharge measurements. The reach overbanks were free of snow for all direct discharge measurements. Bottom-fast ice was present along the profile, but was not continuous across the entire width. Ice was observed lifting off the channel bottom both upstream and downstream of SC2A on May 26, but bottom-fast ice was not observed lifting at SC2A.C. No floes were in the vicinity of the crossing location during measurements and no significant backwater effects were observed.

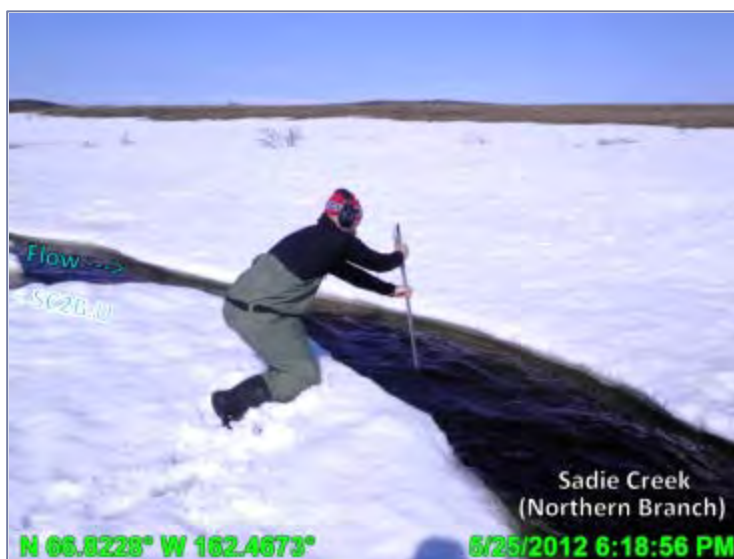
PHOTO 5.3: SC2B CONDITIONS DURING DISCHARGE MEASUREMENT, LOOKING NORTHEAST; MAY 25, 2012

Direct discharge measurements were conducted at SC2B on May 25 and 26 near the centerline gaging location (SC2B.C). As discussed, flow at this location moved on top of and through the snowpack (Photo 5.3 and Photo 5.4) for the duration of the monitoring period, gradually cutting a rectangular channel toward the natural bed. The geometry of the incised channel consistently changed, as did the gradient. Data was collected as conditions allowed and with regard to safety. Mean velocity was estimated from a single measurement from the center of the channel at 60% water depth from the surface. Cross-sectional area was determined using rough measurements of the width and depth of the channel, which was soft and saturated snow. Discharge was computed using the continuity equation (Equation 1) where Q is discharge, A is cross-sectional area, and V is velocity.

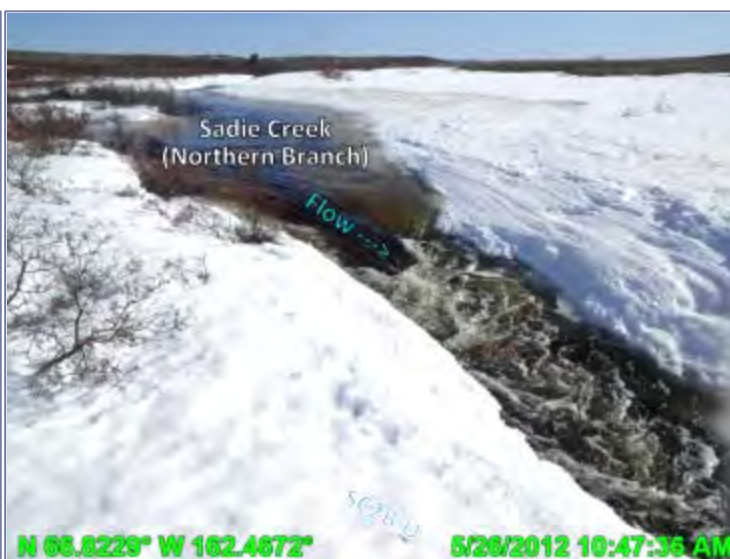
PHOTO 5.4: CONDITIONS UPSTREAM OF SC2B.U, LOOKING NORTH; MAY 26, 2012

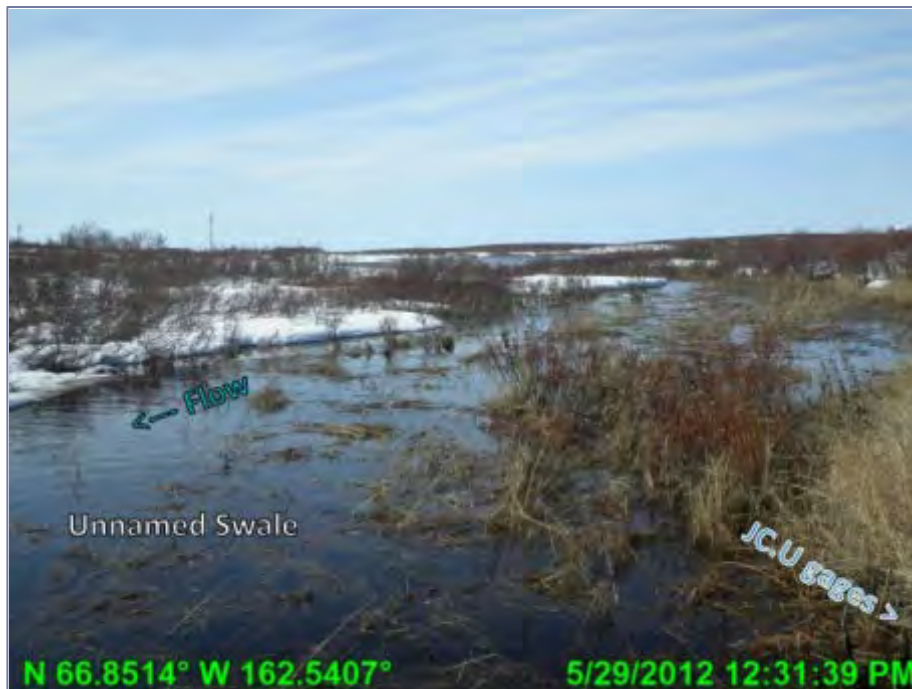
PHOTO 5.5: JC CONDITIONS BEFORE DISCHARGE MEASUREMENT, LOOKING DOWNSTREAM; MAY 29, 2012

Local melt was present under the snow at JC until flow was observed in the unnamed swale on May 29 (Photo 5.5). One discharge measurement was performed at the centerline gage location (JC.C).

Velocity was slow and the depth of water was low. Discharge was impacted by vegetation and snow in the channel.

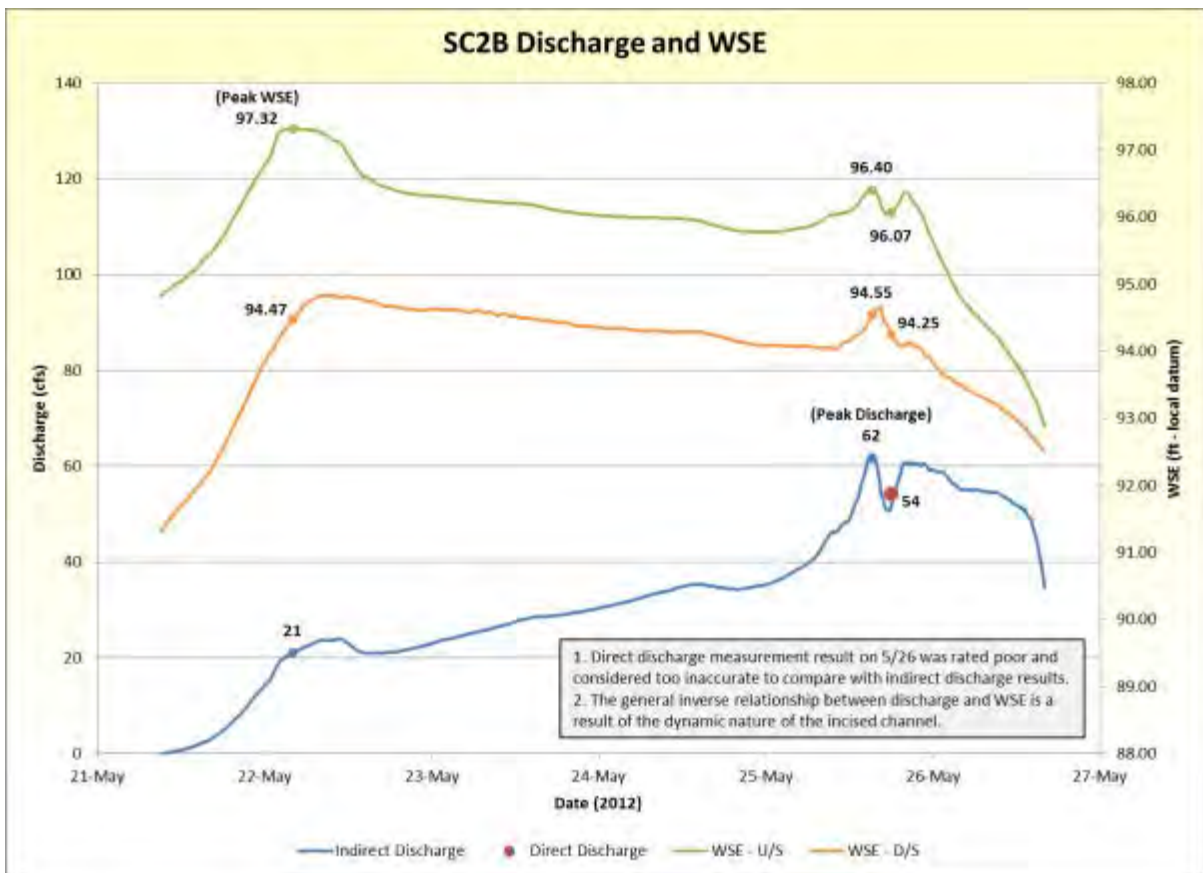
GRAPH 5.3: SC2B DISCHARGE AND WSE

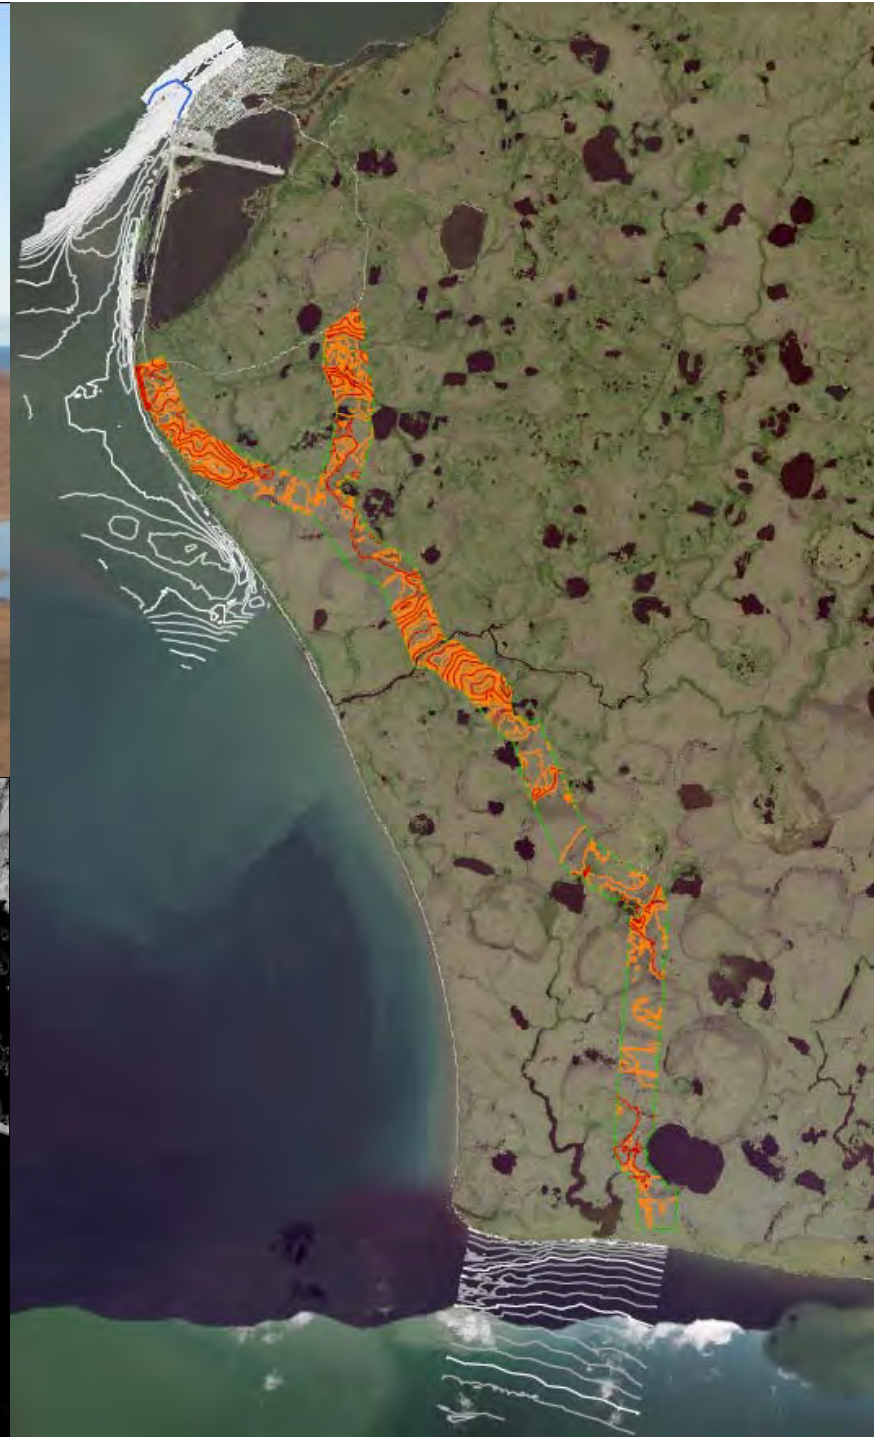
PM/RS: Wendy Davis

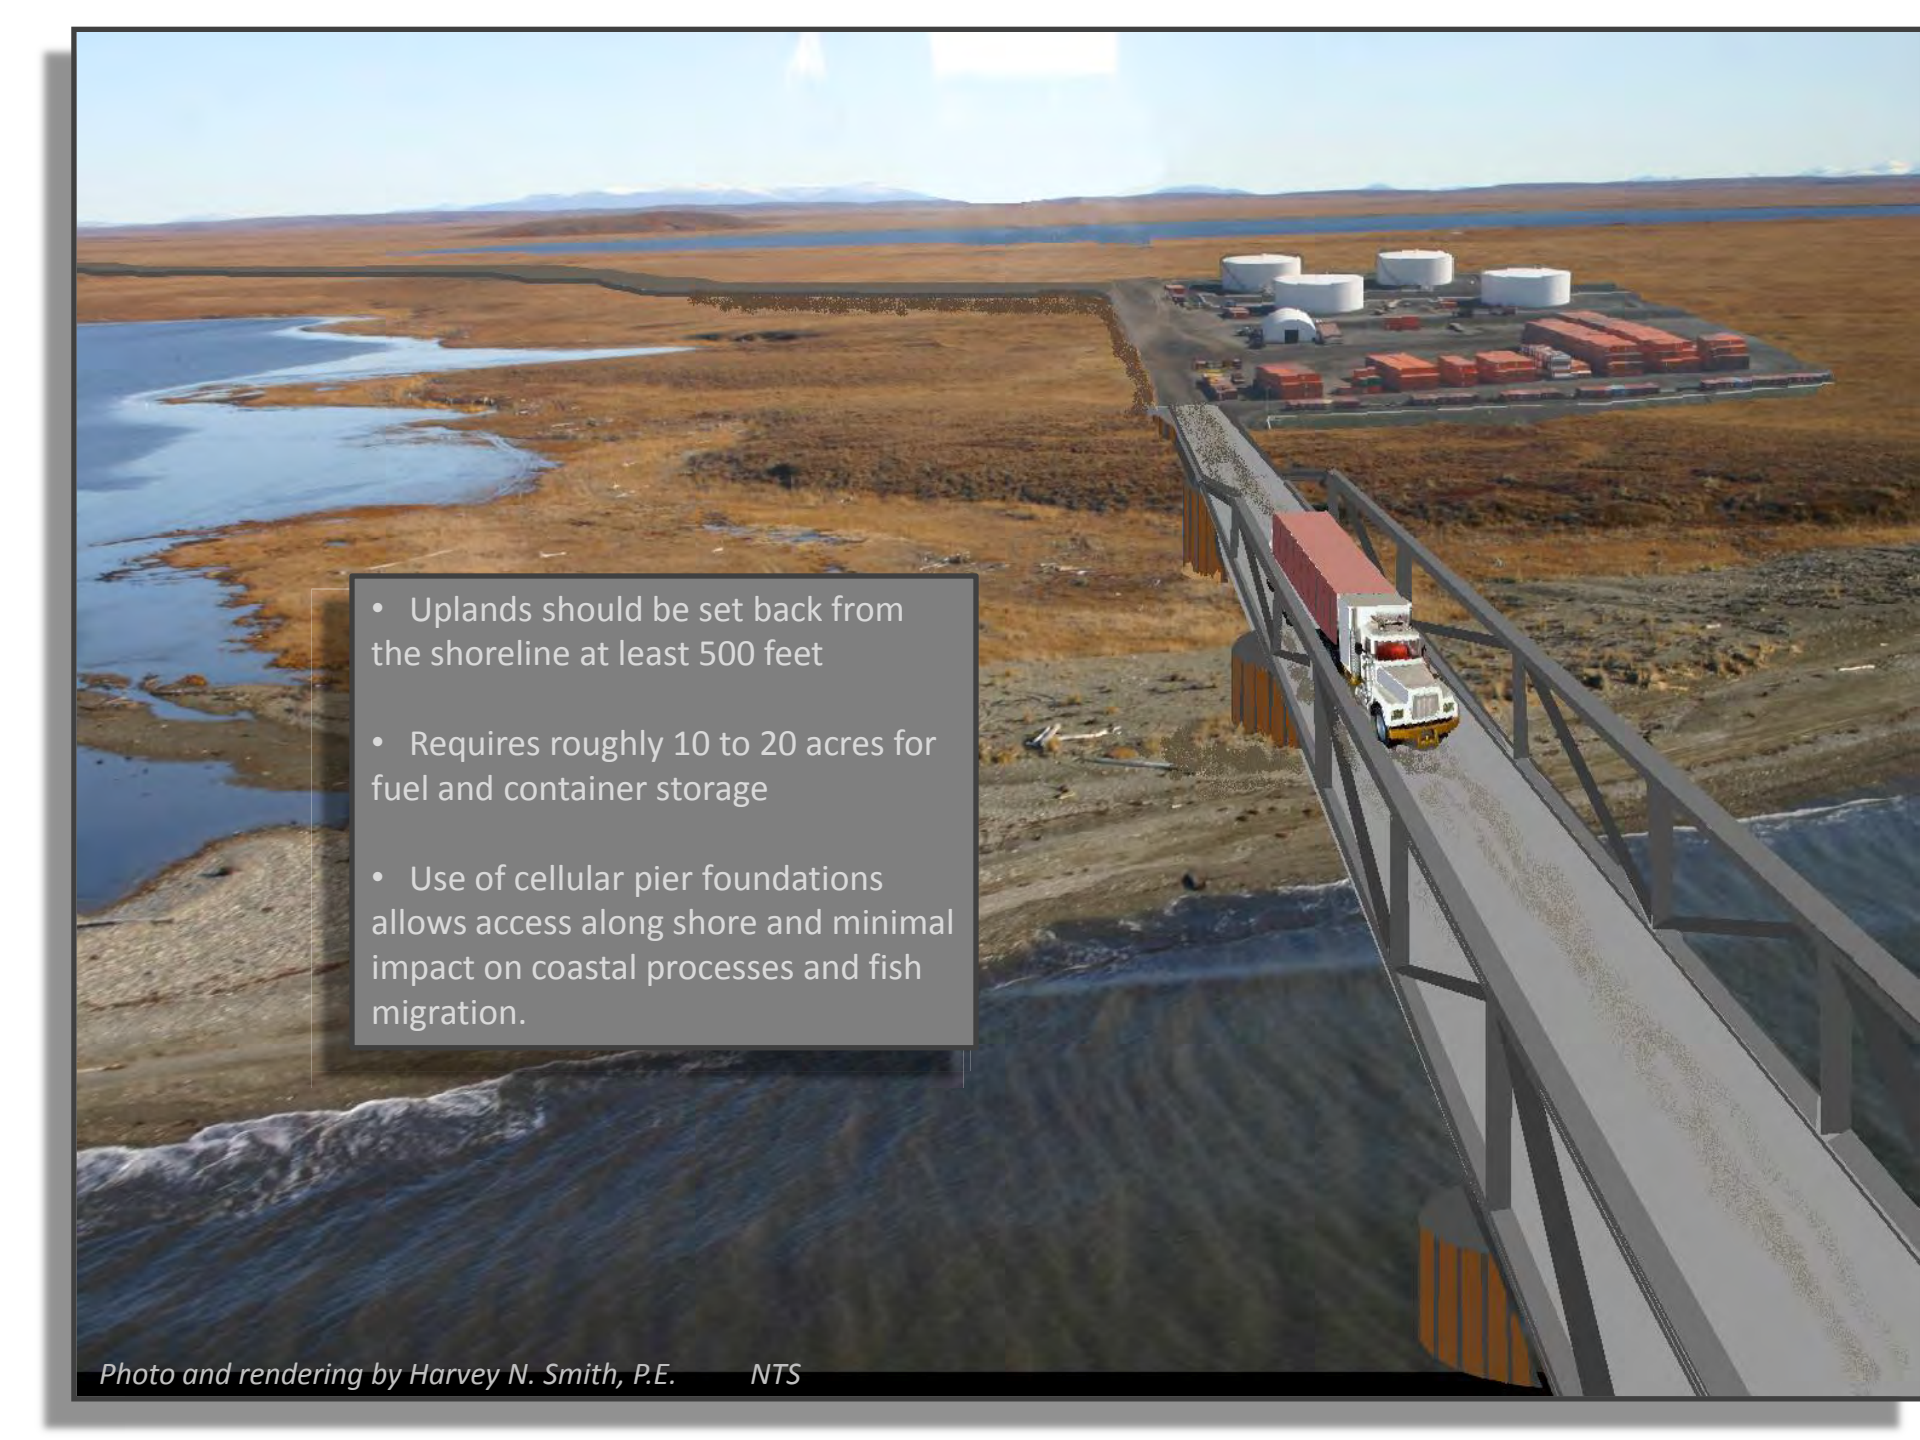
- An aerial rendering of a coastal facility. In the foreground, a long, elevated bridge with a metal railing spans across a body of water. A white truck with a red container is driving on the bridge. The bridge is supported by several cylindrical cellular pier foundations. In the background, a large industrial or storage area is visible, featuring several large white cylindrical tanks, a white dome-shaped structure, and numerous red shipping containers. The surrounding landscape is a flat, brownish plain with some water bodies and distant mountains under a clear blue sky.
- Uplands should be set back from the shoreline at least 500 feet
 - Requires roughly 10 to 20 acres for fuel and container storage
 - Use of cellular pier foundations allows access along shore and minimal impact on coastal processes and fish migration.

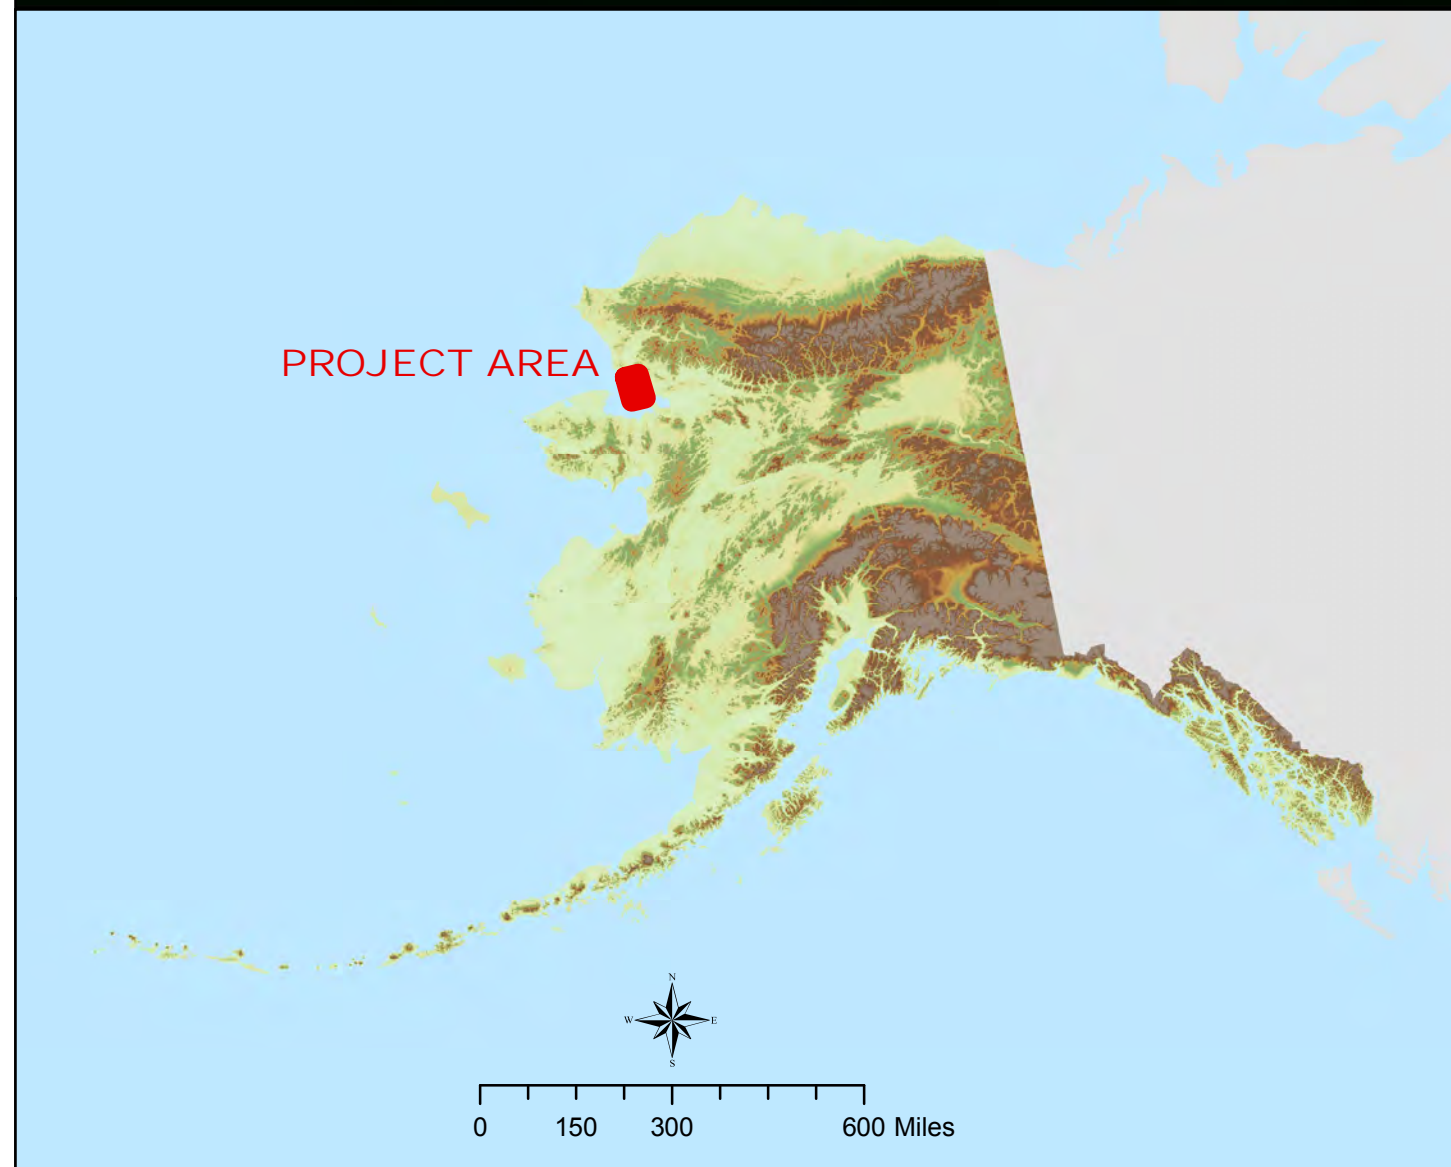
May 10, 2012 Figure 2 of 2

Kotzebue to Cape Blossom Road Environmental Documentation

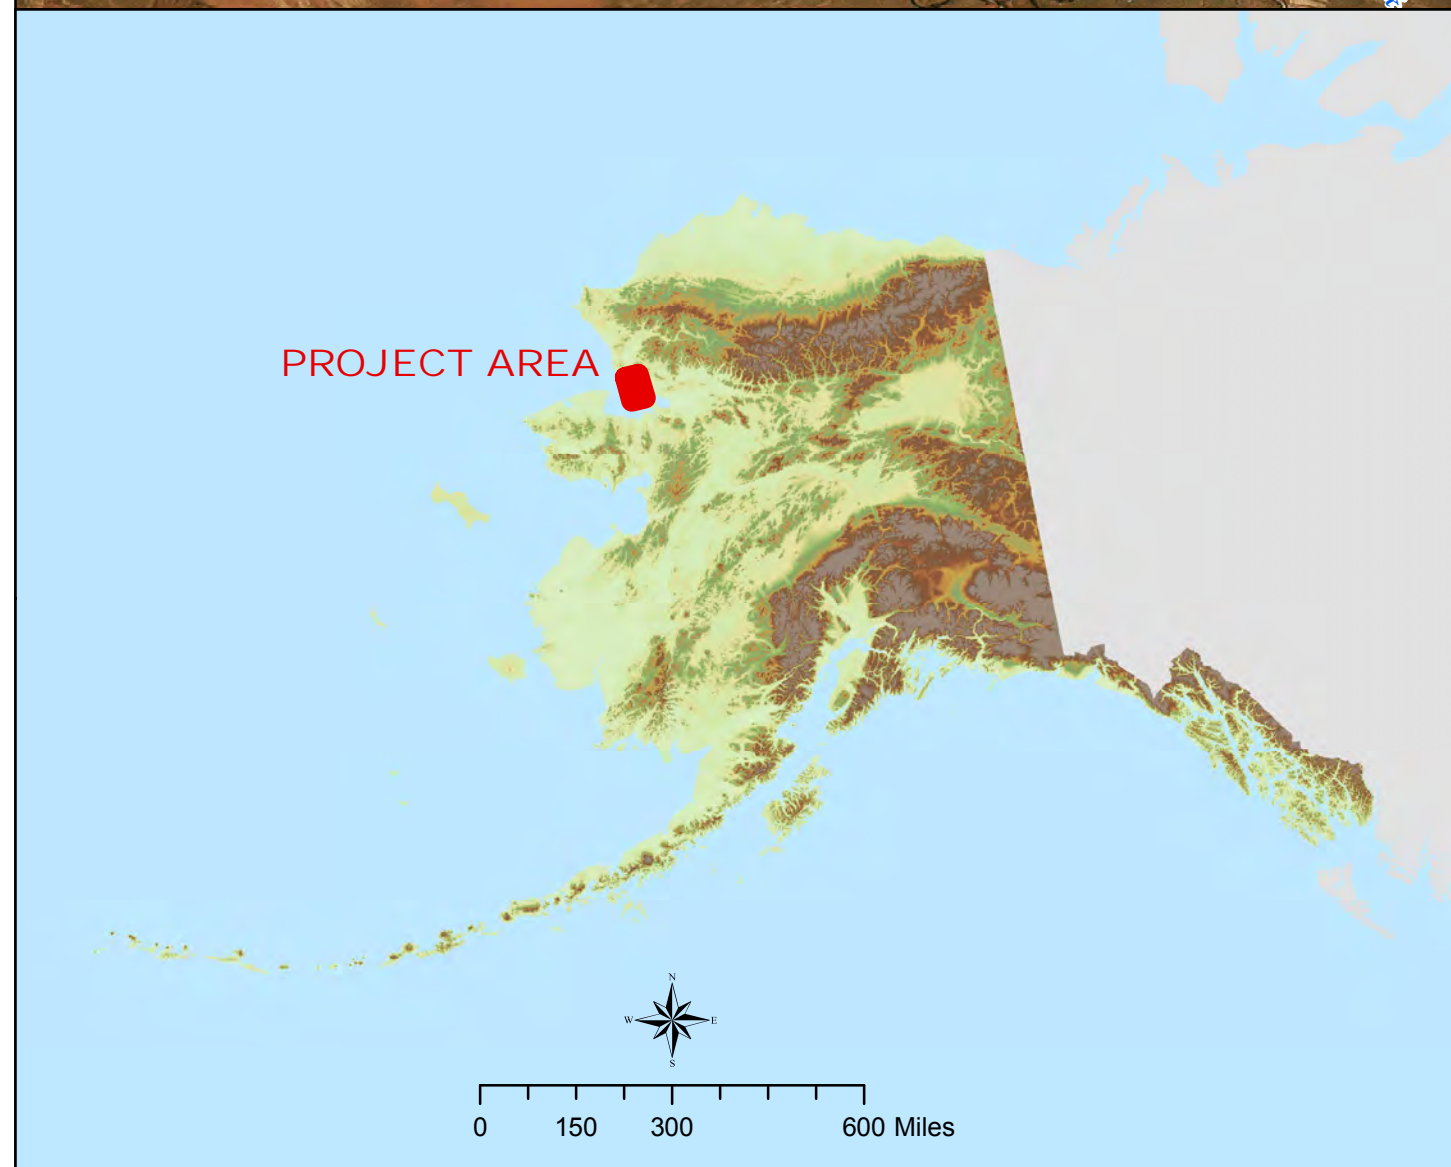
May 10, 2012 Figure 1 of 2

Kotzebue to Cape Blossom Road Environmental Documentation
