GEOTECHNICAL REPORT

AMBLER AIRPORT REHABILITATION MATERIAL SITE REPORT

AKSAS 60851

APRIL 2013

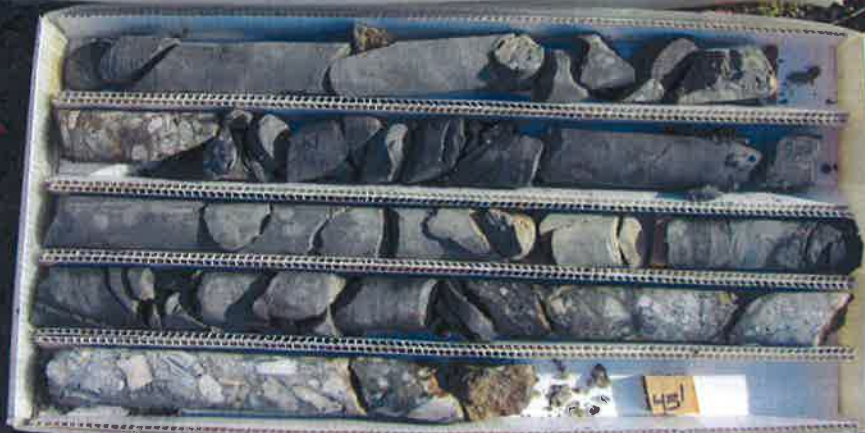
BX HOLE NO. 11-6009 BOX NO. 1

COMPANY AK DOT PROPERTY INGRICHK MT

INTERVAL 37' TO 45'

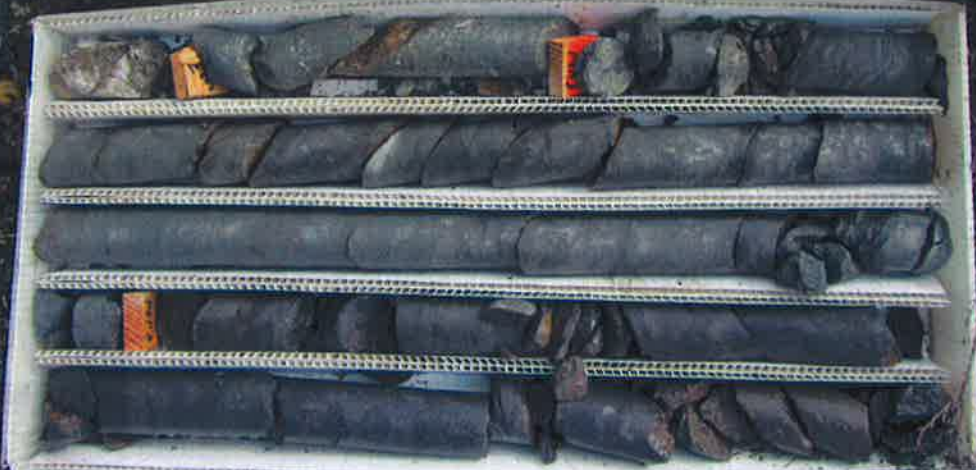
BX HOLE NO. 11-6010 BOX NO. 2

COMPANY AE DOT PROPERTY INBRIQUEX MT

INTERVAL 27.5 TO 39

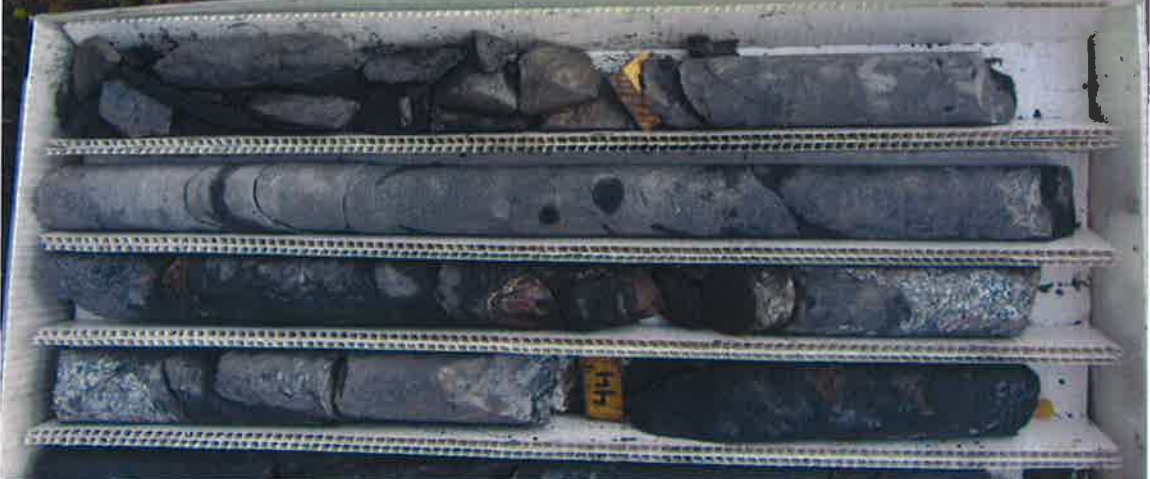
COMPANY AK DOT PROPERTY INDIAN ROCK
BX HOLE NO. 11-6010 BOX NO. 3
INTERVAL 38 TO 47.5

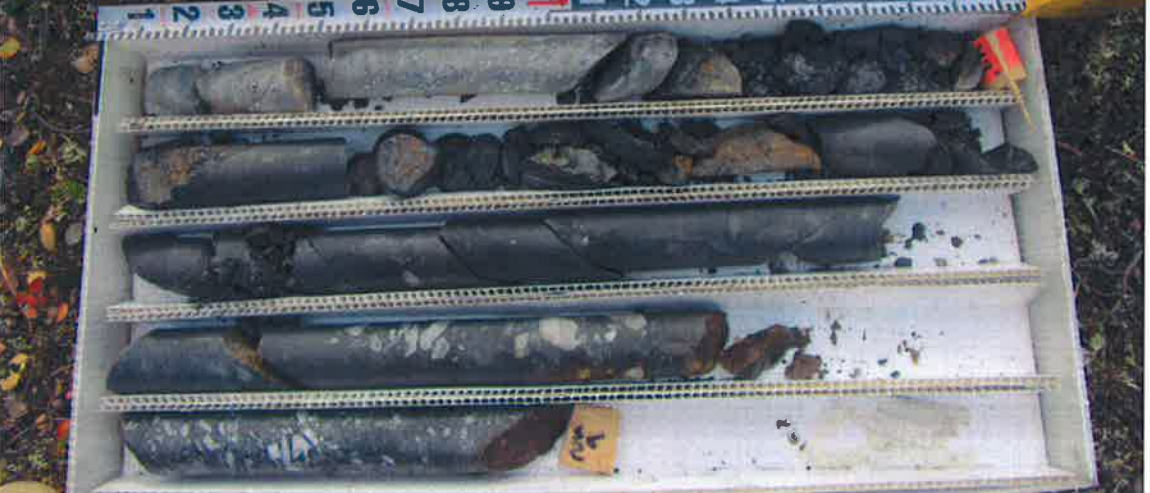
COMPANY AK DOT PROPERTY INDIAN ROCK MI
BX HOLE NO. 11-6010 BOX NO. 4
INTERVAL 47.5 TO 54

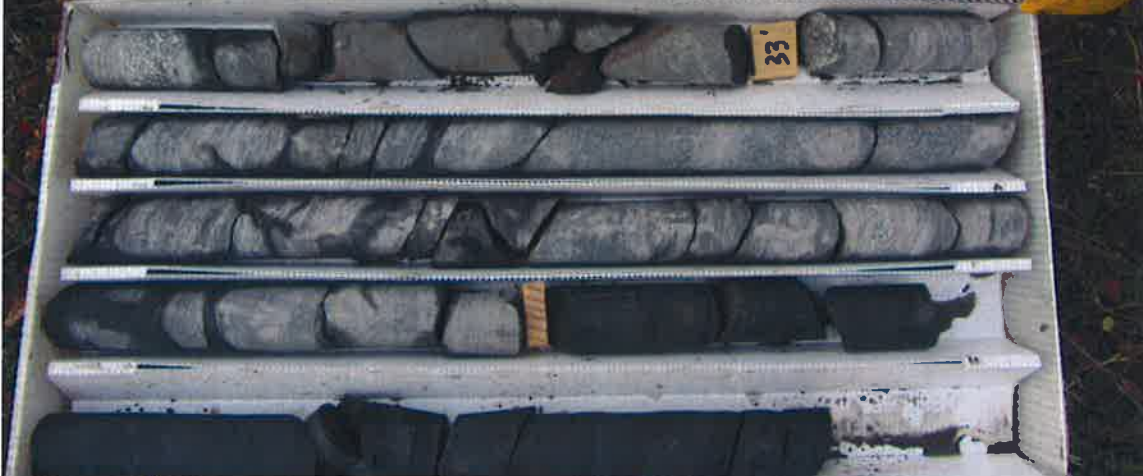
COMPANY AKDOT PROPERTY INRIHERK MT
BX HOLE NO. 11-6011 BOX NO. 3
INTERVAL 31.5 TO 40.5

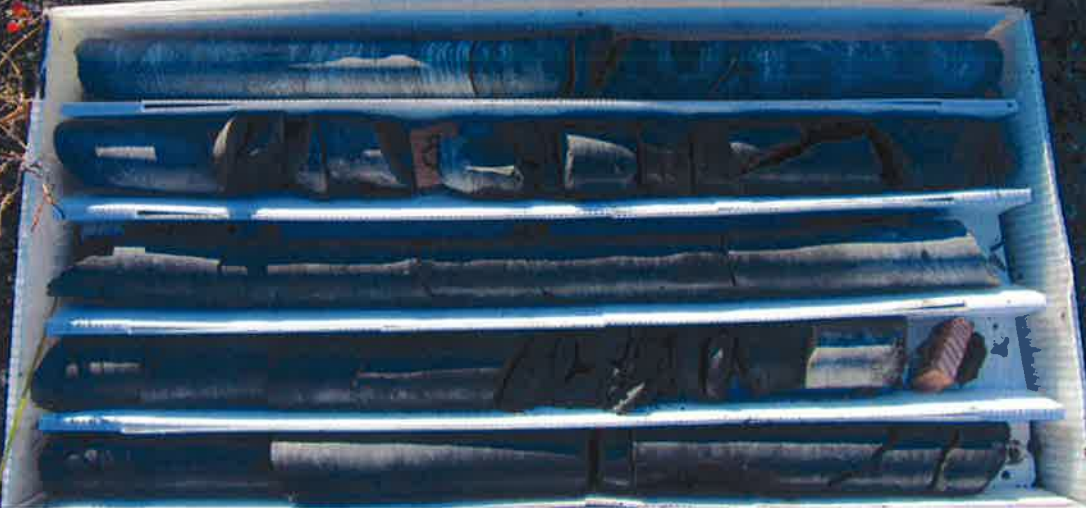
COMPANY AKDOT PROPERTY INRIHERK MT
BX HOLE NO. 11-6011 BOX NO. 4
INTERVAL 40.5 TO 49.3
