# Port Lions Airport Master Plan

Project No. 54746

Alaska Department of Transportation  
and Public Facilities

HDR Alaska, Inc.  
2525 C Street, Suite 305  
Anchorage, AK 99503-2569

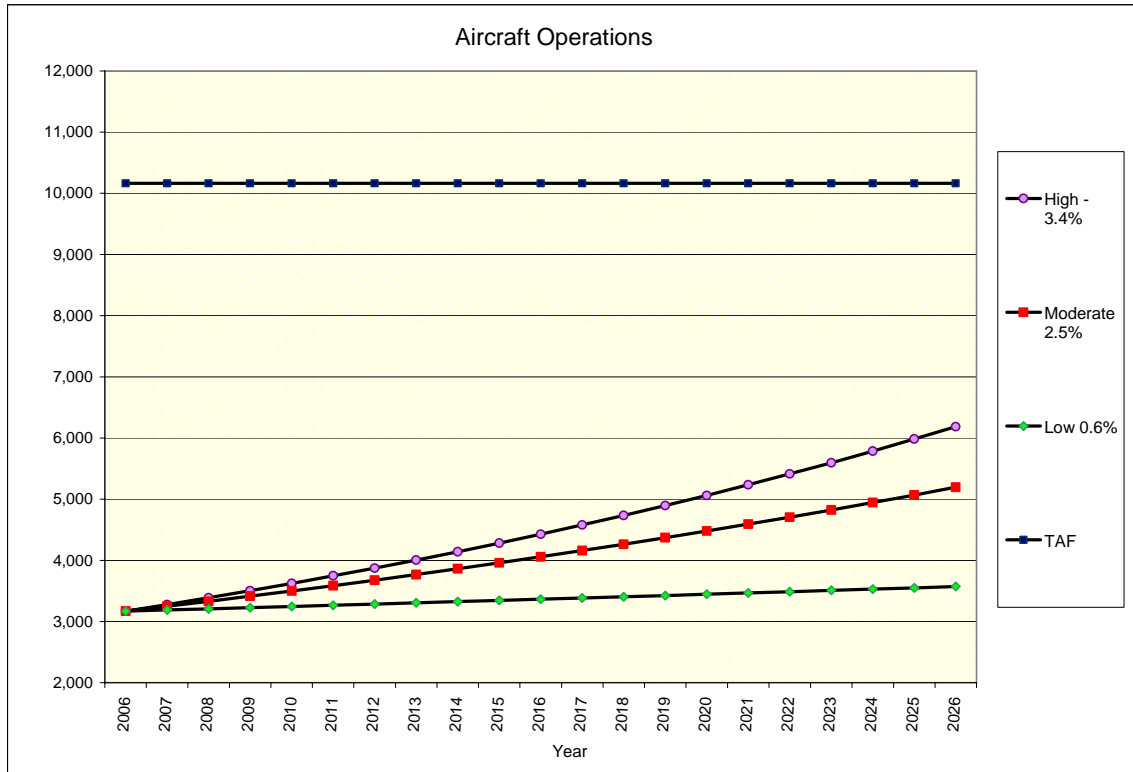
Figure 2-1  
Aircraft Operations Forecast  
Port Lions Airport

Year	Low	Moderate	High	TAF
2006	3,170	3,170	3,170	10,162
2007	3,278	3,249	3,189	10,162
2008	3,389	3,330	3,208	10,162
2009	3,504	3,414	3,227	10,162
2010	3,624	3,499	3,247	10,162
2011	3,747	3,587	3,266	10,162
2012	3,874	3,676	3,286	10,162
2013	4,006	3,768	3,306	10,162
2014	4,142	3,862	3,325	10,162
2015	4,283	3,959	3,345	10,162
2016	4,429	4,058	3,365	10,162
2017	4,579	4,159	3,386	10,162
2018	4,735	4,263	3,406	10,162
2019	4,896	4,370	3,426	10,162
2020	5,062	4,479	3,447	10,162
2021	5,234	4,591	3,468	10,162
2022	5,412	4,706	3,488	10,162
2023	5,596	4,824	3,509	10,162
2024	5,787	4,944	3,530	10,162
2025	5,983	5,068	3,552	10,162
2026	6,187	5,194	3,573	10,162

This section presents three scenarios of air traffic forecasts for aircraft operations, passenger enplanements, and cargo for the Port Lions airport (Figures 2-1 through 2-3). The three forecast scenarios use the base year (2006) estimate for aircraft operations and enplanements, and the 2005 cargo summary from Bureau of Transportation Statistics (BTS).

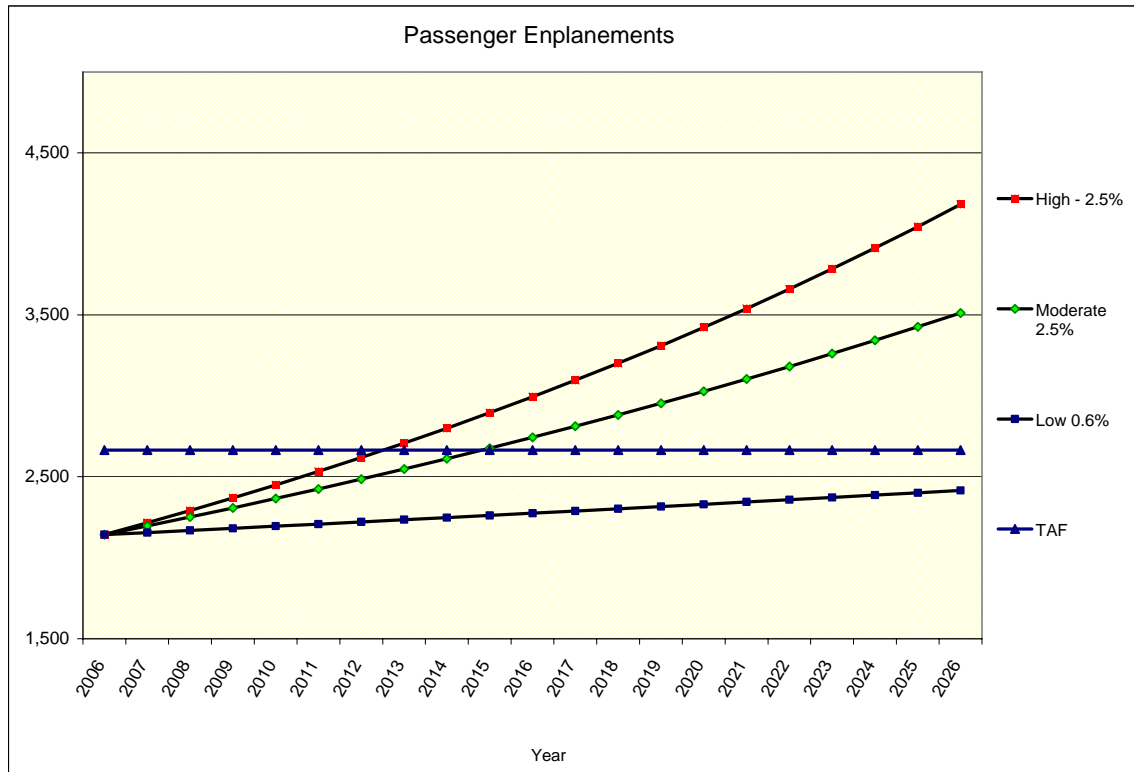
Figure 2-2  
 Passenger Enplanements Forecast  
 Port Lions Airport

Year	Low	Moderate	High	TAF
2006	2,143	2,143	2,143	2,665
2007	2,216	2,197	2,156	2,665
2008	2,291	2,251	2,169	2,665
2009	2,369	2,308	2,182	2,665
2010	2,450	2,365	2,195	2,665
2011	2,533	2,425	2,208	2,665
2012	2,619	2,485	2,221	2,665
2013	2,708	2,547	2,235	2,665
2014	2,800	2,611	2,248	2,665
2015	2,895	2,676	2,262	2,665
2016	2,994	2,743	2,275	2,665
2017	3,096	2,812	2,289	2,665
2018	3,201	2,882	2,302	2,665
2019	3,310	2,954	2,316	2,665
2020	3,422	3,028	2,330	2,665
2021	3,539	3,104	2,344	2,665
2022	3,659	3,181	2,358	2,665
2023	3,783	3,261	2,372	2,665
2024	3,912	3,342	2,387	2,665
2025	4,045	3,426	2,401	2,665
2026	4,182	3,512	2,415	2,665

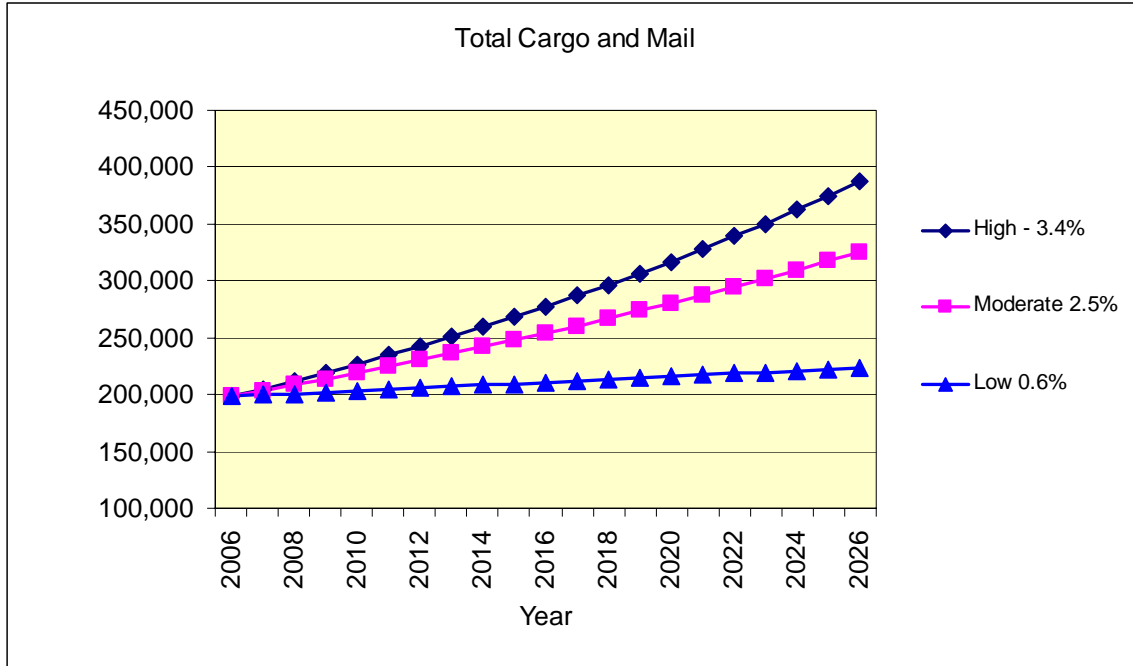
Figure 2-3  
Cargo Operations Forecast  
Port Lions Airport

Year	Low	Moderate	High
2006	<b>198,519</b>	<b>198,519</b>	<b>198,519</b>
2007	199,710	203,482	205,269
2008	200,908	208,569	212,248
2009	202,114	213,783	219,464
2010	203,327	219,128	226,926
2011	<b>204,546</b>	<b>224,606</b>	<b>234,641</b>
2012	205,774	230,221	242,619
2013	207,008	235,977	250,868
2014	208,250	241,876	259,398
2015	209,500	247,923	268,217
2016	<b>210,757</b>	<b>254,121</b>	<b>277,337</b>
2017	212,021	260,474	286,766
2018	213,294	266,986	296,516
2019	214,573	273,661	306,598
2020	215,861	280,502	317,022
2021	<b>217,156</b>	<b>287,515</b>	<b>327,801</b>
2022	218,459	294,703	338,946
2023	219,770	302,070	350,470
2024	221,088	309,622	362,386
2025	222,415	317,362	374,707
2026	<b>223,749</b>	<b>325,296</b>	<b>387,447</b>

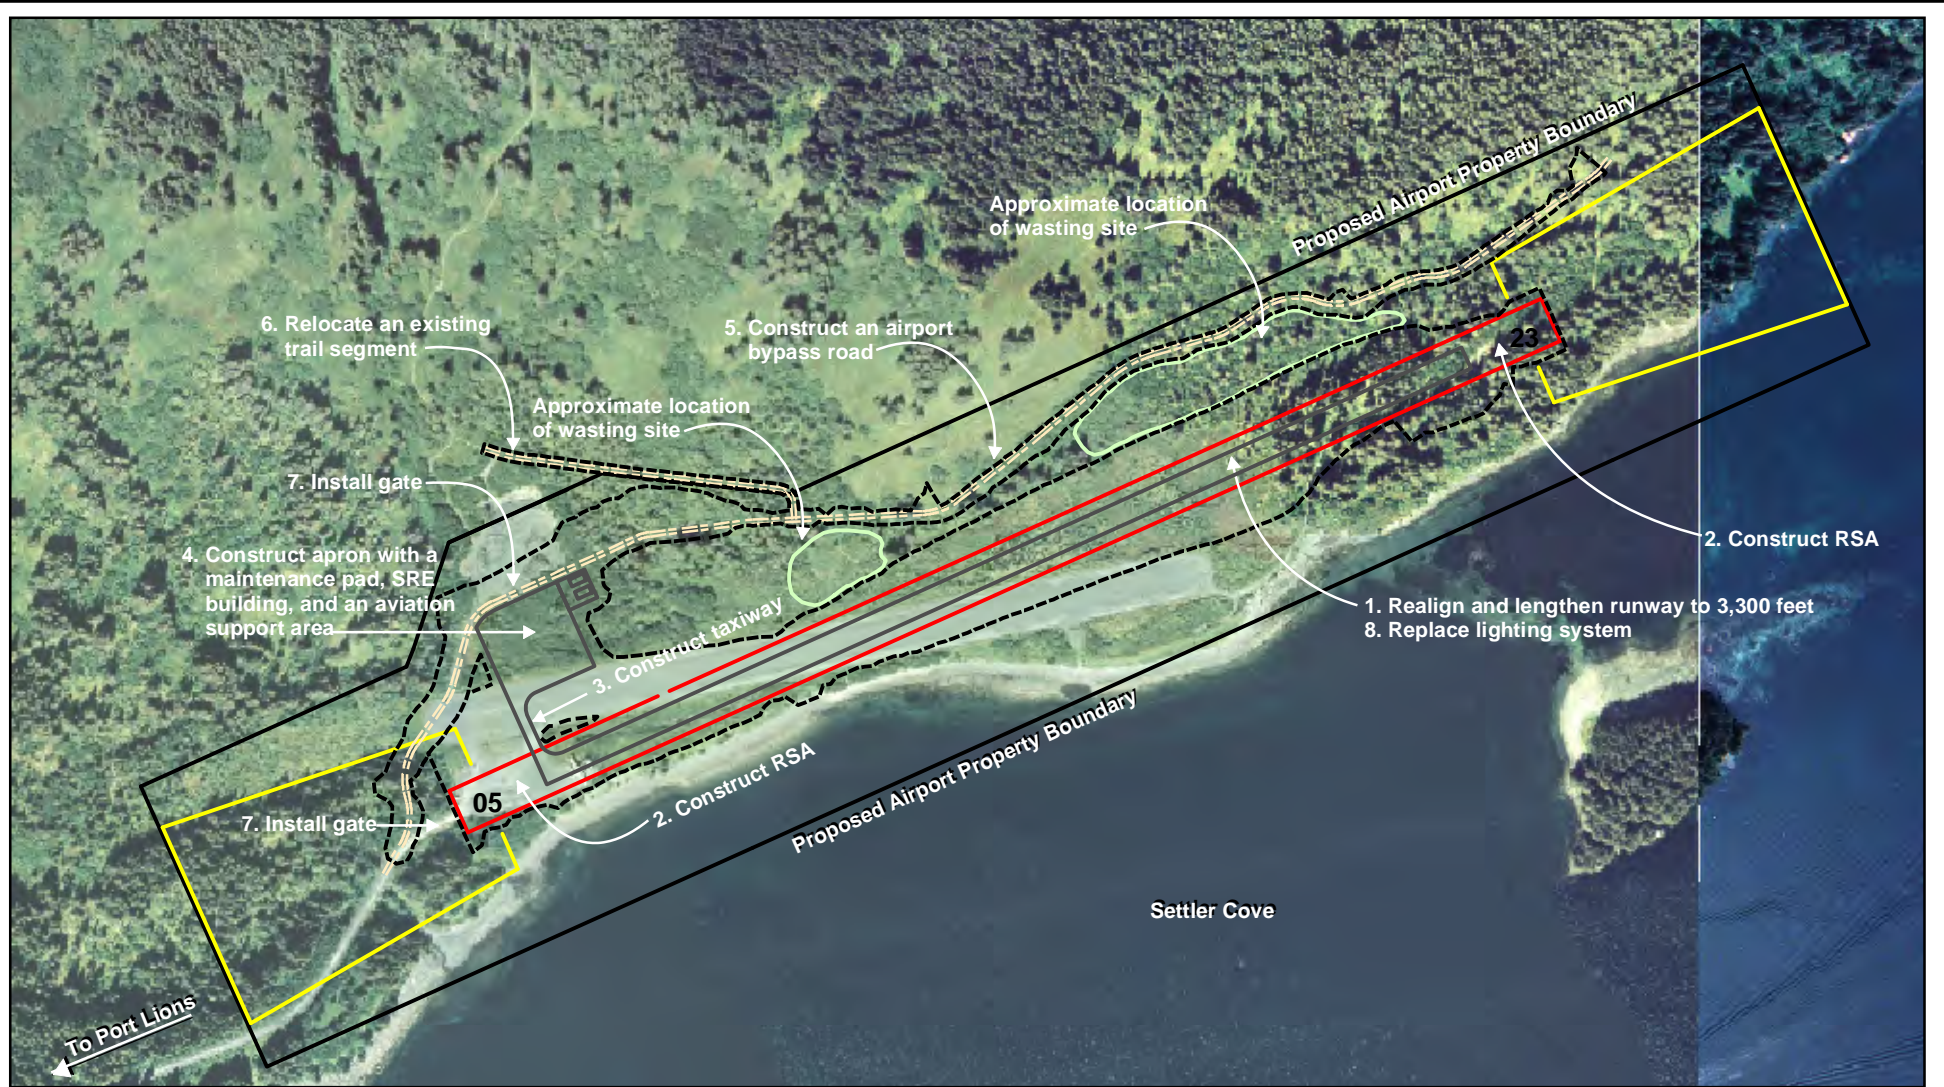
**Figure  
4.2**

**Port Lions Airport Master Plan  
Environmental Assessment  
Alternative 2  
Runway Realignment**

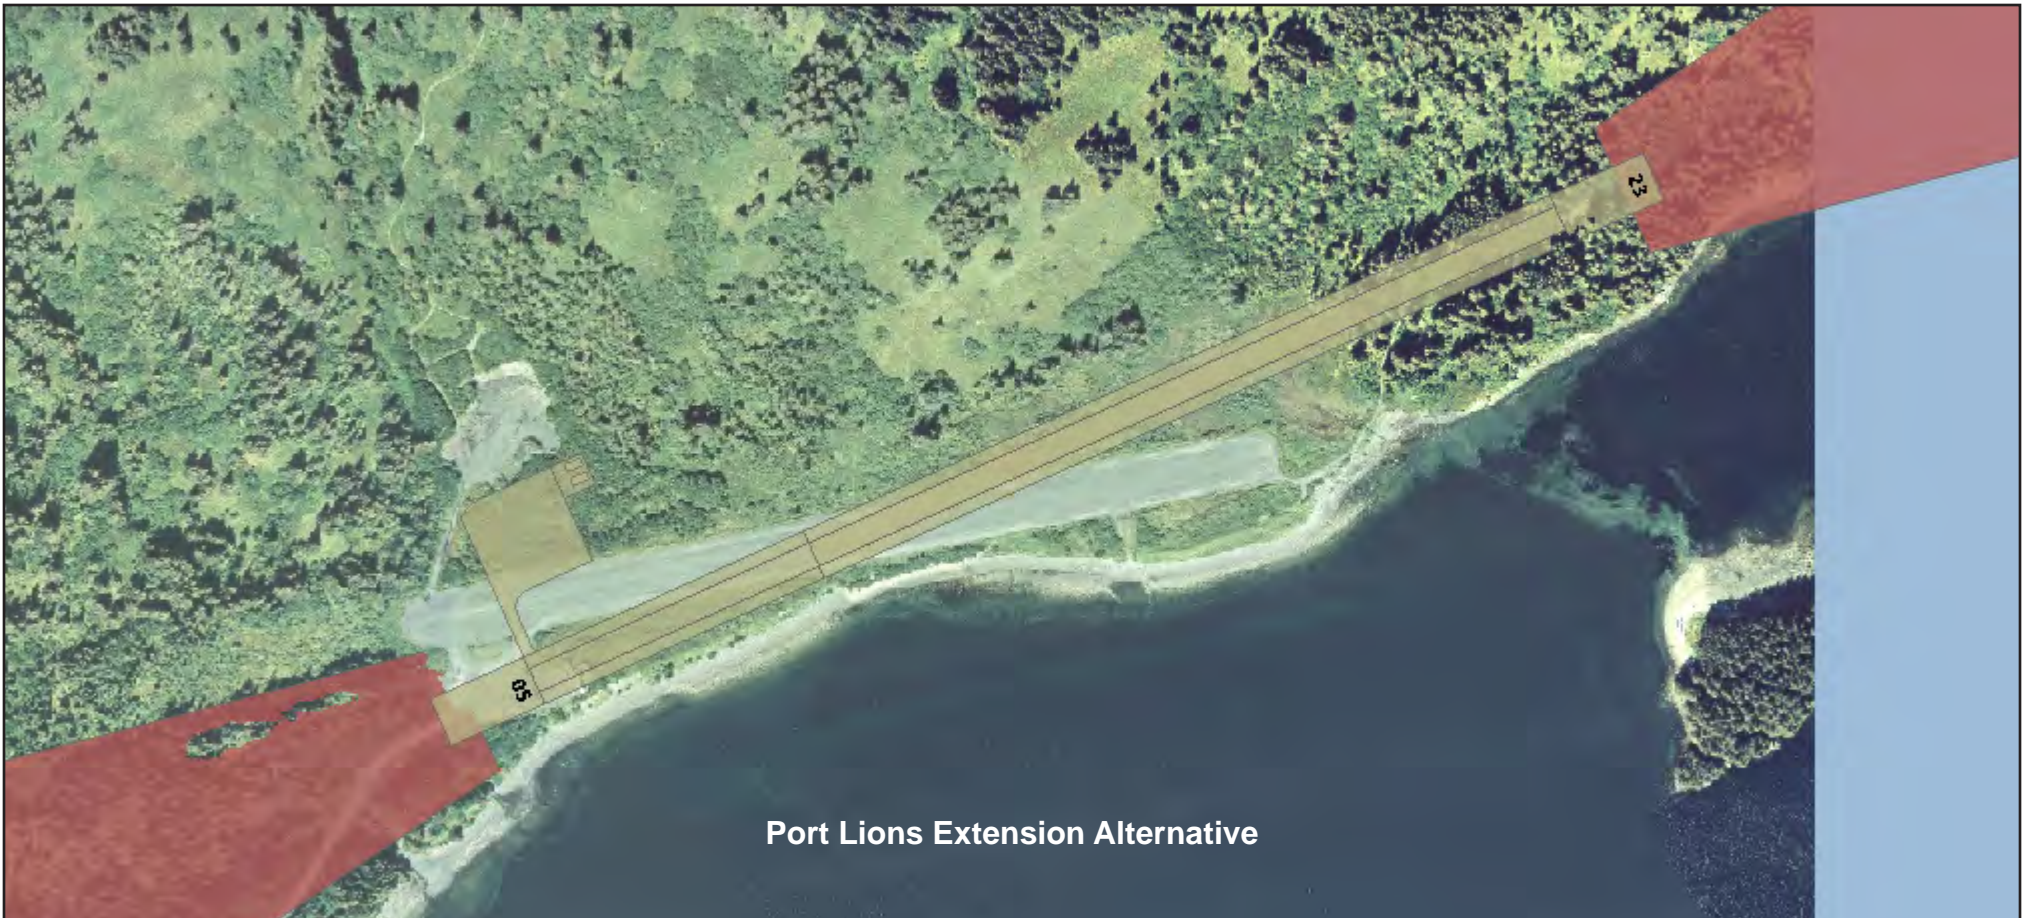
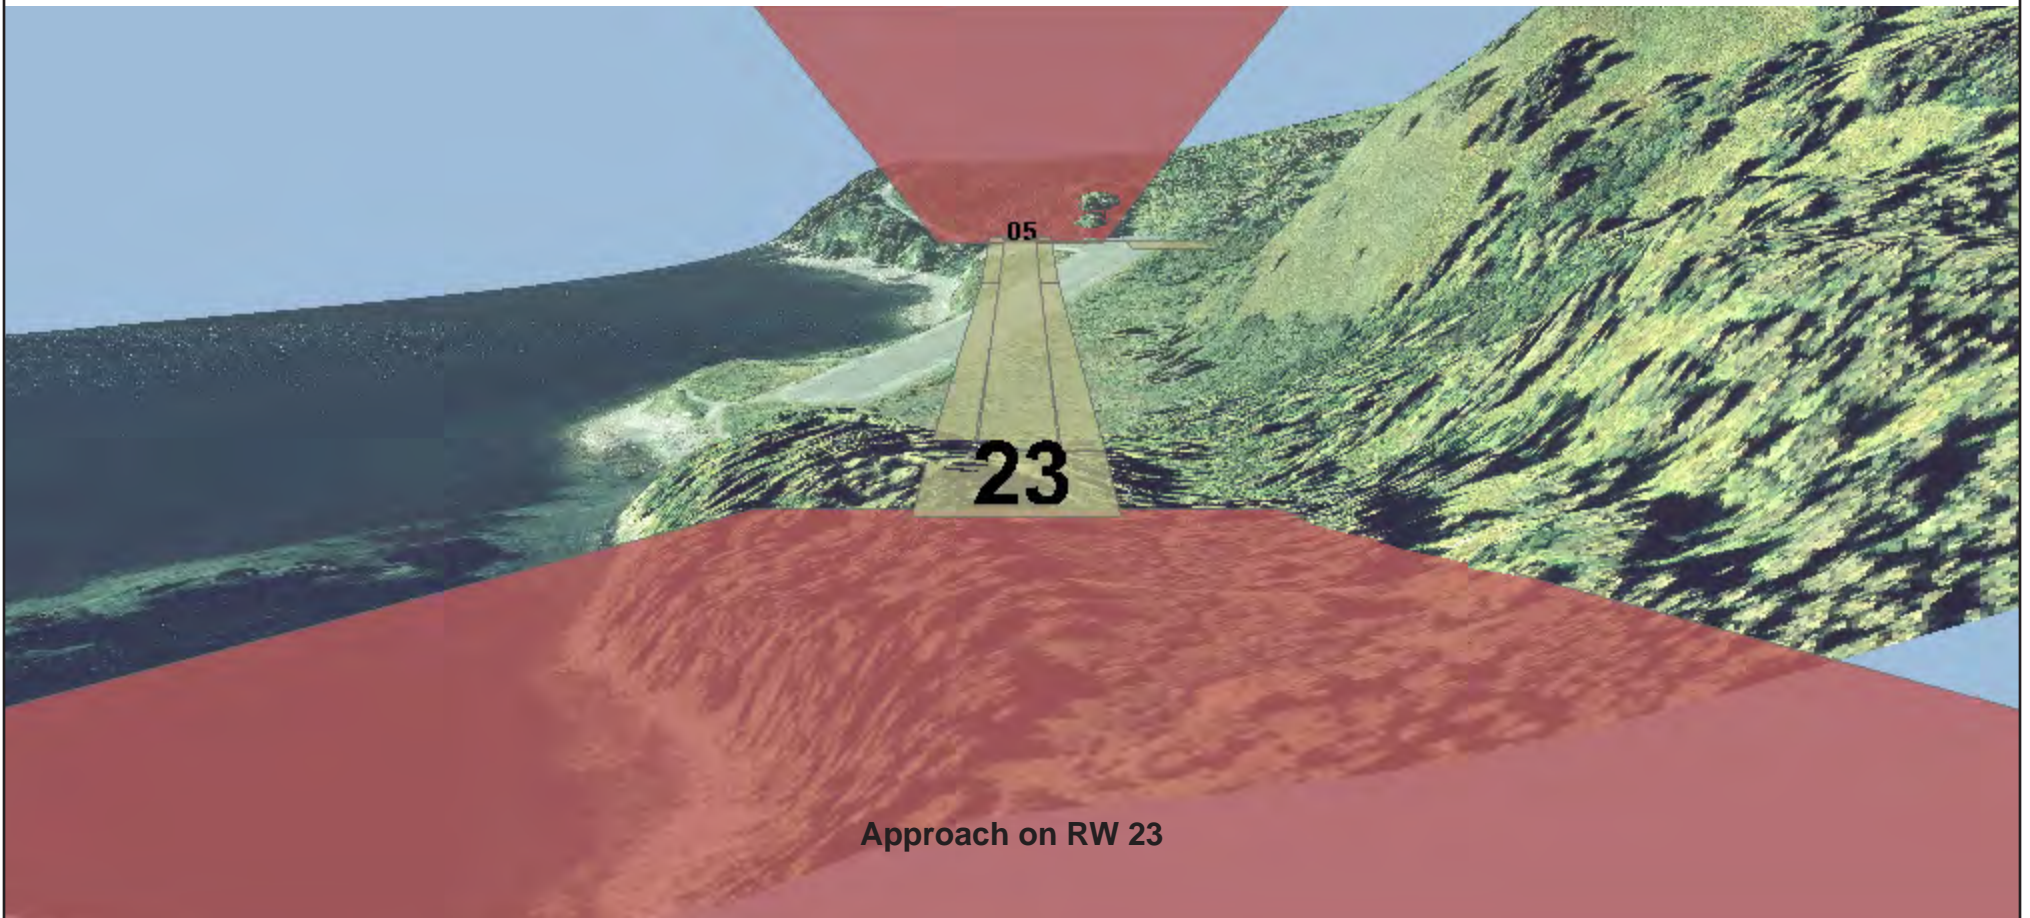
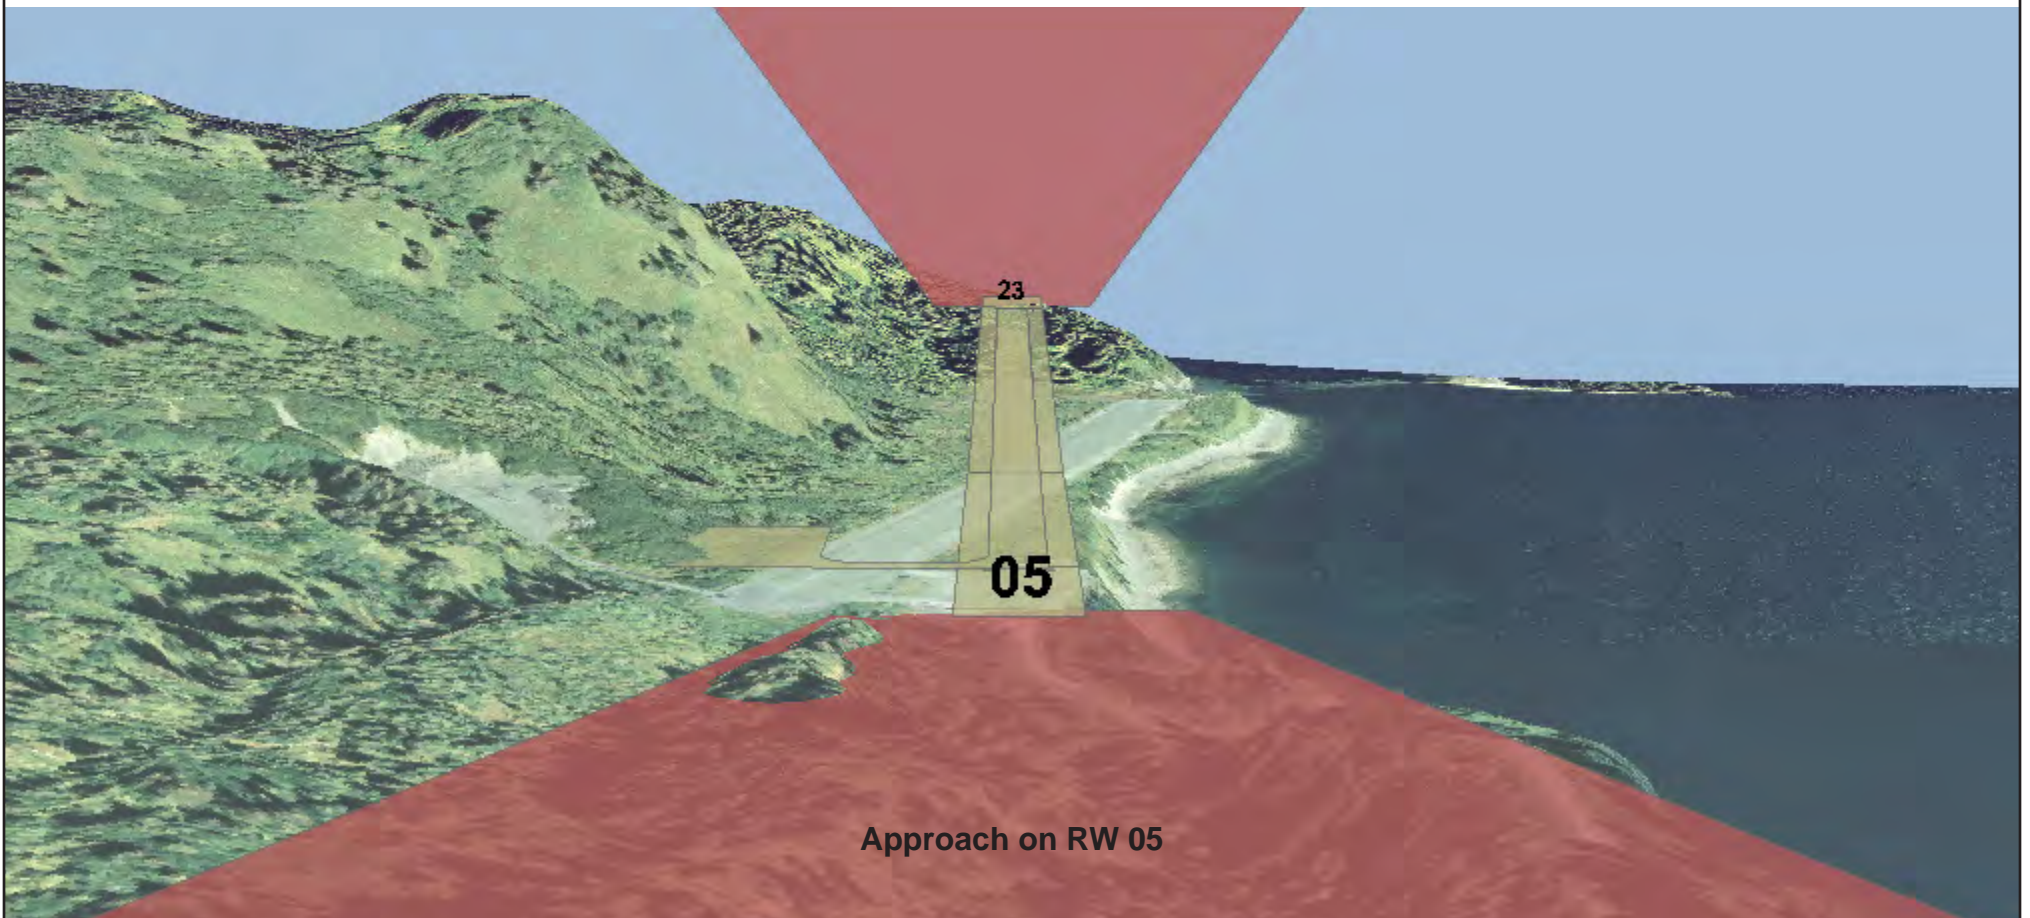
**FIGURE 4-3**

PROPOSED RUNWAY  
75' X 3,300'

**PORT LIONS AIRPORT**  
PORT LIONS, ALASKA  
THRESHOLD SITING SURFACE  
APPENDIX 2, TABLE A2-1 LINE 5

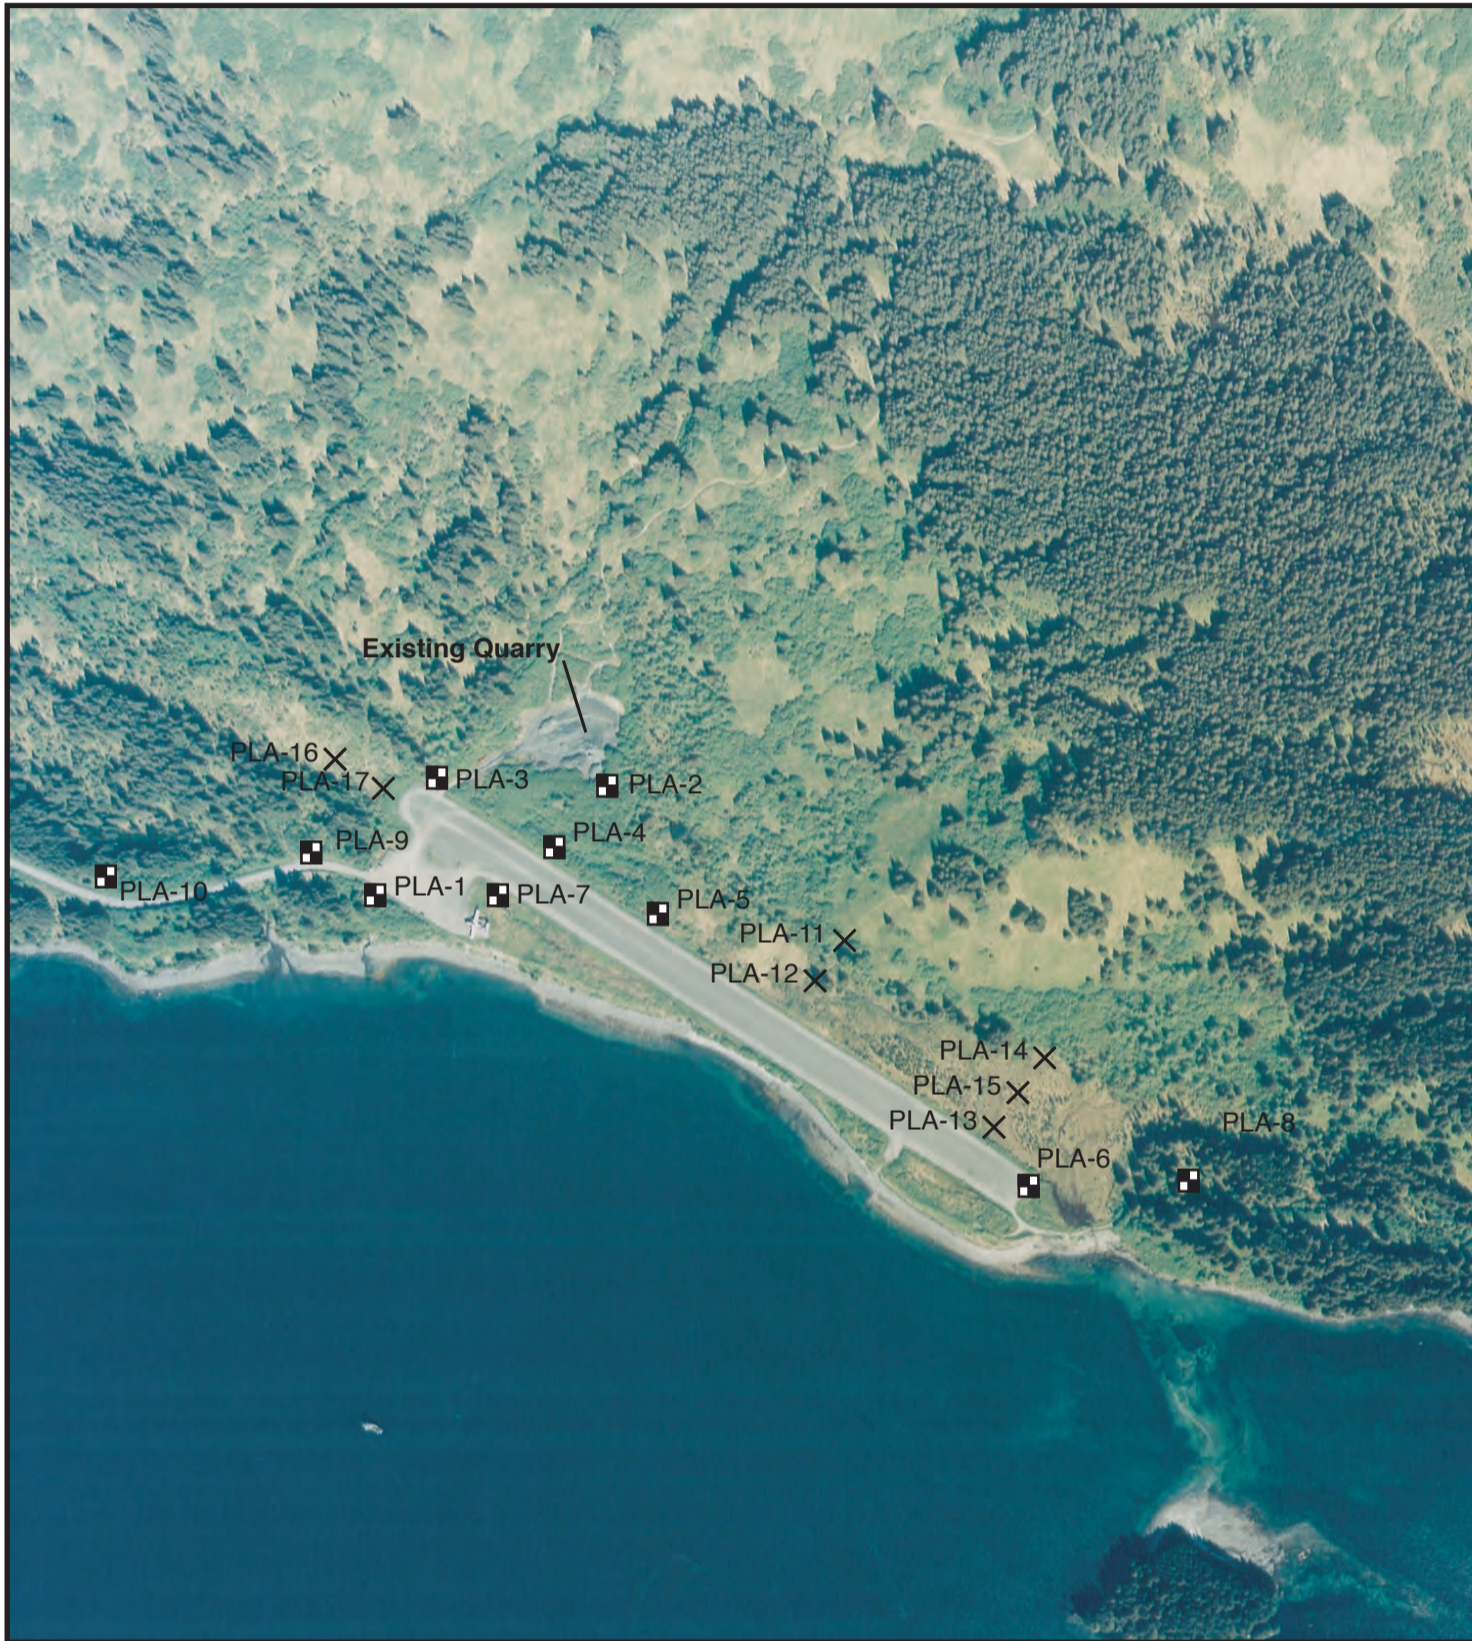
Note: Air photo © 2001, AeroMap, Inc.  
All locations are approximate.

Ten test pits (PLA-1 through PLA-10) were dug with a Case 580D backhoe equipped with an 18-inch toothed bucket. The pits ranged in depth from 4.5 to 8.5 feet. Mr. Walt Phillips, P.G., DM&A Project Geologist, observed the soil and groundwater conditions encountered in each test pit and collected representative soil samples. Pit locations were determined by measuring from identifiable landmarks and then quantified by use of a handheld GPS system. In addition, surface observations were made to the north and west of the runway in areas inaccessible to the backhoe. At seven sites (PLA-11 through PLA-17), the depth of overburden was determined using a 6-foot long steel probe. Test hole and probe locations are shown schematically on Plate 1.

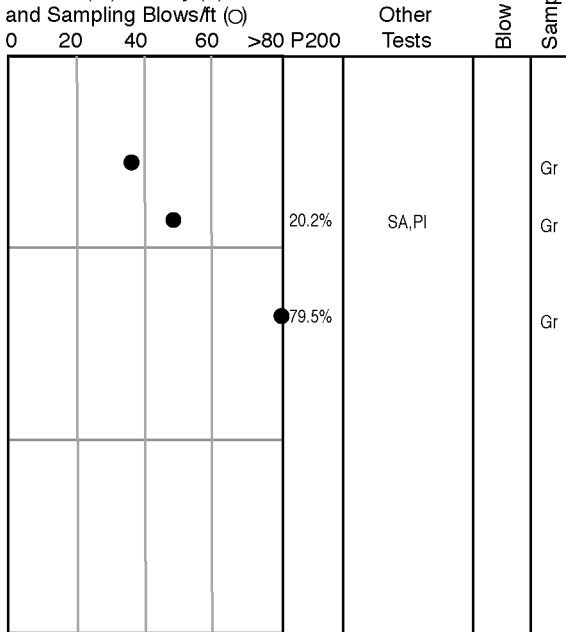
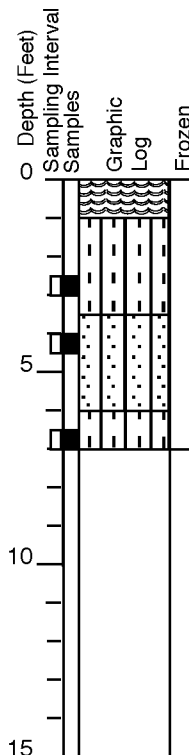
**Log of HOLE: PLA-1**

Date Drilled: August 3, 2004  
 Contractor: City  
 Equipment: CASE 580D w/ 18" toothed bucket  
 GPS Coord.: N 57° 53' 02.5" W 152° 51' 04.2"  
 Elevation: -

Depth (Feet)	Description
0 - 1	<b>ORGANIC MAT (Pt)</b> Root mat w/ organic silt
1 - 3	<b>ORGANIC SILT (OL)</b> Dark brown w/ roots and traces of organic material
3 - 5	<b>SILTY SAND (SM)</b> Light gray ash (?)
5 - 7	<b>ORGANIC SILT (OL)</b> Brown w/ trace to some organic material Bottom of pit at 7.0 ft.

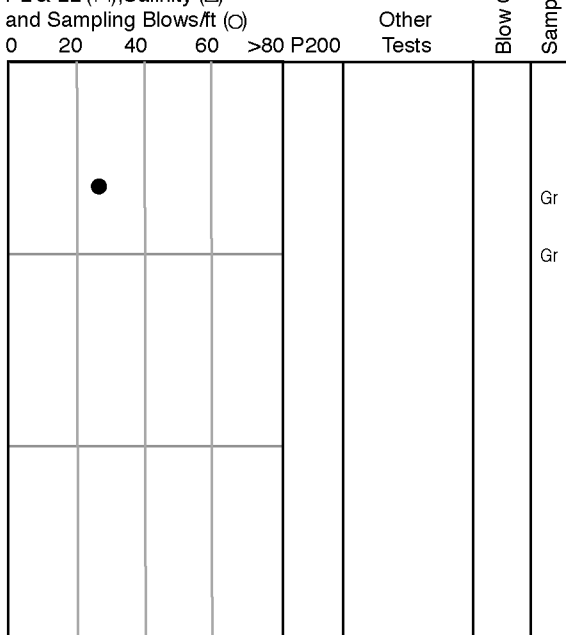
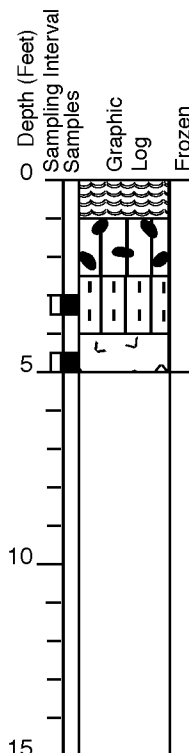
**Log of HOLE: PLA-2**

Date Drilled: August 4, 2004  
 Contractor: City  
 Equipment: CASE 580D w/ 18" toothed bucket  
 GPS Coord.: 25' E of N 57° 53' 11.1" W 152° 50' 59.5"  
 Elevation: -

Depth (Feet)	Description
0 - 1	<b>ORGANIC MAT (Pt)</b> Brown w/ organic silt
1 - 3	<b>SILTY GRAVEL (GM)</b> Gray-brown rock fragments to 2"+ mixed with organic silt
3 - 5	<b>ORGANIC SILT (OL)</b> Brown w/ trace to some angular sand and small rock fragments
5 - 5.0	<b>BEDROCK (Bx)</b> Black shale w/ thin quartz interbeds Bottom of pit at 5.0 ft.

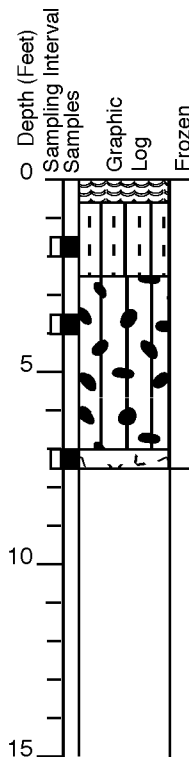
**Log of HOLE: PLA-3**

Date Drilled: August 4, 2004  
 Contractor: City  
 Equipment: CASE 580D w/ 18" toothed bucket  
 GPS Coord.: N 57° 53' 06.6" W 152° 51' 07.2"  
 Elevation: -

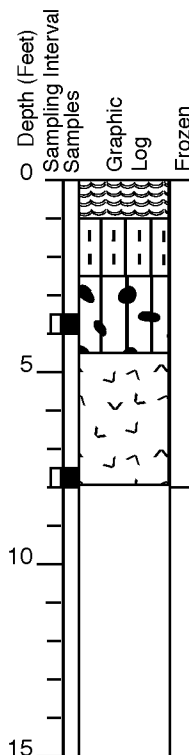
**Log of HOLE: PLA-4**

Date Drilled: August 4, 2004  
 Contractor: City  
 Equipment: CASE 580D w/ 18" toothed bucket  
 GPS Coord.: N 57° 53' 08.5" W 152° 50' 56.6"  
 Elevation: -

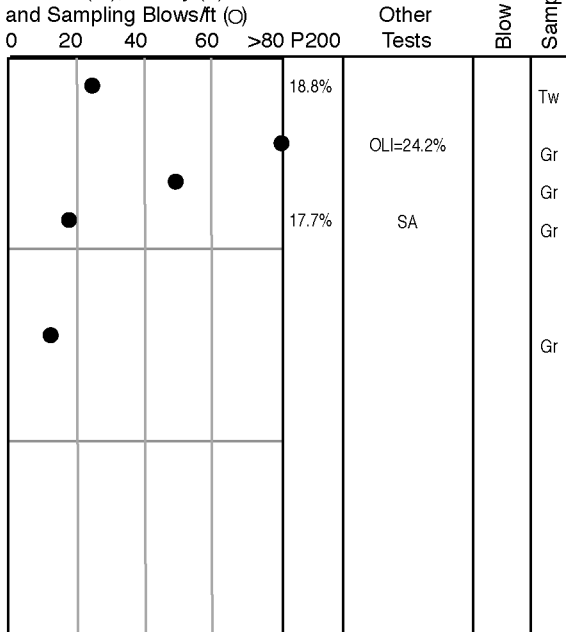
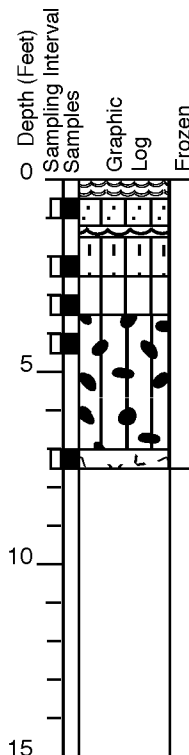
**Log of HOLE: PLA-5**

Date Drilled: August 4, 2004  
 Contractor.: City  
 Equipment: CASE 580D w/ 18" toothed bucket  
 GPS Coord.: N 57° 53' 08.8" W 152° 50' 45.8"  
 Elevation: -

Depth (Feet)	Description
0 - 0.5	ORGANIC MAT (Pt)
0.5 - 1.5	SILTY SAND (SM) Tan sandy ash
1.5 - 2.5	PEAT (Pt) Dark brown w/ some silt
2.5 - 3.5	ORGANIC SILT (OL) Brown
3.5 - 4.5	SILT (ML) Gray
4.5 - 7.5	SILTY GRAVEL (GM) Dark gray oriented rock fragments mixed w/ silt, some silty sand (SM), colluvium
7.5 - 15	WEATHERED BEDROCK (Bx-w) Gray Bottom of pit at 7.5 ft.

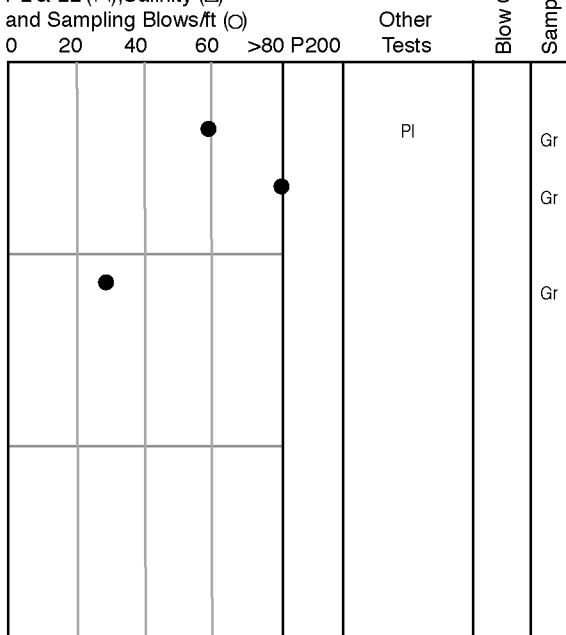
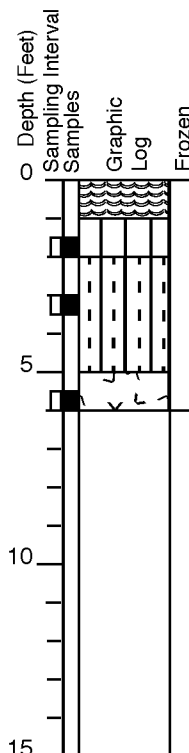
**Log of HOLE: PLA-6**

Date Drilled: August 4, 2004  
 Contractor.: City  
 Equipment: CASE 580D w/ 18" toothed bucket  
 GPS Coord.: N 57° 53' 11.5" W 152° 50' 20.8"  
 Elevation: -

Depth (Feet)	Description
0 - 0.5	ORGANIC MAT (Pt) w/ grass roots and organic silt
0.5 - 1.5	SILT (ML) Tan to gray ash w/ sand
1.5 - 6.0	ORGANIC SILT (OL) w/ roots and thin peat (Pt) layers Water at 1'
6.0 - 15	WEATHERED BEDROCK (Bx-w) Gray oriented rock fragments w/ silt Bottom of pit at 6.0 ft.

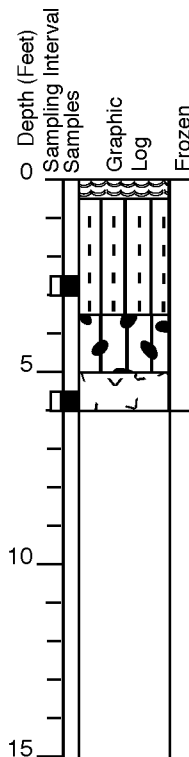
**Log of HOLE: PLA-7**

Date Drilled: August 4, 2004  
 Contractor: City  
 Equipment: CASE 580D w/ 18" toothed bucket  
 GPS Coord.: N 57° 53' 06.0" W 152° 50' 53.9"  
 Elevation: -

Depth (Feet)	Description
0	ORGANIC MAT (Pt)
0 - 4	ORGANIC SILT (OL) w/ thin ash layers and scattered rock fragments
4 - 6	SILTY GRAVEL (GM) Mixed oriented black rock fragments and gray-brown colluvial rock fragments w/ silt
6.0	WEATHERED BEDROCK (Bx-w) Gray Bottom of pit at 6.0 ft.

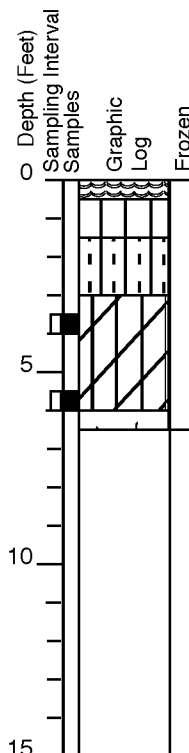
**Log of HOLE: PLA-8**

Date Drilled: August 4, 2004  
 Contractor: City  
 Equipment: CASE 580D w/ 18" toothed bucket  
 GPS Coord.: N 57° 53' 13.1" W 152° 50' 14.9"  
 Elevation: -

Depth (Feet)	Description
0	ORGANIC MAT (Pt)
0 - 1	SILT (ML) Tan ash
1 - 4	ORGANIC SILT (OL) Dark brown
4 - 6.5	CLAYEY GRAVELLY SILT (gML) Light gray, hard, clayey silt w/ rock fragments to 8"+, till (?), ppn is 1 to 1.5 T/ft <sup>2</sup>
6.5	WEATHERED BEDROCK (Bx-w) Gray shale Bottom of pit at 6.5 ft.

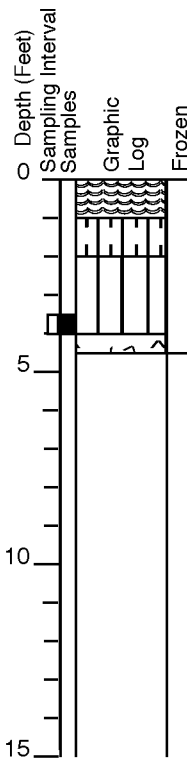
**Log of HOLE: PLA-9**

Date Drilled: August 4, 2004  
 Contractor.: City  
 Equipment: CASE 580D w/ 18" toothed bucket  
 GPS Coord.: N 57° 53' 01.1" W 152° 51' 09.2"  
 Elevation: -

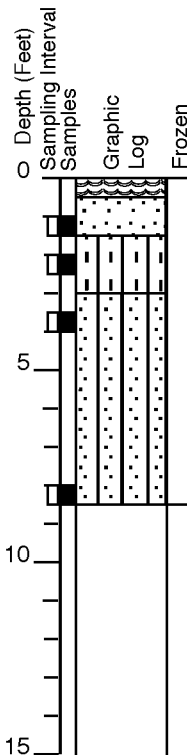
**Log of HOLE: PLA-10**

Date Drilled: August 4, 2004  
 Contractor.: City  
 Equipment: CASE 580D w/ 18" toothed bucket  
 GPS Coord.: N 57° 52' 56.0" W 152° 51' 17.2"  
 Elevation: -

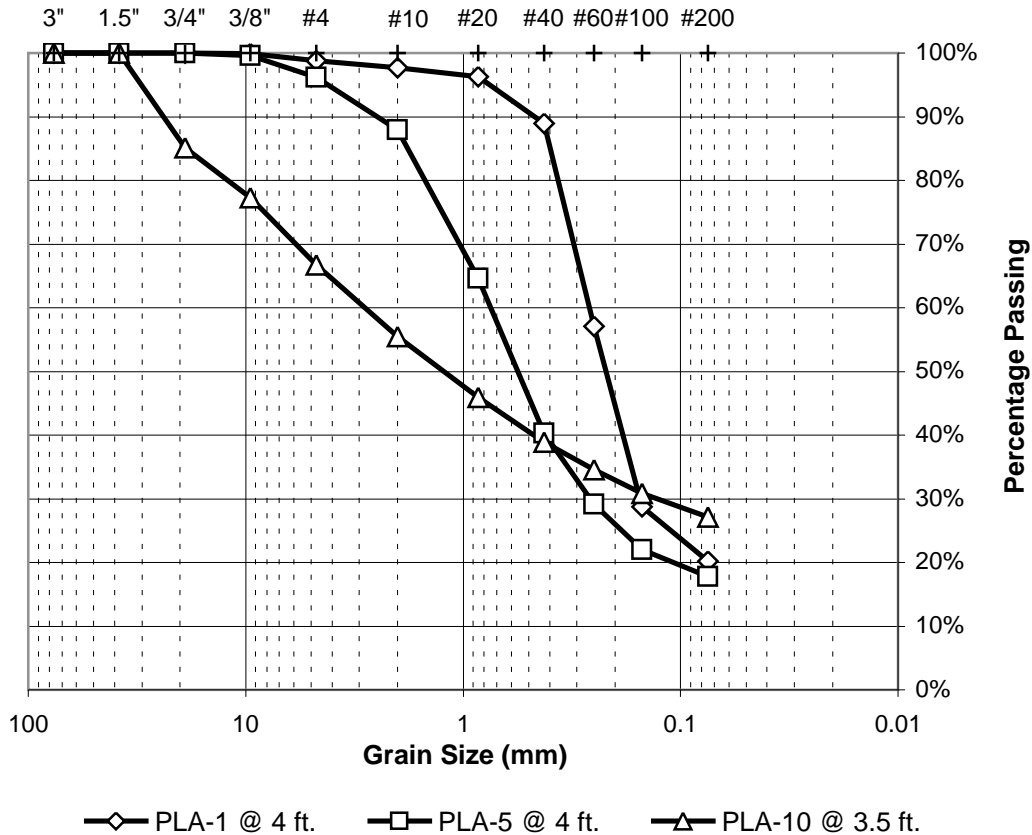
Boring =>	PLA-1	PLA-5	PLA-10
Depth =>	4.0 ft.	4.0 ft.	3.5 ft.
3" =>	100.0%	100.0%	100.0%
1 1/2" =>	100.0%	100.0%	100.0%
3/4" =>	100.0%	100.0%	85.1%
3/8" =>	99.9%	99.6%	77.2%
#4 =>	98.8%	96.1%	66.8%
#10 =>	97.7%	87.9%	55.5%
#20 =>	96.3%	64.6%	45.9%
#40 =>	88.9%	40.3%	38.9%
#60 =>	57.0%	29.1%	34.6%
#100 =>	28.8%	22.0%	30.9%
#200 =>	20.2%	17.7%	27.1%
<b>Analysis of Data</b>			
D10 size =>			
D30 size =>	0.153 mm	0.261 mm	0.127 mm
D50 size =>	0.220 mm	0.561 mm	1.224 mm
D60 size =>	0.263 mm	0.745 mm	2.822 mm
Coeff. of Uniformity, Cu =			
Coeff. of Curvature, Cc =			
Gravel (+#4) percentage =	1%	4%	33%
Sand percentage =	78.6%	78.4%	39.7%
Fines percentage =	20.2%	17.7%	27.1%
Unified Soil Class Symbol =	<b>SM</b>	<b>SM</b>	<b>SM</b>
