# Port Lions Airport Master Plan

Project No. 54746

Alaska Department of Transportation  
and Public Facilities

HDR Alaska, Inc.  
2525 C Street, Suite 305  
Anchorage, AK 99503-2569

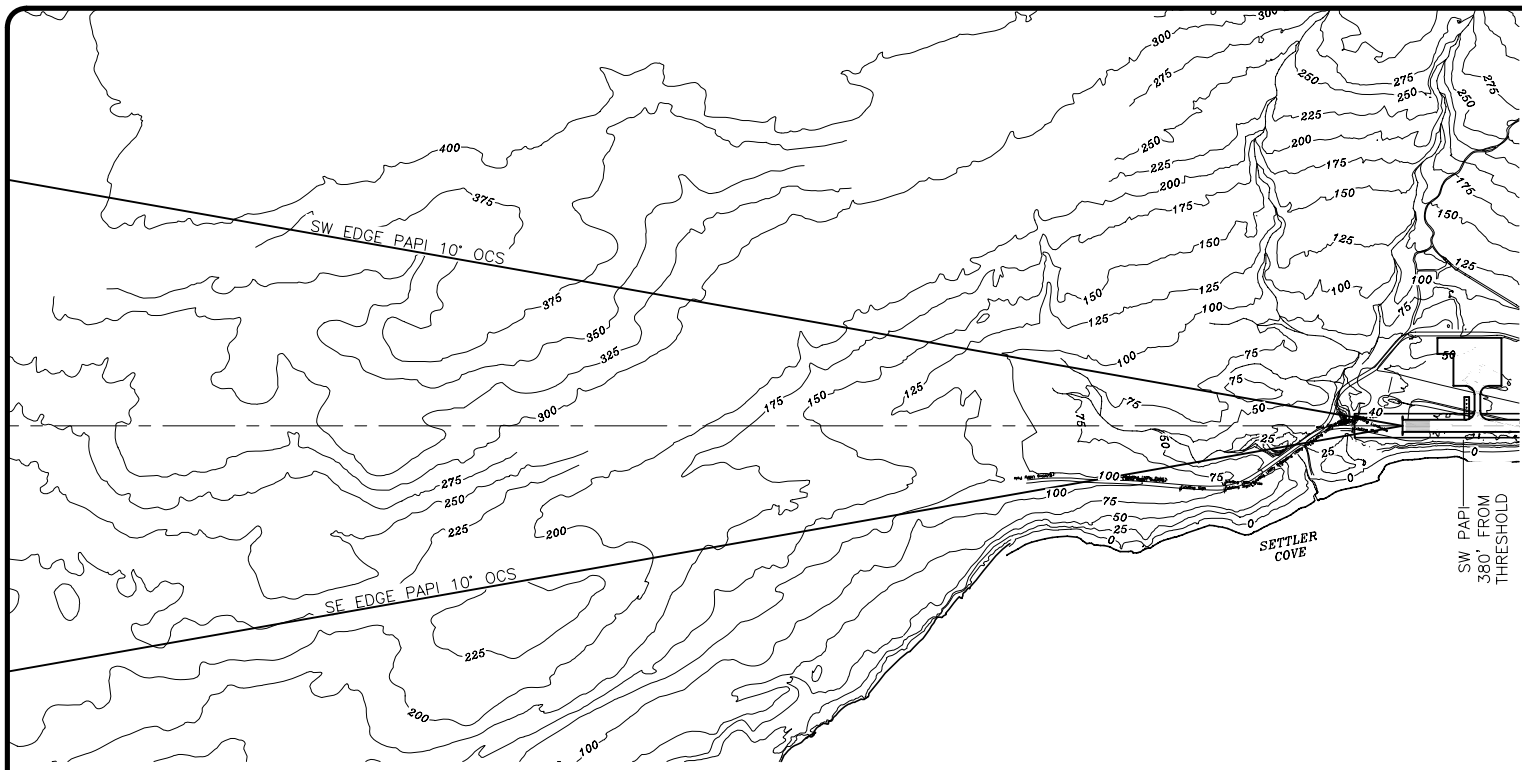
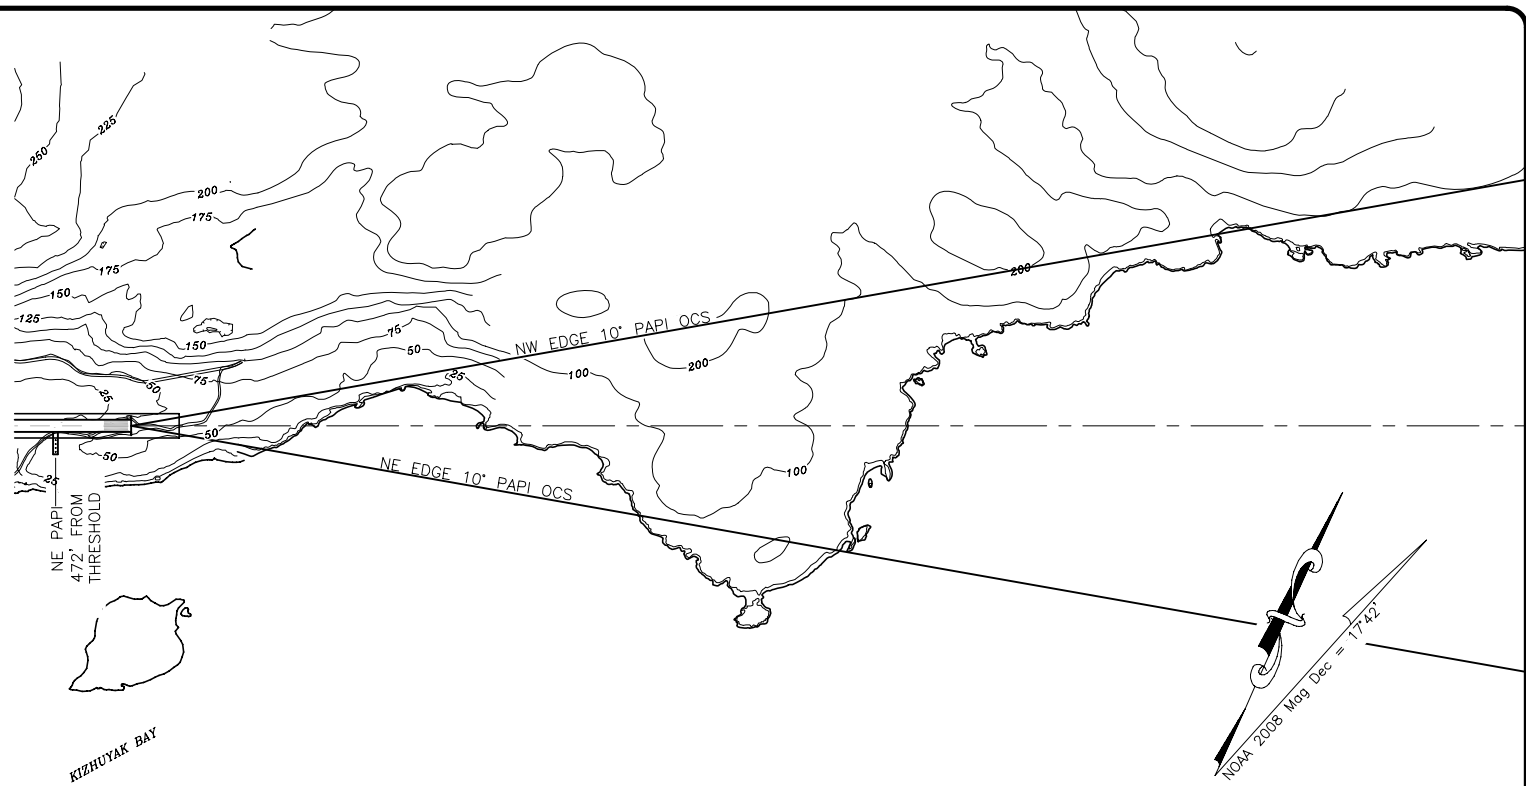
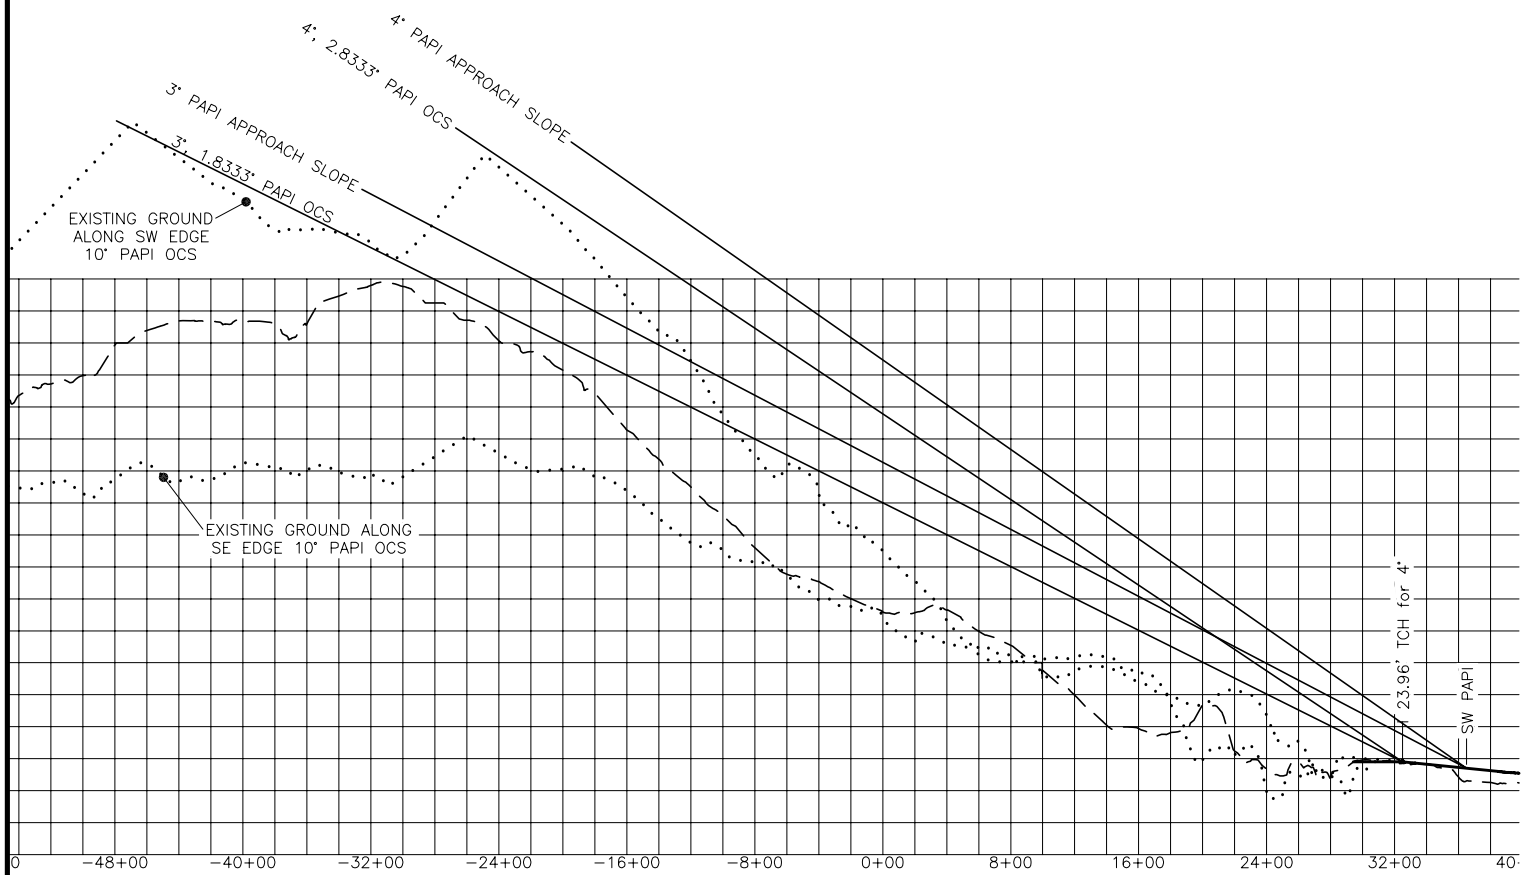
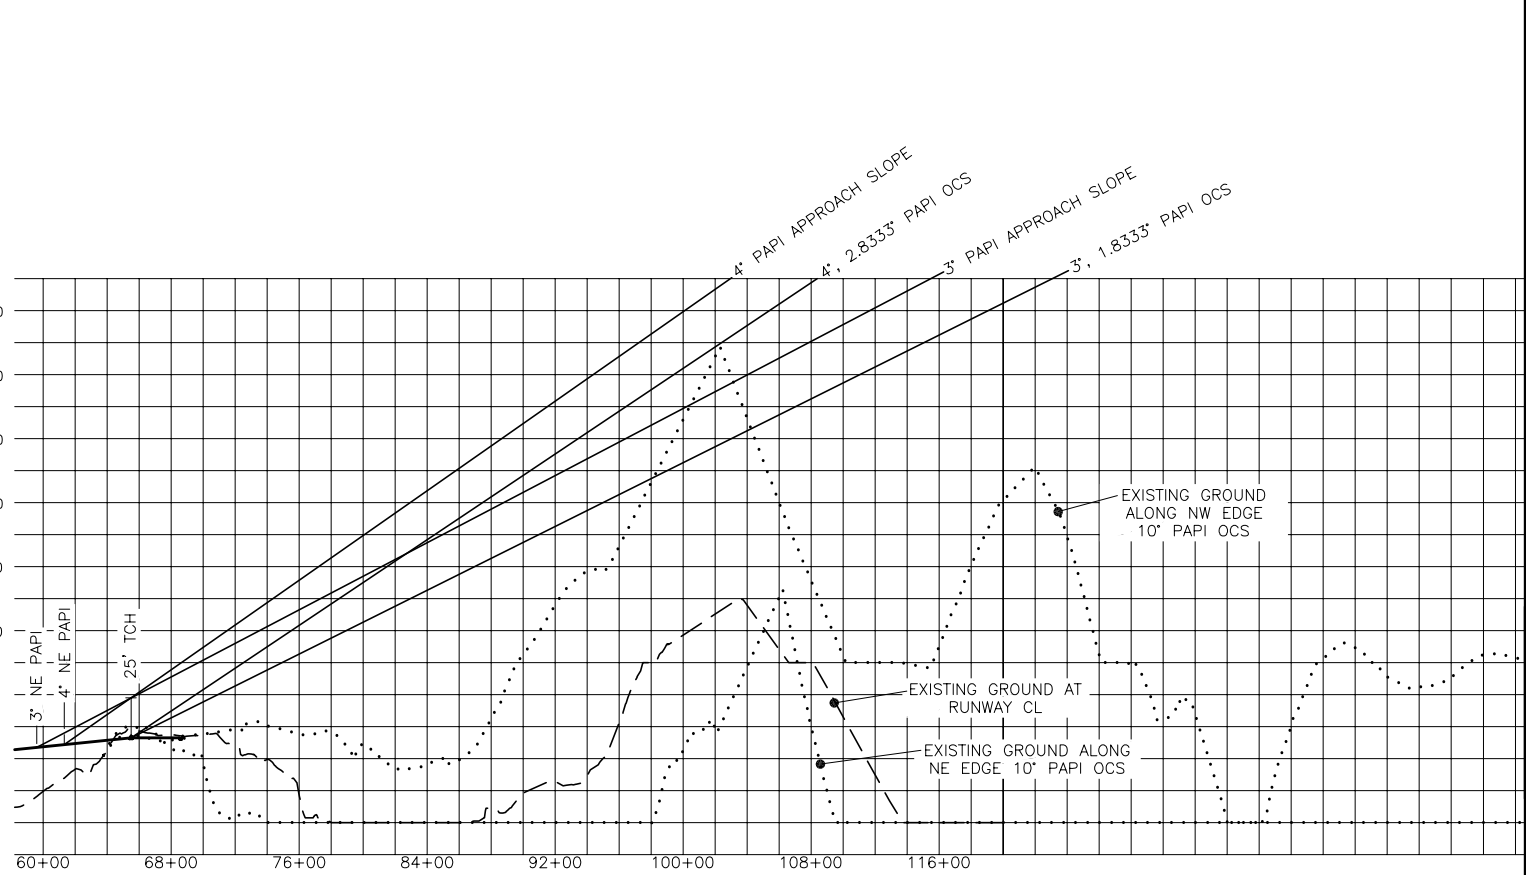
DATE:	3-5-07
APPENDIX	6
FIGURE	1

**Appendix 3**  
**PAPI Approach Slope Analysis**

PAPI: PRECISION APPROACH PATH INDICATOR  
 OCS: OBSTACLE CLEARANCE SURFACE

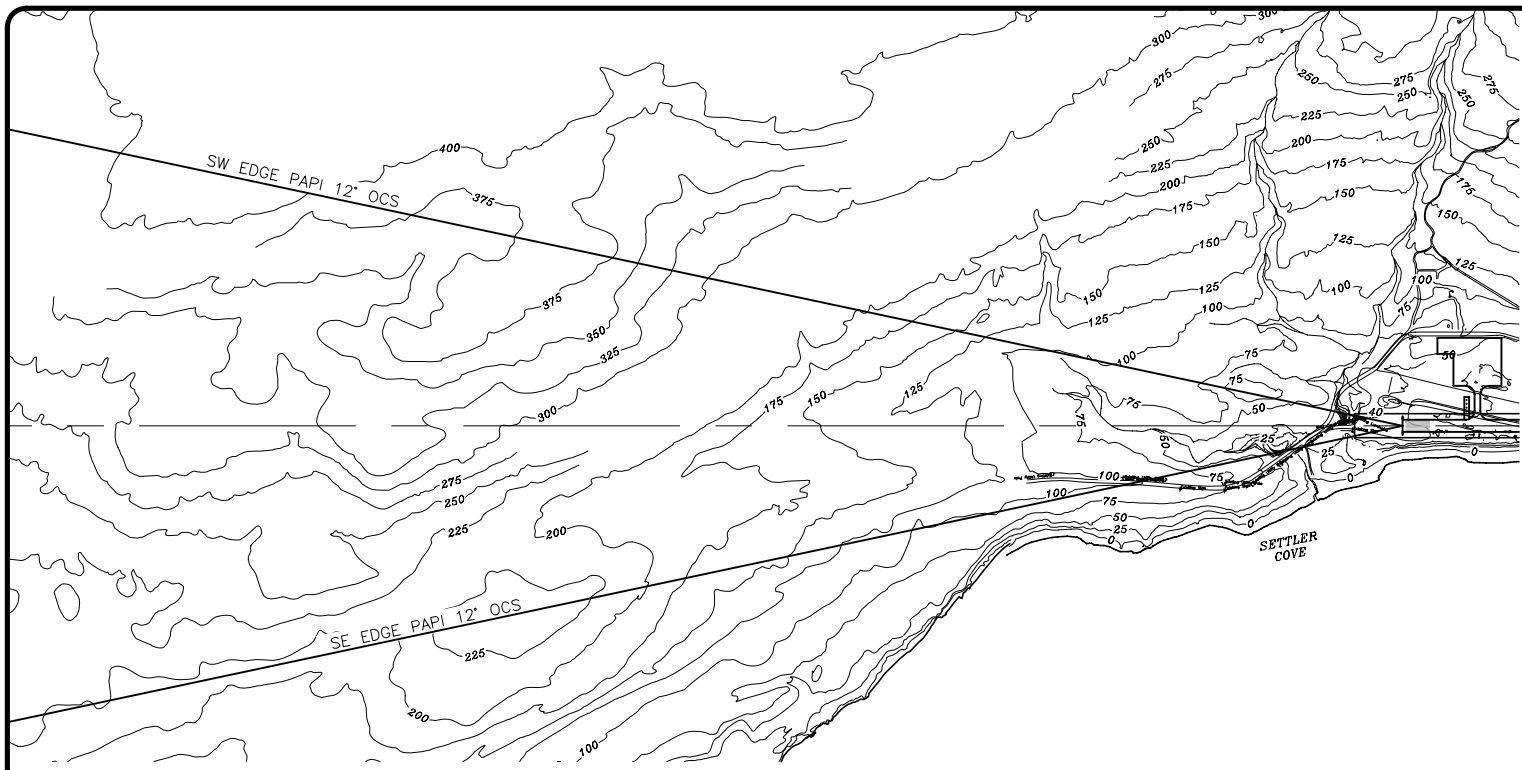
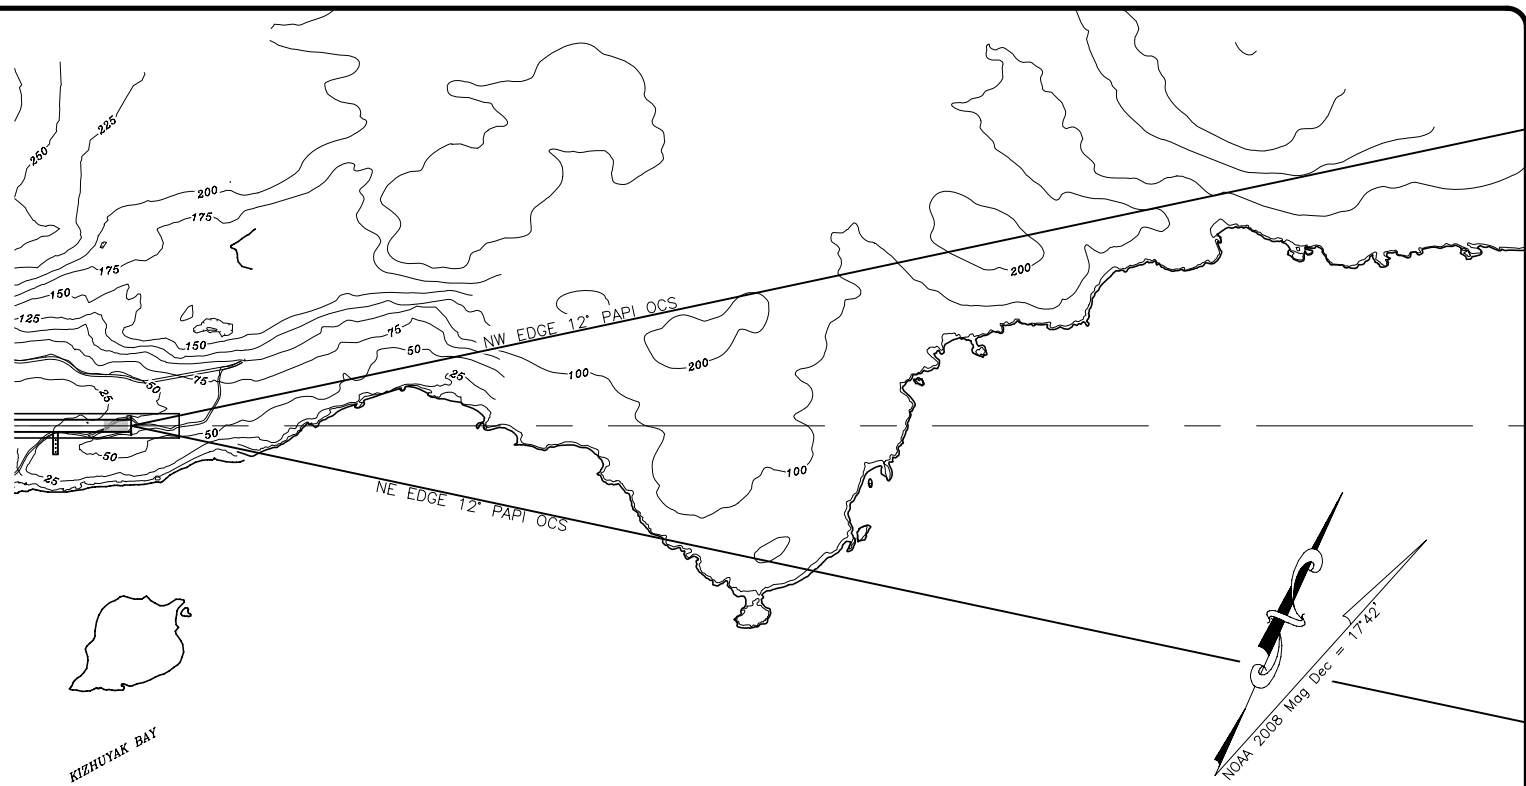
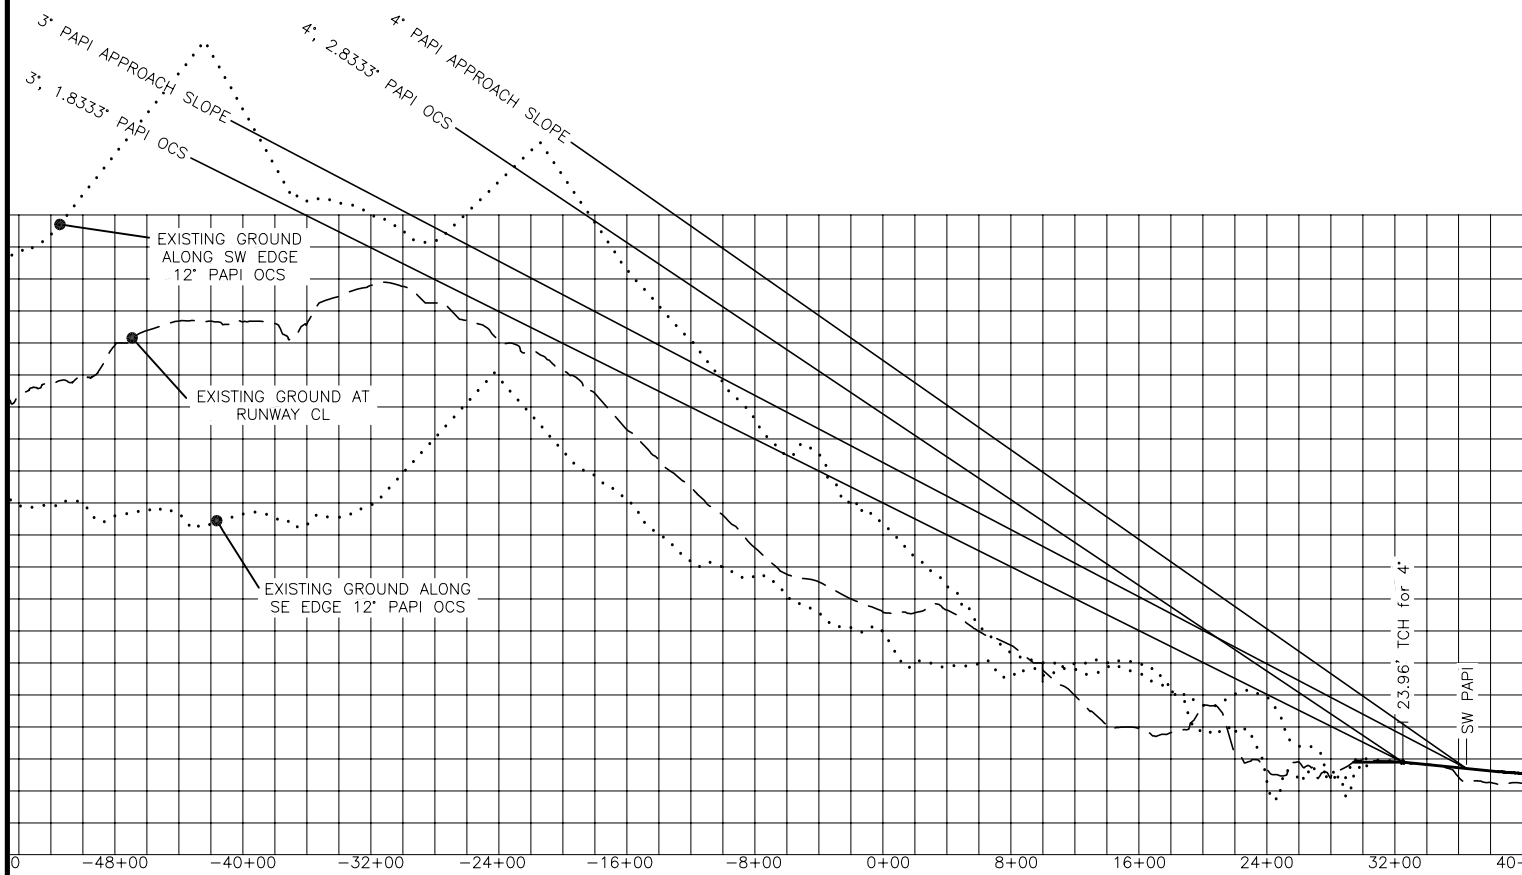
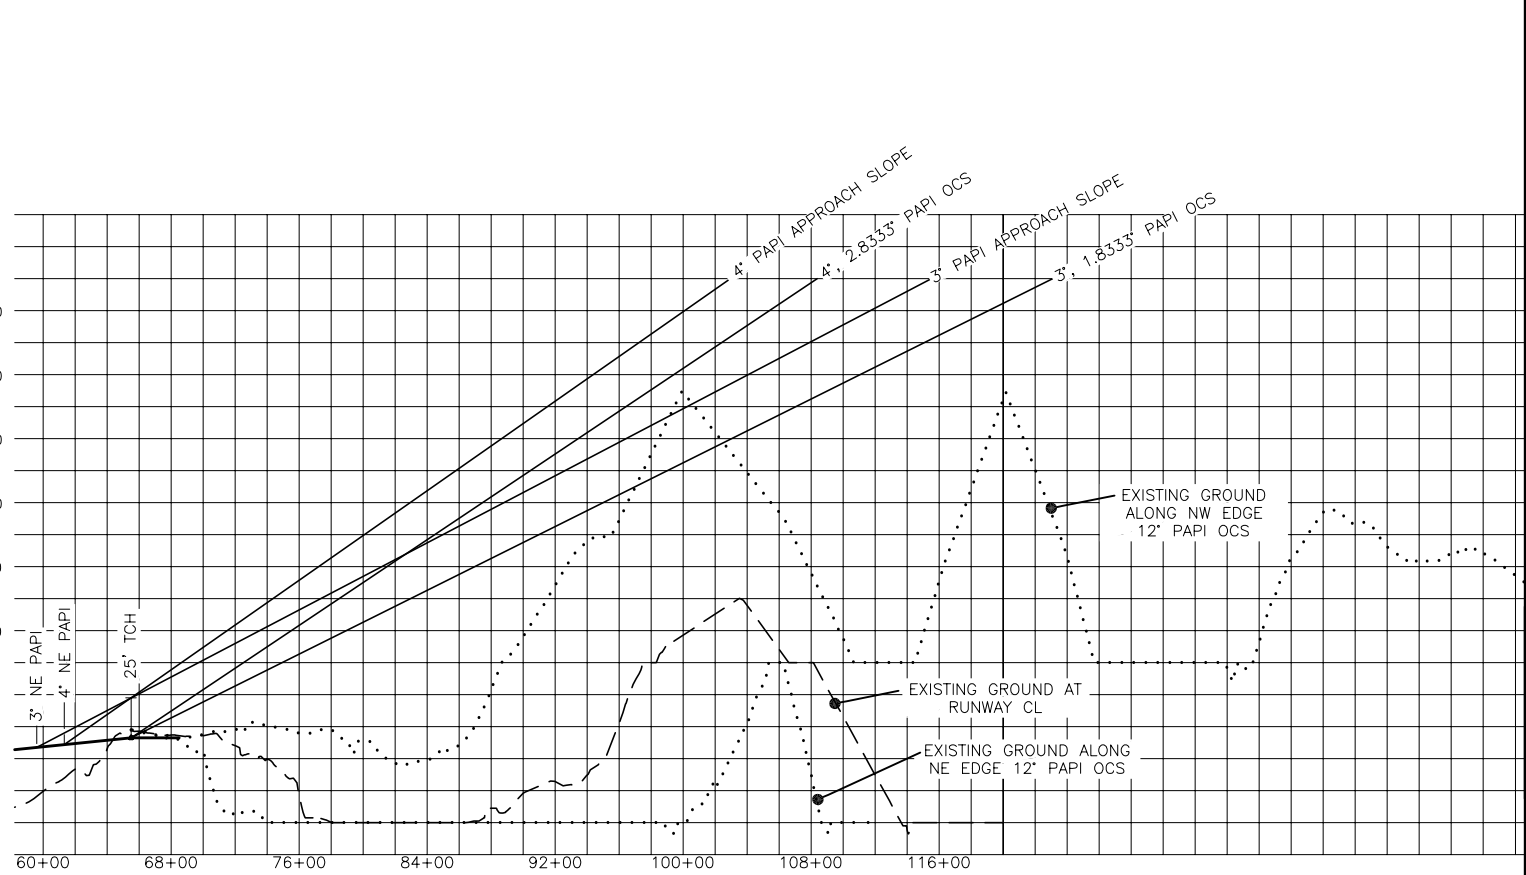
PAPI: PRECISION APPROACH PATH INDICATOR  
 OCS: OBSTACLE CLEARANCE SURFACE
